**MINERALS PROGRAM INSPECTION REPORT**  
**PHONE: (303) 866-3567**

<b>MINE NAME:</b> South D-20 Pit	<b>MINE/PROSPECTING ID#:</b> M-1992-102	<b>MINERAL:</b> Sand and gravel	<b>COUNTY:</b> Montrose
<b>INSPECTION TYPE:</b> Monitoring	<b>INSPECTOR(S):</b> Lucas J. West	<b>INSP. DATE:</b> February 26, 2019	<b>INSP. TIME:</b> 09:56
<b>OPERATOR:</b> The Uncompahgre Valley Water Users Assoc	<b>OPERATOR REPRESENTATIVE:</b> Gary Cooper	<b>TYPE OF OPERATION:</b> 112c - Construction Regular Operation	
<b>REASON FOR INSPECTION:</b> Normal I&E Program	<b>BOND CALCULATION TYPE:</b> Complete Bond	<b>BOND AMOUNT:</b> \$121,573.00	
<b>DATE OF COMPLAINT:</b> NA	<b>POST INSP. CONTACTS:</b> None	<b>JOINT INSP. AGENCY:</b> None	
<b>WEATHER:</b> Clear	<b>INSPECTOR'S SIGNATURE:</b>

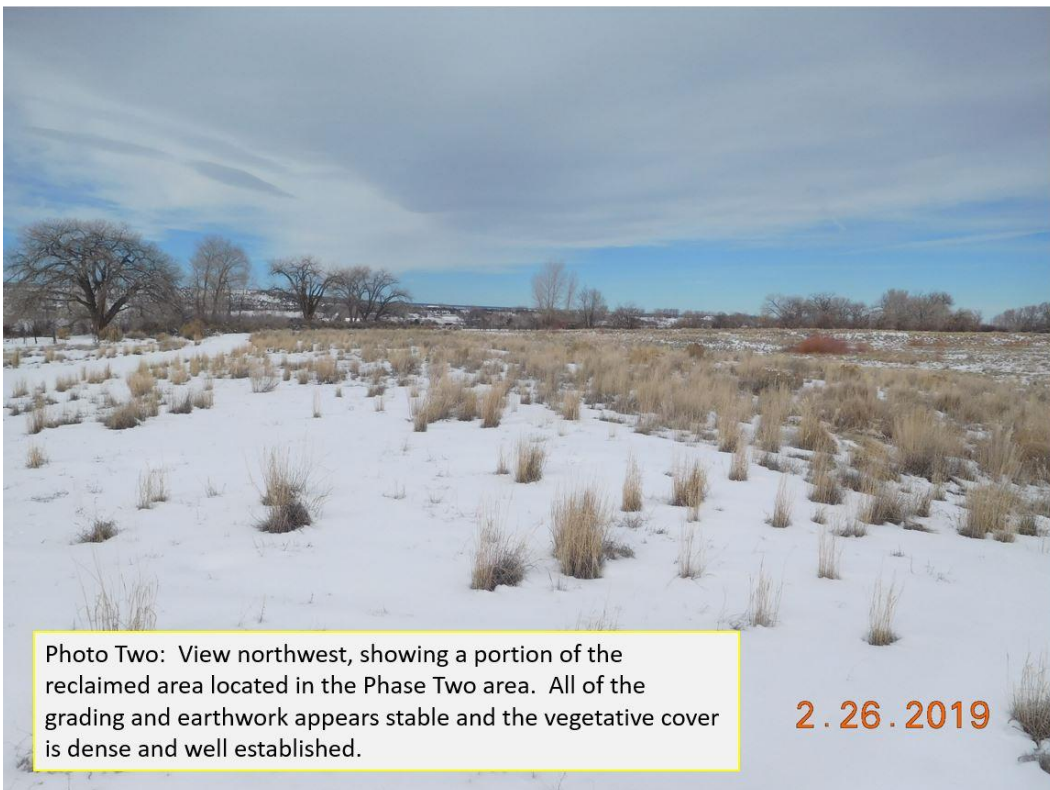
The proper mine identification signage was posted at the entrance to the site and can be seen in Photo One and the permit boundaries were clearly marked. Various mining related equipment was present on site but the site was not active the day of the inspection. Mining activities in the area identified as Phase2, have been completed and the area has been reclaimed. All grading, earthwork and revegetation has been completed. This area can be seen in Photos Two and Three. The grading all appears to be stable and in good condition, no signs of settling, slumping or erosion were noted. The vegetative cover appears to be dense and diverse despite being partially buried in snow. On site discussions with the Operator Representative indicates that mining and reclamation activities in the area are complete and that they would be interested in an Acreage and Surety Reduction. The Division advised the Operator to await the onset of the growing season then submit an Acreage Reduction Request (enclosed) if they feel they have met their reclamation requirements.
