**MINERALS PROGRAM INSPECTION REPORT****PHONE: (303) 866-3567**

MINE NAME: Valco T Pit	MINE/PROSPECTING ID#: M-2004-043	MINERAL: Sand and gravel	COUNTY: Las Animas
INSPECTION TYPE: Monitoring	INSPECTOR(S): Jared L. Ebert	INSP. DATE: March 20, 2019	INSP. TIME: 10:07
OPERATOR: Larry and Christine Tortorice	OPERATOR REPRESENTATIVE: None	TYPE OF OPERATION: 112c - Construction Regular Operation

Valco T Pit, M-2004-043

March 20, 2019 DRMS Inspection

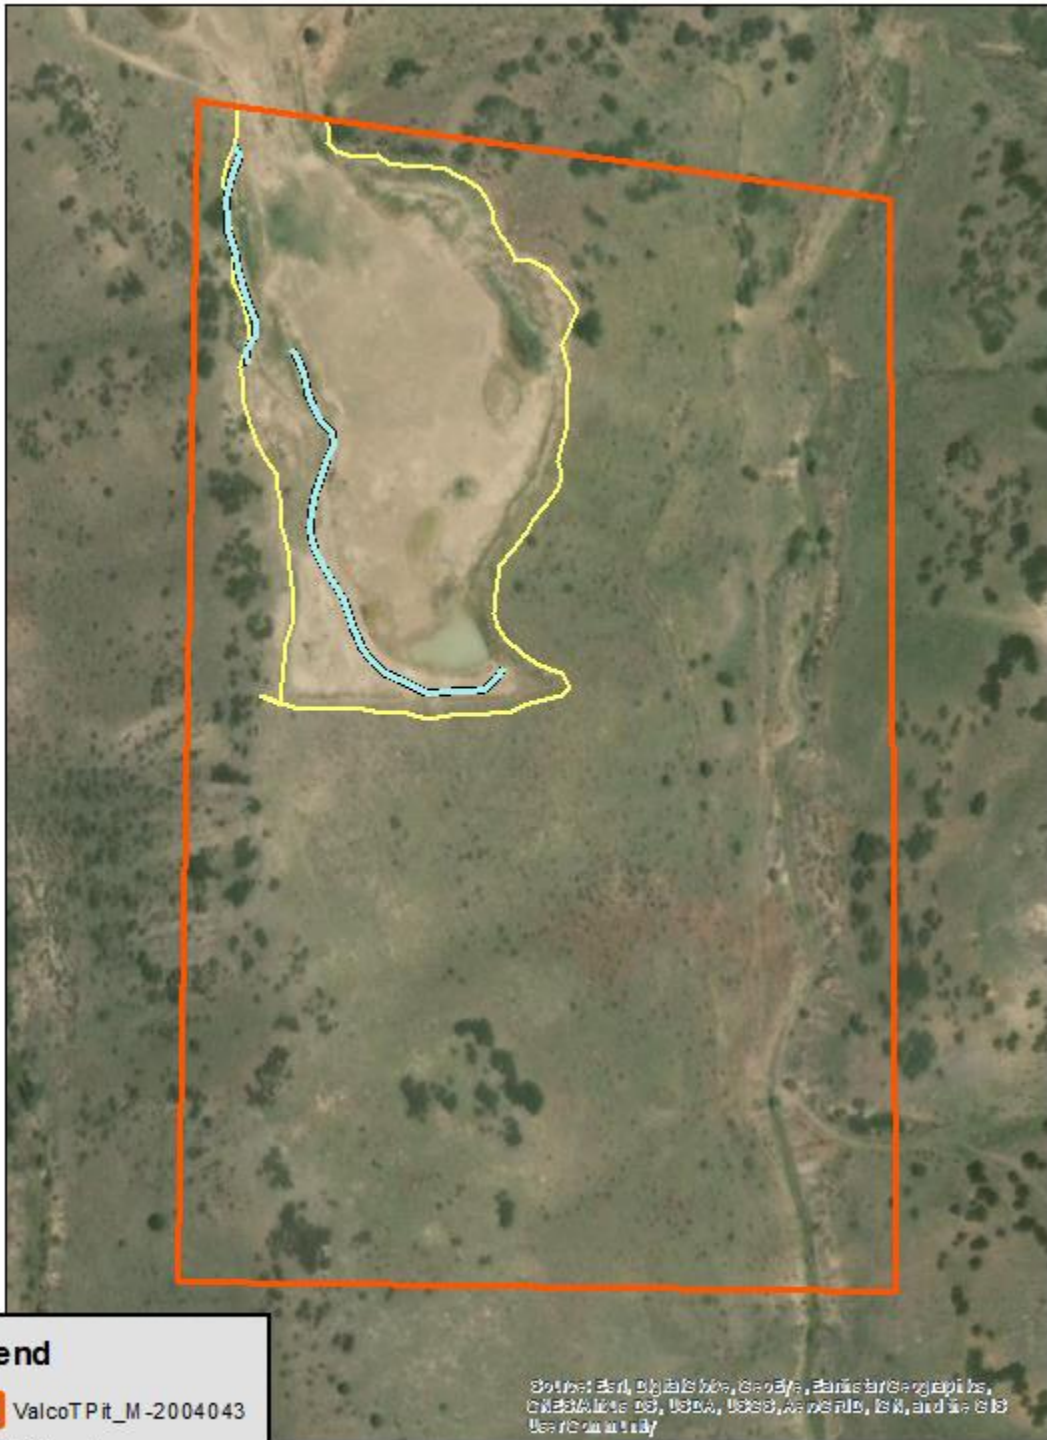
Only one boundary marker was observed, the northwest corner marker. The Division could not located any of the other boundary markers. This issue is cited as a problem at the beginning of this report.

CORRECTIVE ACTIONS: The Operator shall conduct a survey and replace the boundary markers in the correct location(s). The operator shall provide proof to the Division that this has been done by the corrective action date.
