Appendix A Logan Wash Mine Pond Facility Relining Project Summary Report

Garfield County, Colorado

Project No. 10202.01

March 27, 2019

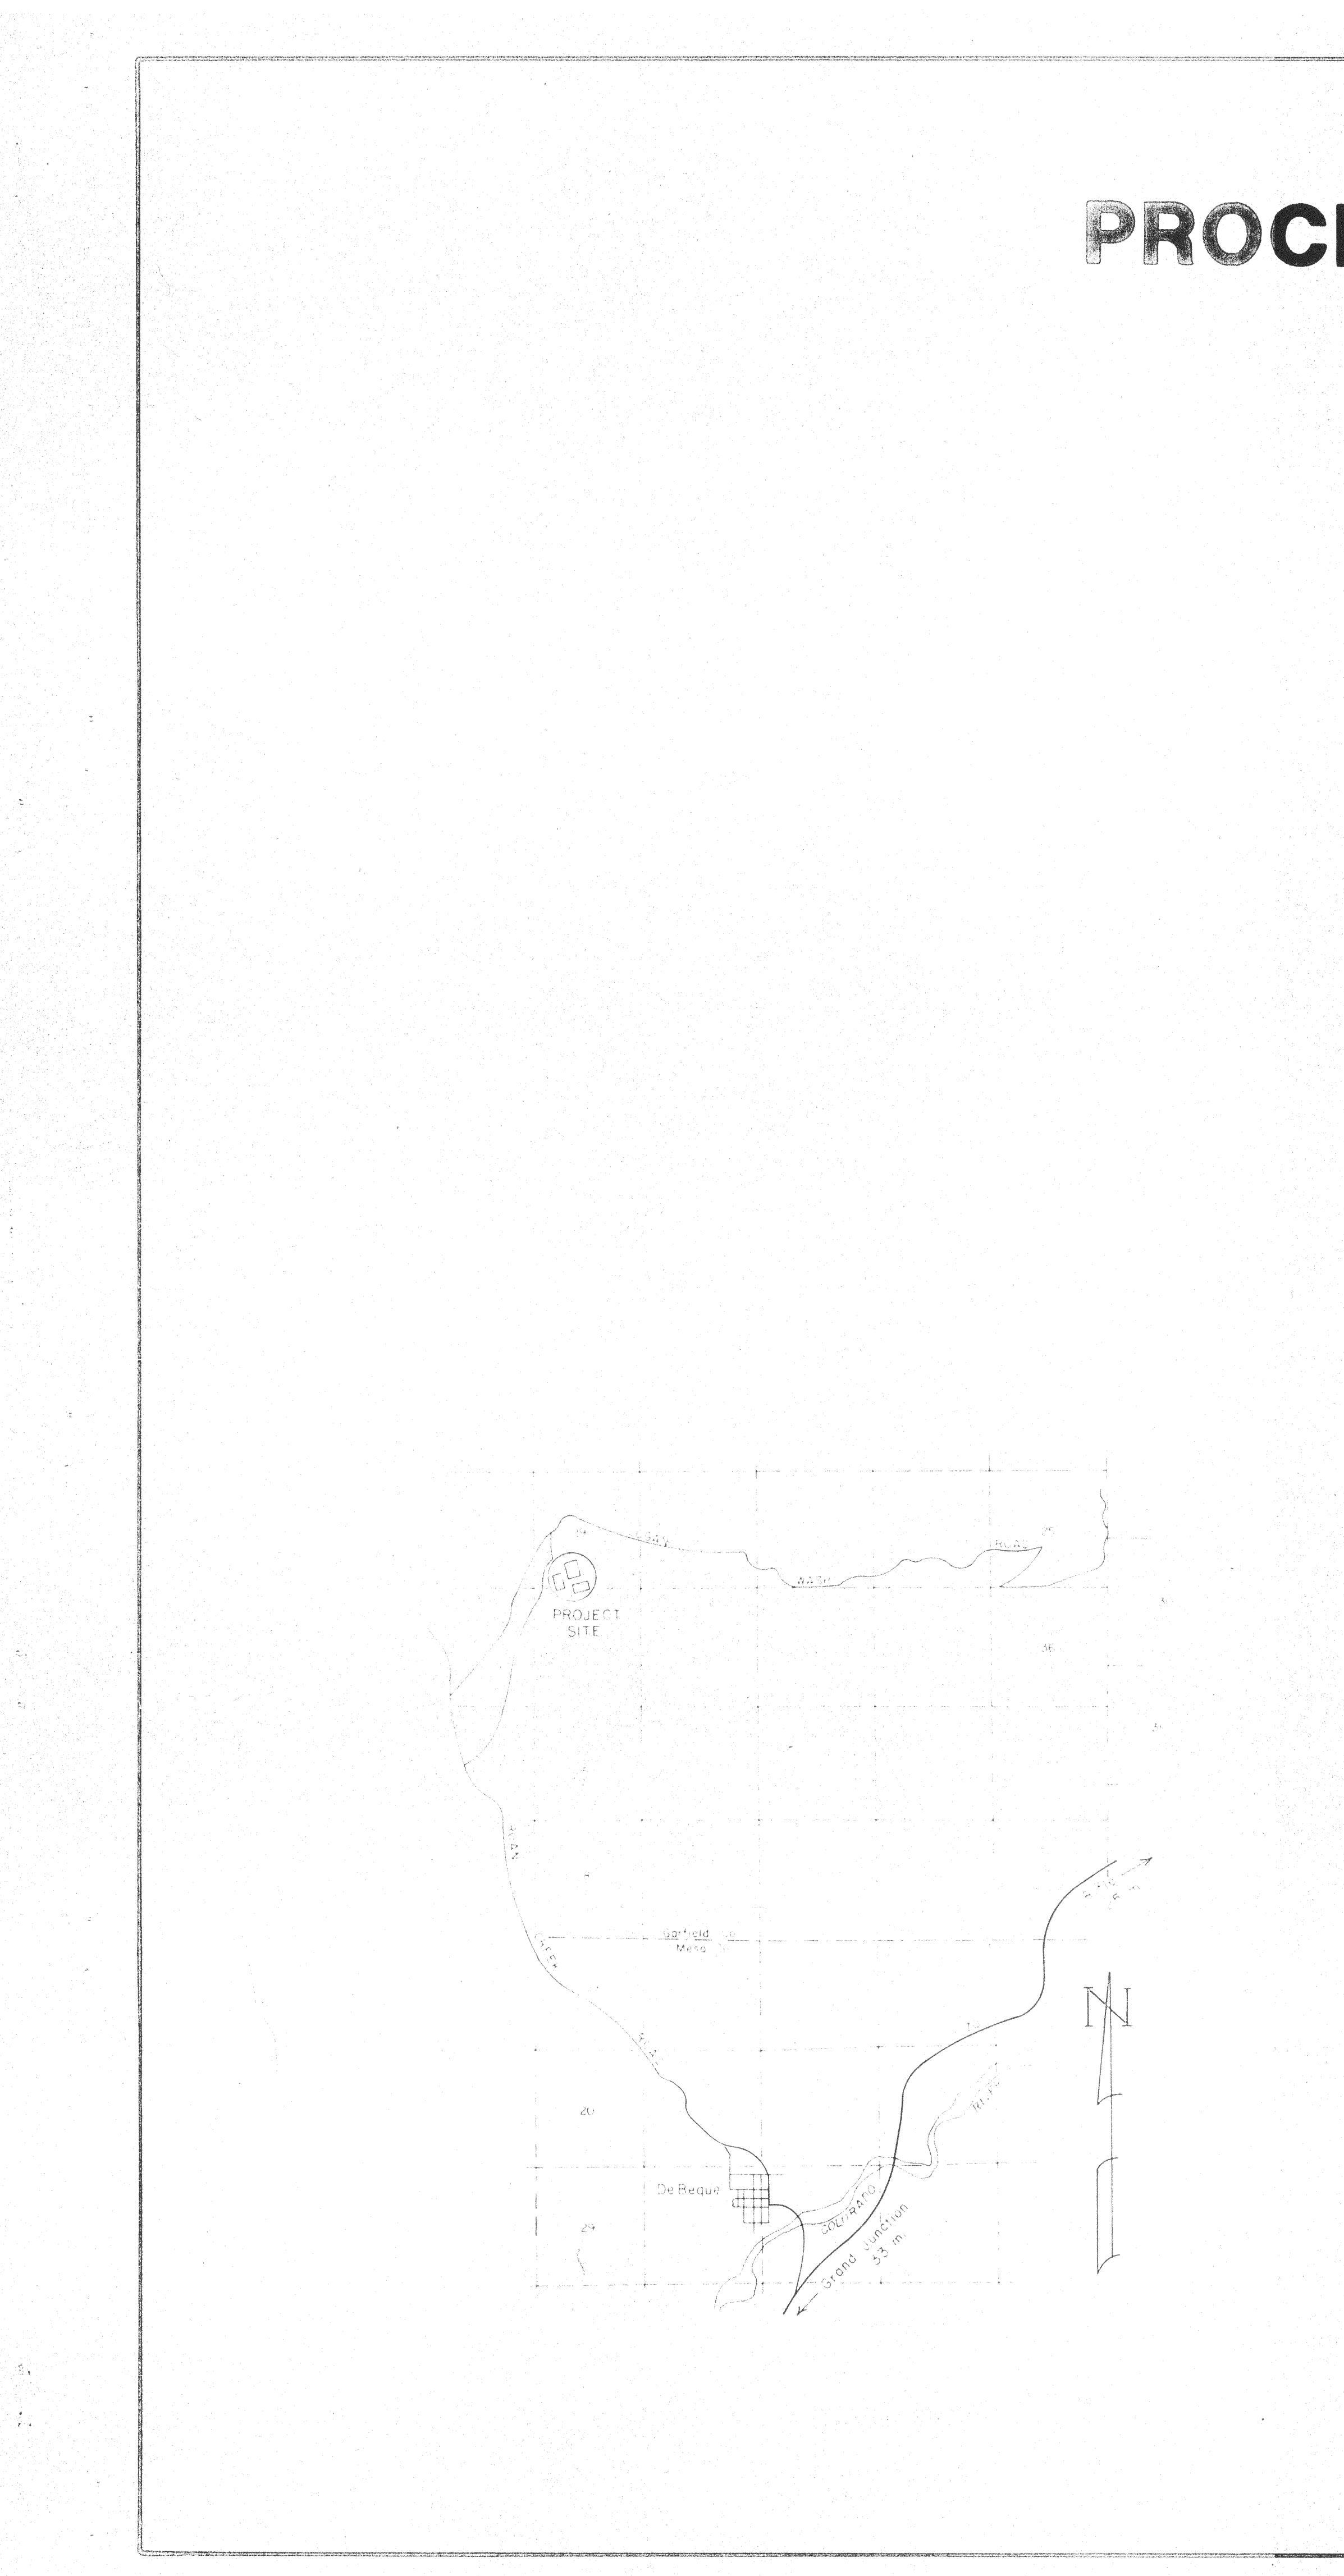
PROCESS WATER EVAPORATION POND AND TRANSMISSION PIPELINE LOGAN WASH FACILITY

The original construction design of the Settling and Evaporation Ponds is indicated in drawings located in project files (see Attachment A). It is apparent that the ponds were constructed by site leveling and excavation of the pond impoundments, likely followed by soil compaction, installation of leak detection drains and vault, and installation of 60 mil HDPE geosynthetic liner. Drawings in Attachment A show details of the 1984 As-Built construction design.

The Evaporation Pond was constructed with an underlying leak detection system. The leak detection system consisted of three main 2-inch diameter, perforated PVC leak gathering pipes that were aligned east to west and equally spaced across the bottom of the pond within excavated channels in the pond subgrade soils. Each pipe was set within a gravel envelope and also had four gravel drain channels that extended perpendicular from the pipe alignment on both sides of the pipe. These gravel drains acted as the main means to capture leakage from the overlying 60-mil HDPE liner. The three main leak conveyance pipes are connected to a common 2-inch vent pipe that trends north-south on the bottom of the east quarter of the pond. The pond bottom was constructed flat, but the intended slope of the leak detection drains and pipes was indicated to be 0.30% or 0.3 feet of vertical drop per 100 feet of horizontal distance. This slope represents a potential drop of approximately 1 foot across the bottom of the pond from east to west (see Drawing Sheet 4 of 8, Attachment A).
