## Airport Gravel Pit, M-1983-039

**MINERALS PROGRAM INSPECTION REPORT****PHONE: (303) 866-3567**

<b>MINE NAME:</b> Airport Gravel Pit	<b>MINE/PROSPECTING ID#:</b> M-1983-039	<b>MINERAL:</b> Sand and gravel	<b>COUNTY:</b> Las Animas
<b>INSPECTION TYPE:</b> Monitoring	<b>INSPECTOR(S):</b> Jared L. Ebert	<b>INSP. DATE:</b> March 19, 2019	<b>INSP. TIME:</b> 10:00
<b>OPERATOR:</b> Las Animas County	<b>OPERATOR REPRESENTATIVE:</b> John Lucero	<b>TYPE OF OPERATION:</b> 112c - Construction Regular Operation

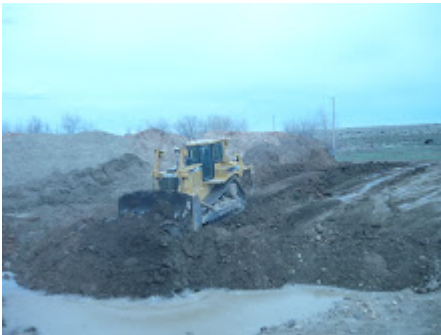
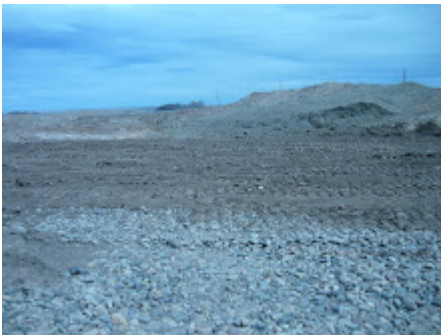
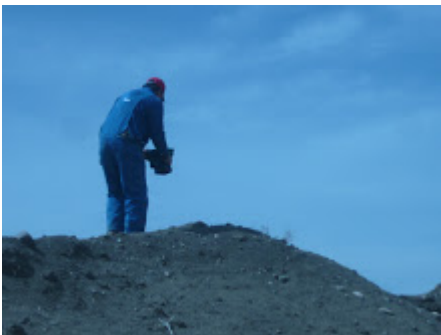
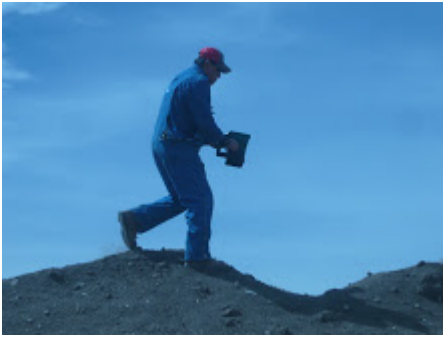
Jared, attached are pics showing our filling in of the "pond" and seeding of the stockpiles. Let me know if we need to do anything more. Thanks, phil

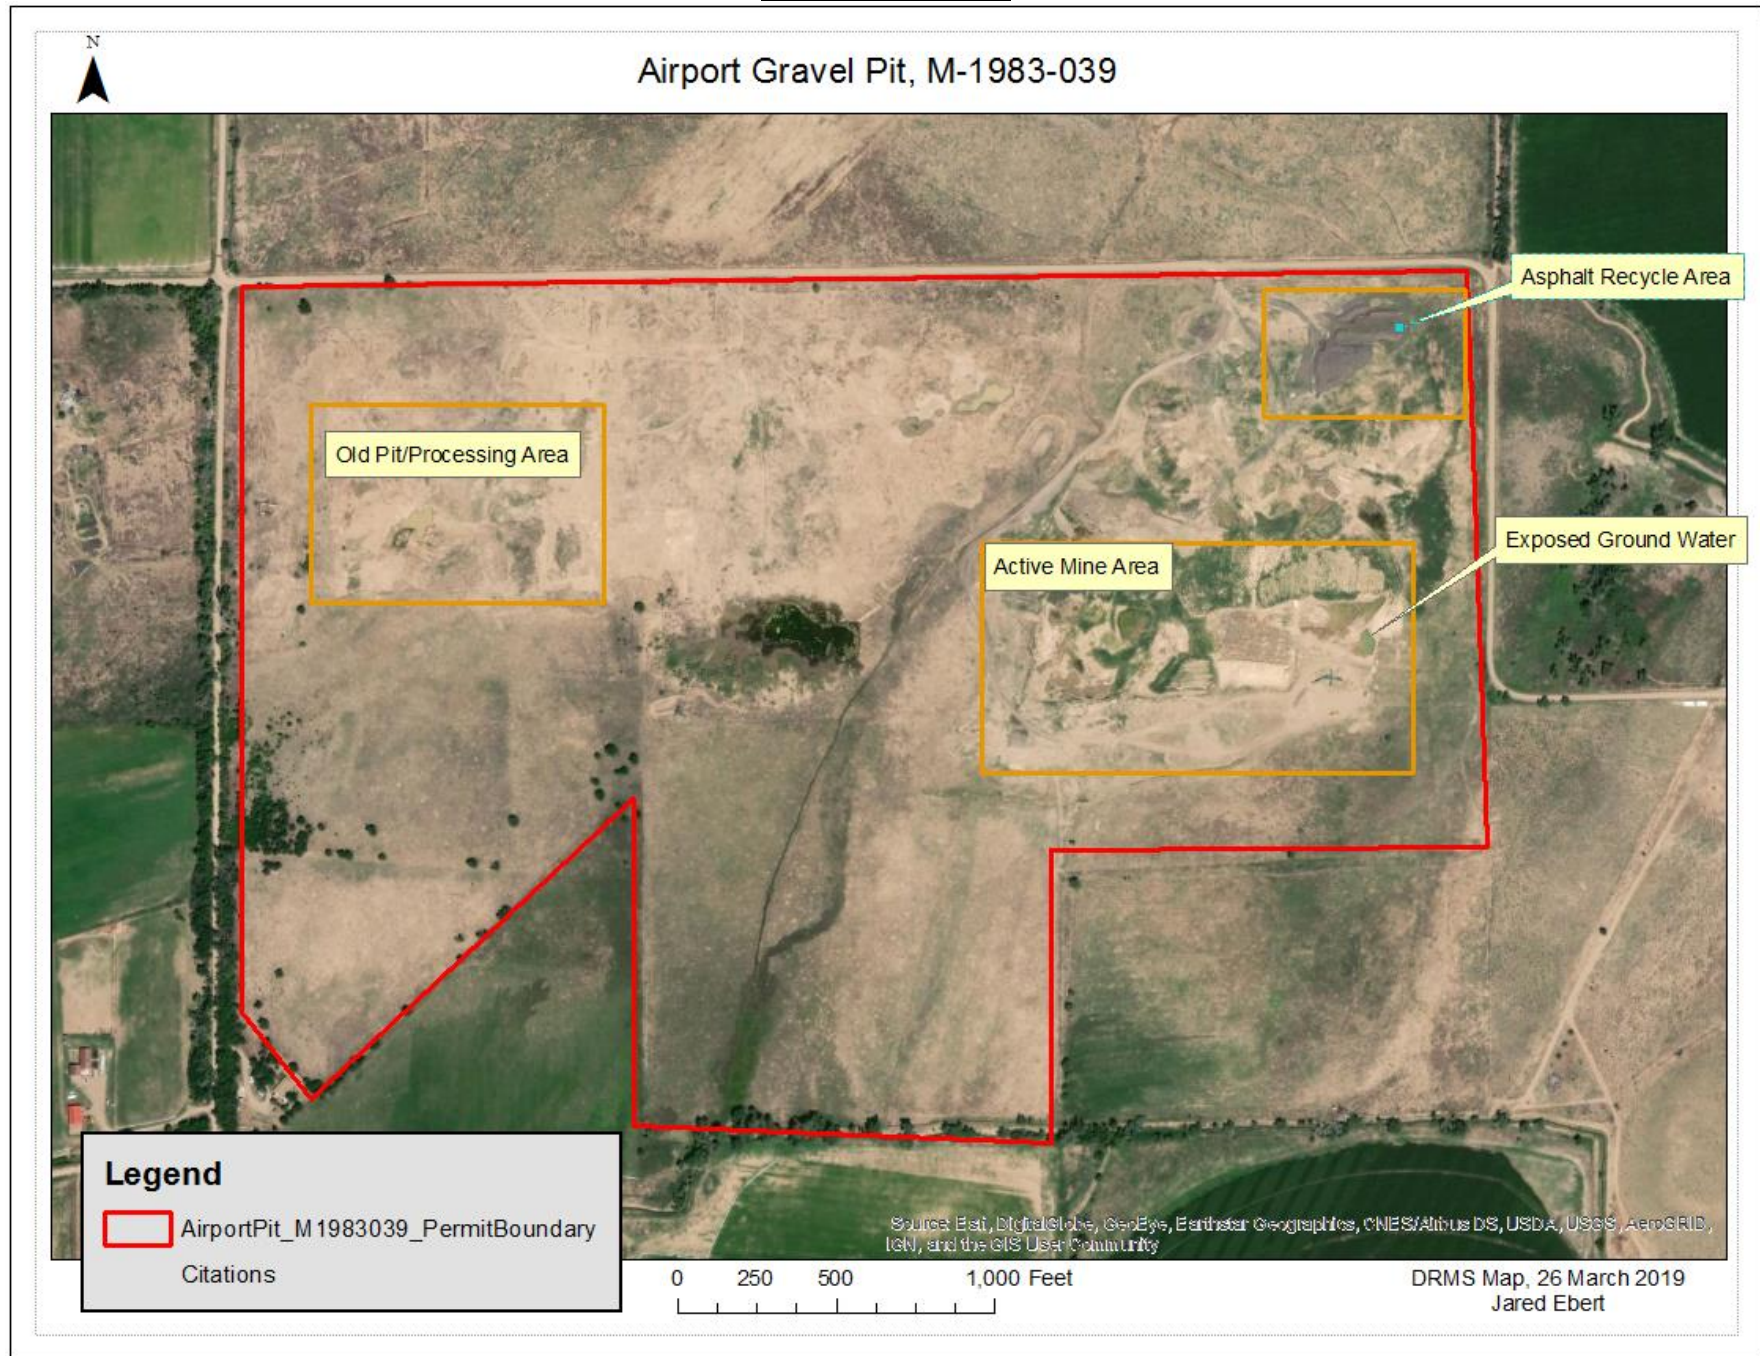
**Figure 1. From the northwest corner of the active pit area.**
