**MINERALS PROGRAM INSPECTION REPORT****PHONE: (303) 866-3567**

<b>MINE NAME:</b> Adams Pit	<b>MINE/PROSPECTING ID#:</b> M-1983-177	<b>MINERAL:</b> Sand and gravel	<b>COUNTY:</b> Bent
<b>INSPECTION TYPE:</b> Monitoring	<b>INSPECTOR(S):</b> Amy Eschberger	<b>INSP. DATE:</b> March 7, 2019	<b>INSP. TIME:</b> 10:45
<b>OPERATOR:</b> Bent County	<b>OPERATOR REPRESENTATIVE:</b> Robert Darnell	<b>TYPE OF OPERATION:</b> 110c - Construction Limited Impact	
<b>REASON FOR INSPECTION:</b> Normal I&E Program	<b>BOND CALCULATION TYPE:</b> None	<b>BOND AMOUNT:</b> \$0.00	
<b>DATE OF COMPLAINT:</b> NA	<b>POST INSP. CONTACTS:</b> None	<b>JOINT INSP. AGENCY:</b> None	
<b>WEATHER:</b> Clear	<b>INSPECTOR'S SIGNATURE:</b>

# M-1983-177 / Adams Pit / Bent County

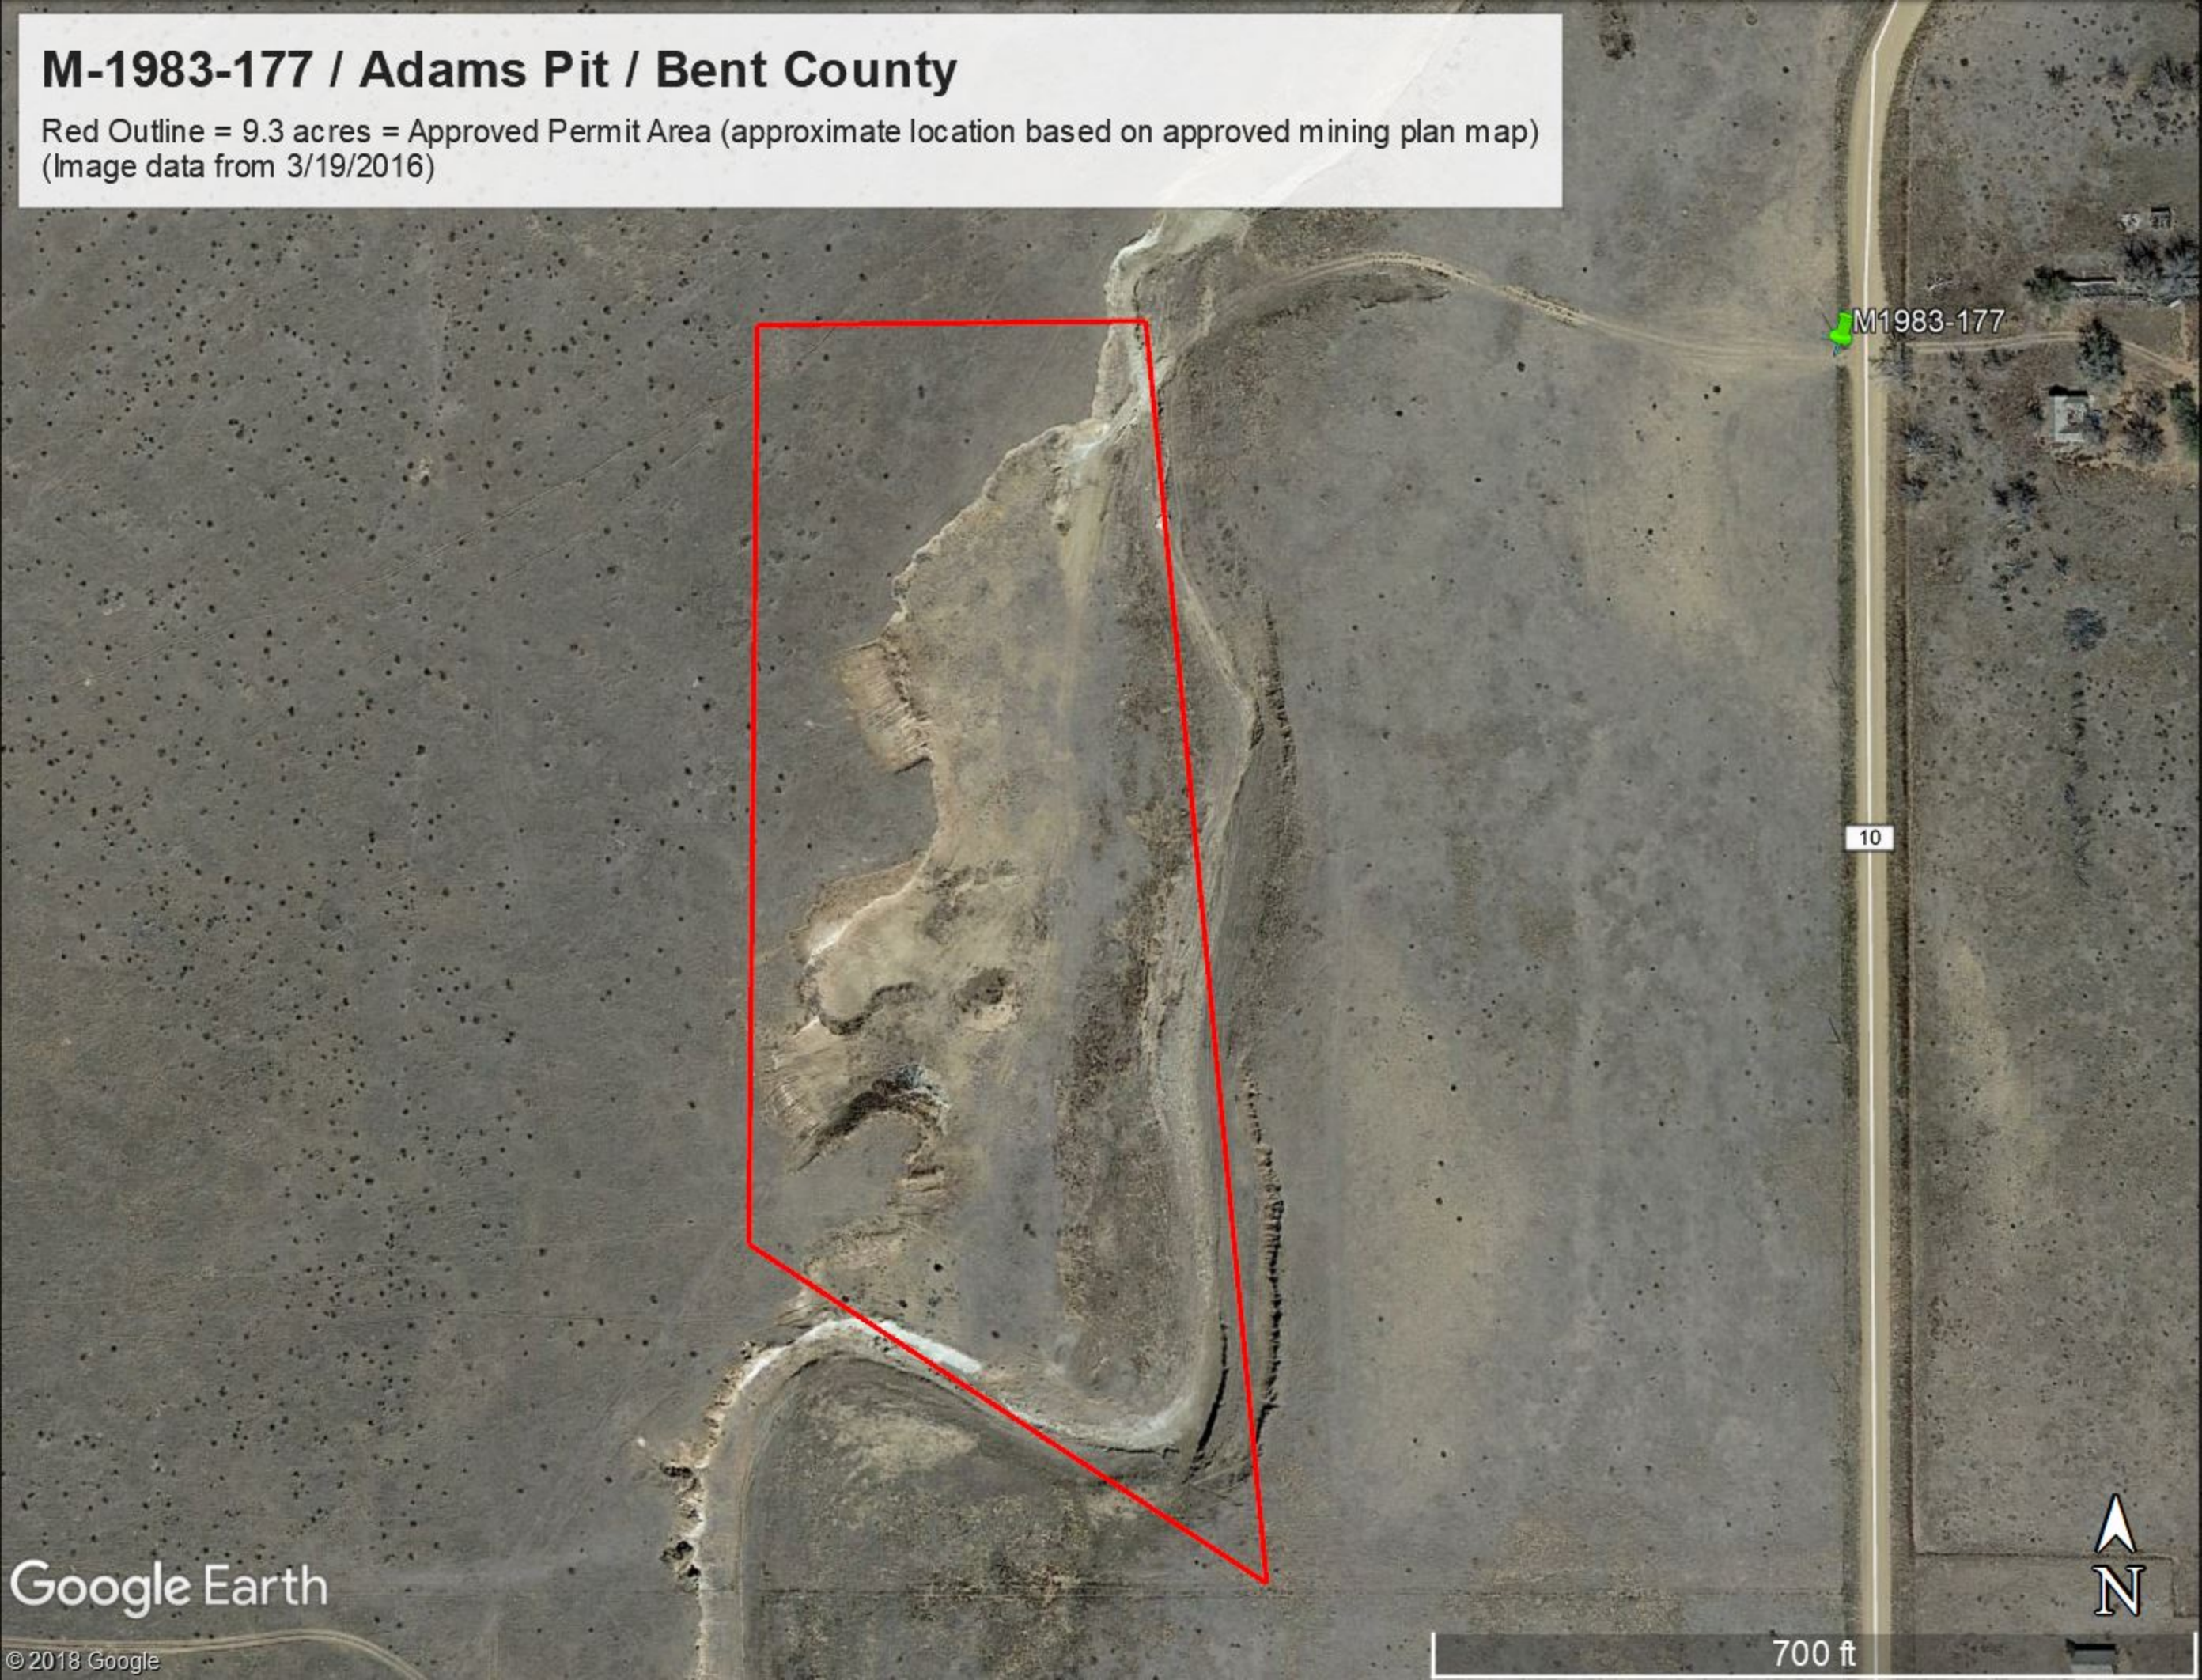
The operation appears to be following the approved mining plan. However, a portion of the highwall at the southwestern edge of the site is currently very close to the western permit boundary. Therefore, the operator should be careful not to disturb land outside the approved permit boundary in this area, especially when reclaiming this portion of the highwall. The Division estimates the operation has disturbed a total of 2.9 acres. No problems were observed.

Red Outline = 9.3 acres = Approved Permit Area (approximate location based on approved mining plan map)  
(Image data from 3/19/2016)
