Subject: Corrective Actions Documentation for Stocks Clay Mine  
Mine/Prospecting ID#: M-1977-324

## MINERALS PROGRAM INSPECTION REPORT

<b>MINE NAME:</b> Stocks Clay Mine	<b>MINE/PROSPECTING ID#:</b> M-1977-324	<b>MINERAL:</b> Clay (general)	<b>COUNTY:</b> Fremont
<b>INSPECTION TYPE:</b> Monitoring	<b>INSPECTOR(S):</b> Timothy A. Cazier	<b>INSP. DATE:</b> August 1, 2018	<b>INSP. TIME:</b> 14:00
<b>OPERATOR:</b> Summit Brick & Tile Co.	<b>OPERATOR REPRESENTATIVE:</b> Mike Leidich & Mark Jesik	<b>TYPE OF OPERATION:</b> 112c - Construction Regular Operation

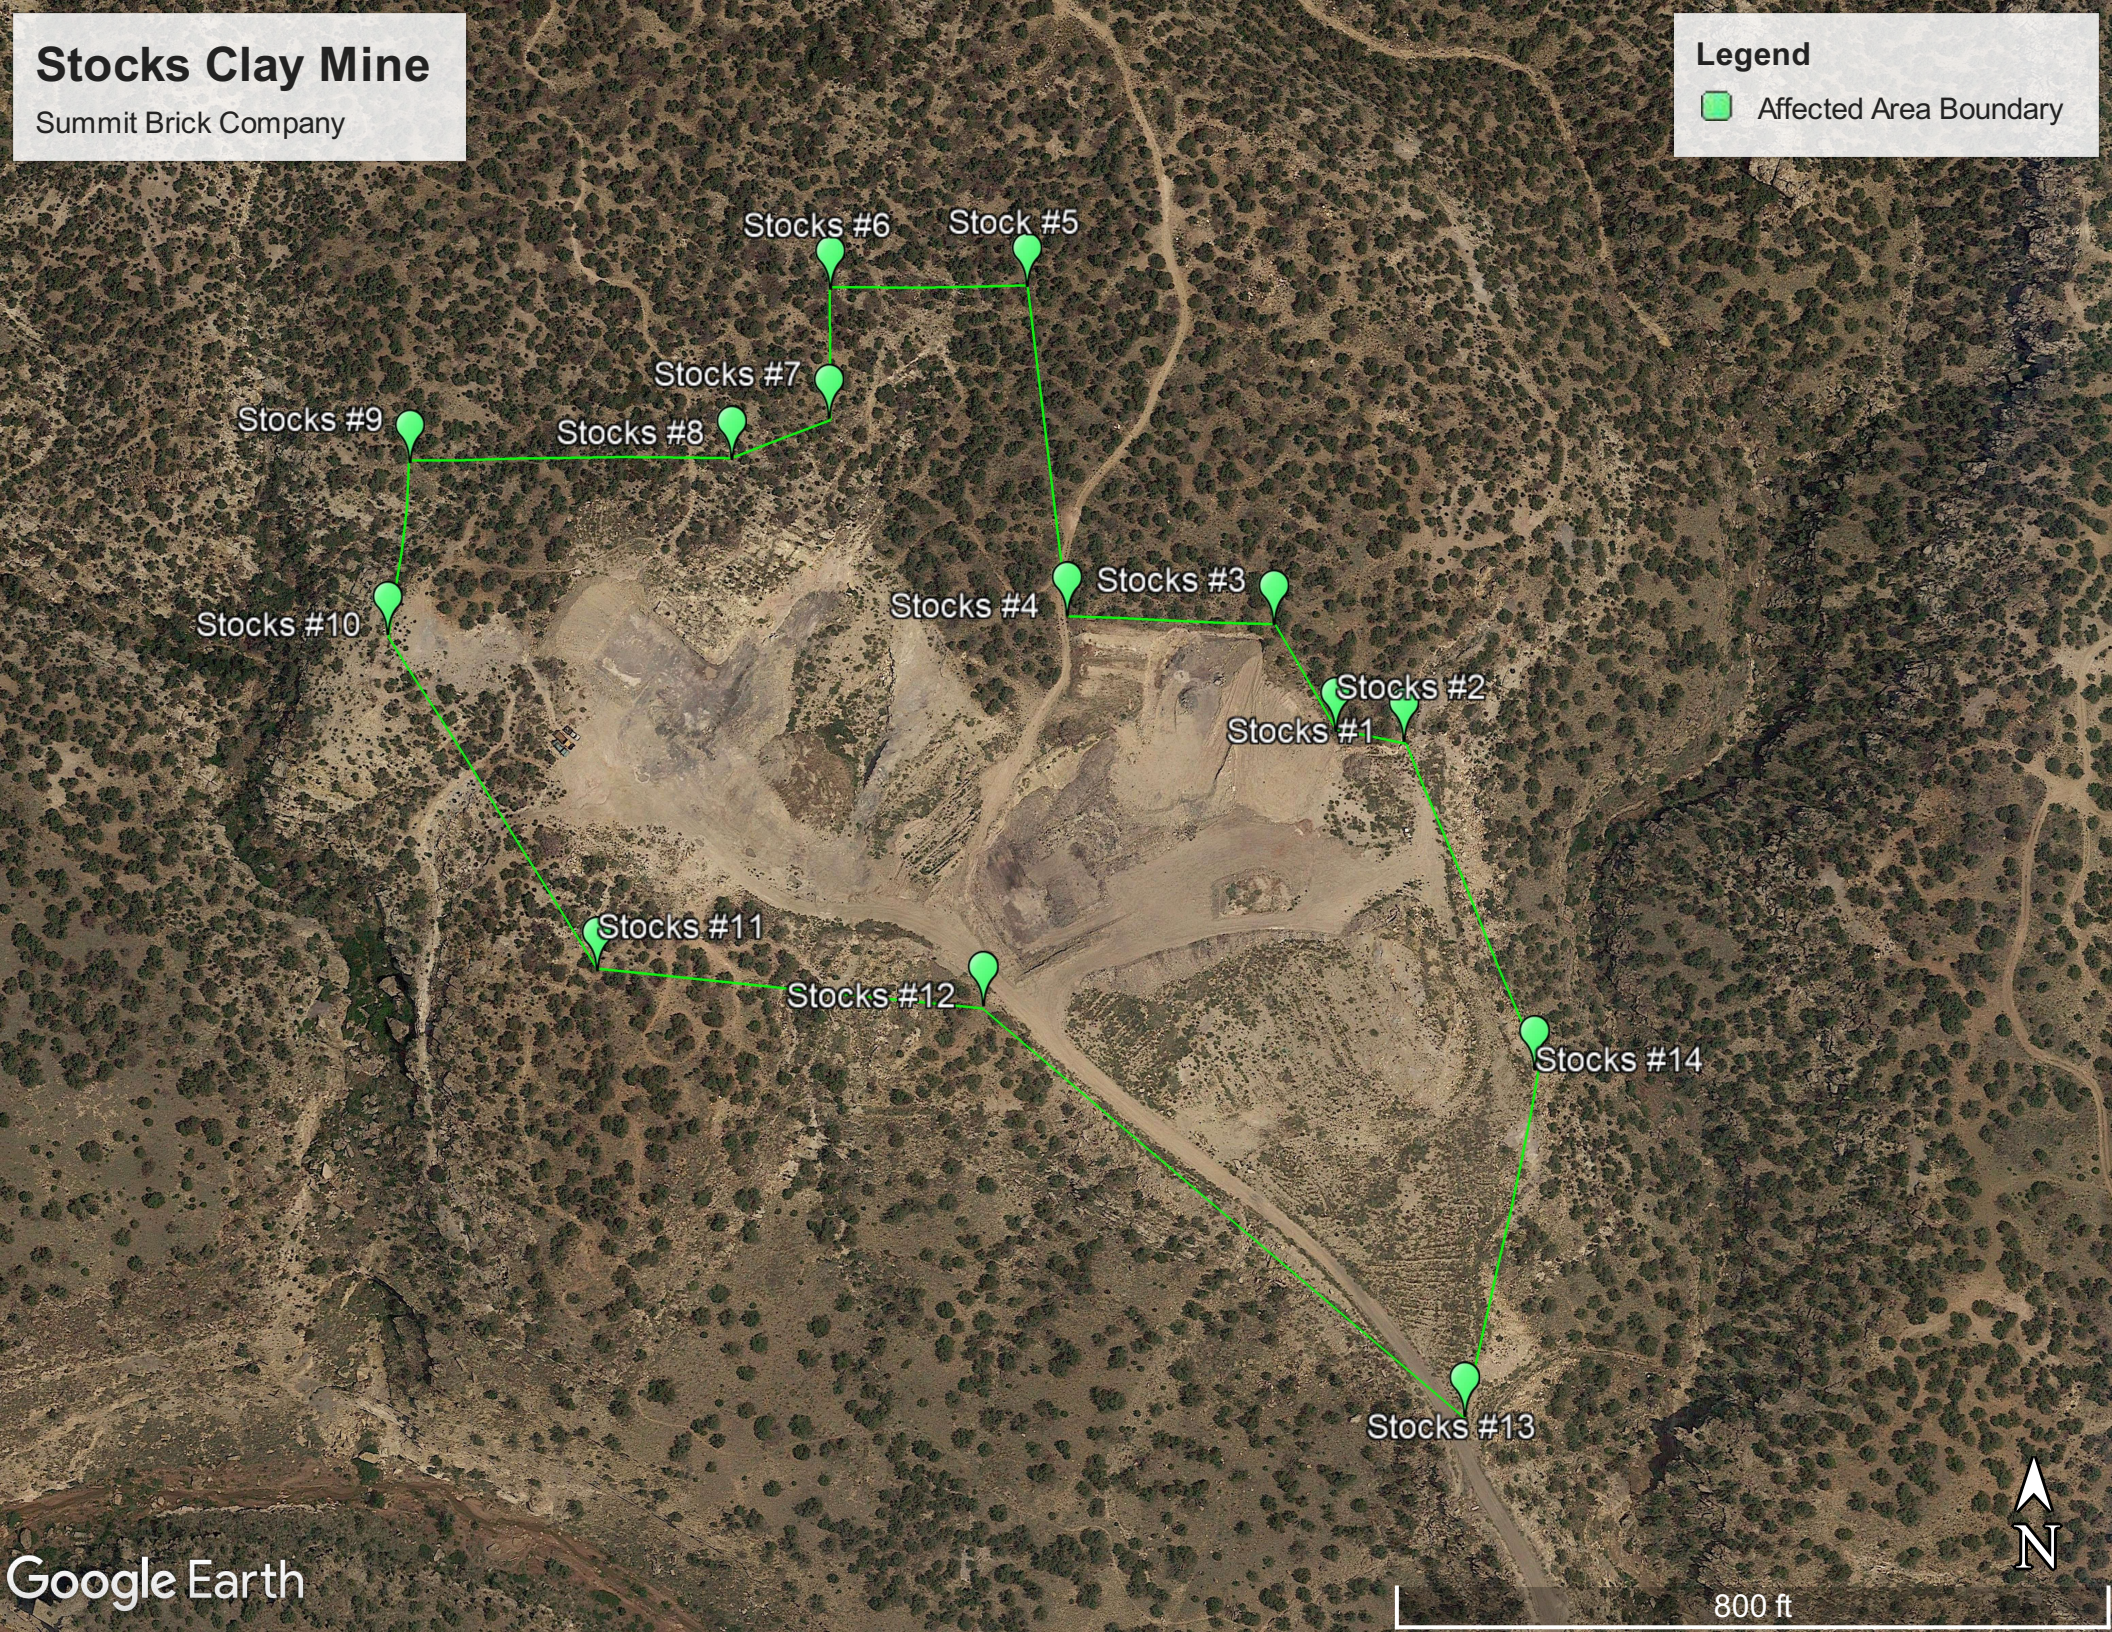
1. August 1, 2018 Minerals Program Inspection Report & Post-Inspection Map
2. Google Earth map, displaying the outline of the affected area and the locations of boundary markers
3. Table of the GPS coordinates for the affected area boundary markers
4. Photograph of boundary markers, representing type of markers placed at all listed boundary marker locations

**CORRECTIVE ACTIONS:** The operator shall conduct a survey and replace the west side boundary markers in the correct location(s). The operator shall provide proof to the Division that this has been done by the corrective action date.

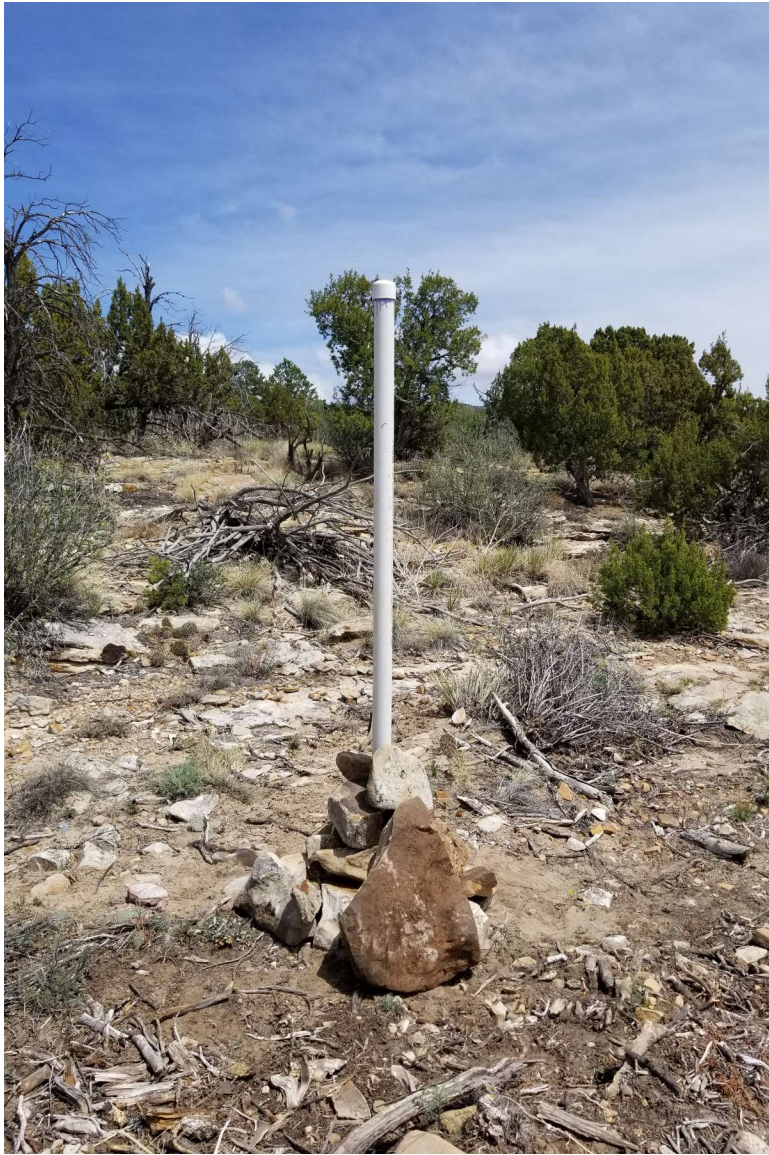
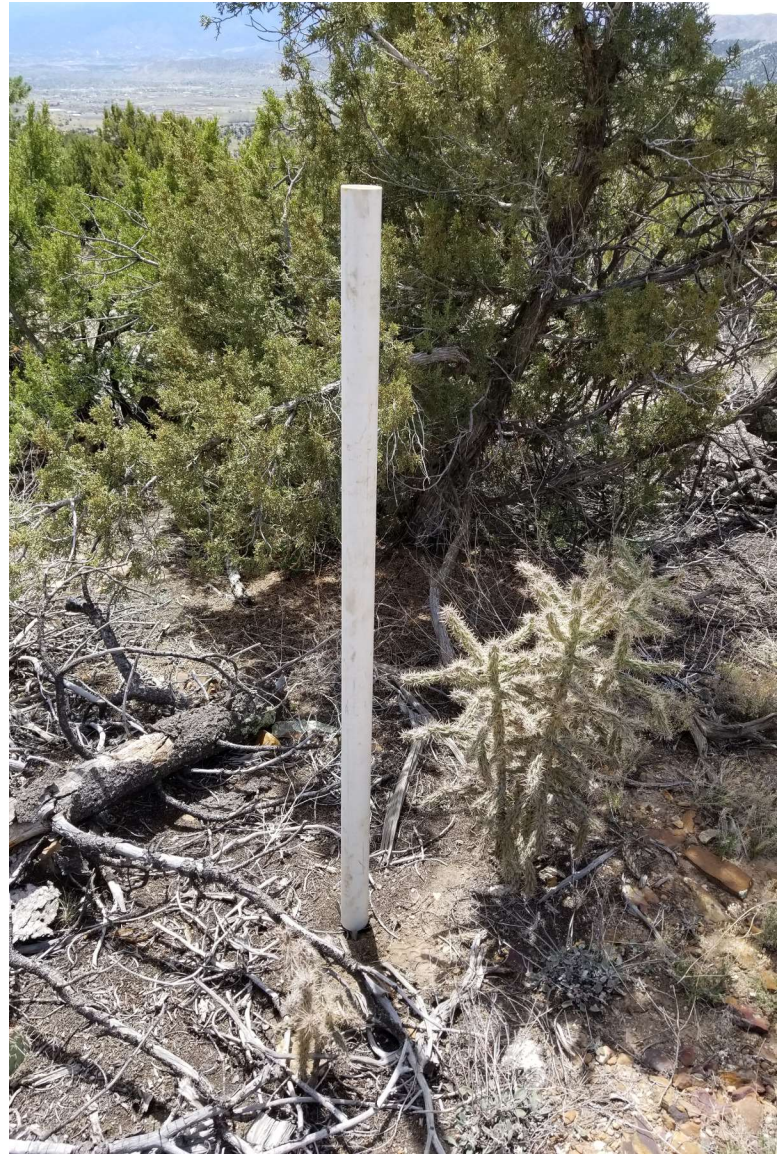
**PROBLEM/POSSIBLE VIOLATION:** Problem: The west side affected area boundary markers are missing or incorrectly placed. This is a problem for failure to maintain boundary markers around the affected area as required by Section 3.1.12(2) of the rule.
