**MINERALS PROGRAM INSPECTION REPORT**  
**PHONE: (303) 866-3567**

| <b>MINE NAME:</b><br>Cresson Project | <b>MINE/PROSPECTING ID#:</b><br>M-1980-244 | <b>MINERAL:</b><br>Gold | <b>COUNTY:</b><br>Teller |
| <b>INSPECTION TYPE:</b><br>Monitoring | <b>INSPECTOR(S):</b><br>Amy Eschberger, Patrick Lennberg | <b>INSP. DATE:</b><br>April 23, 2019 | <b>INSP. TIME:</b><br>09:45 |

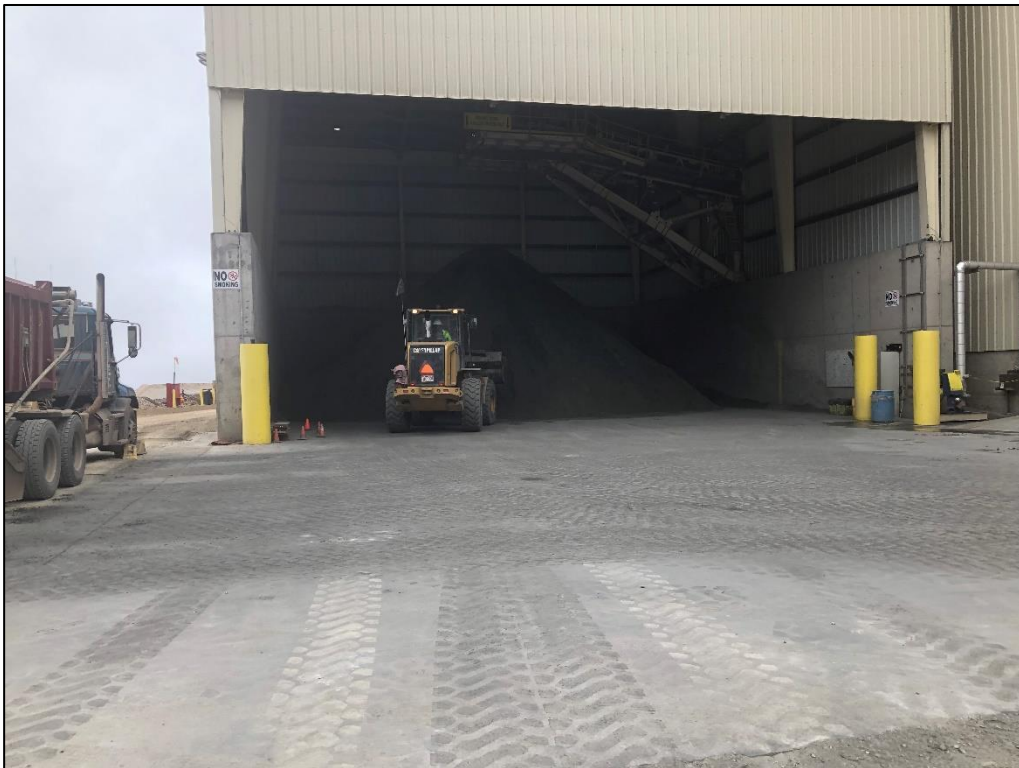
**Photo 18.** View looking northwest at Con Barn located at southern edge of HGM.

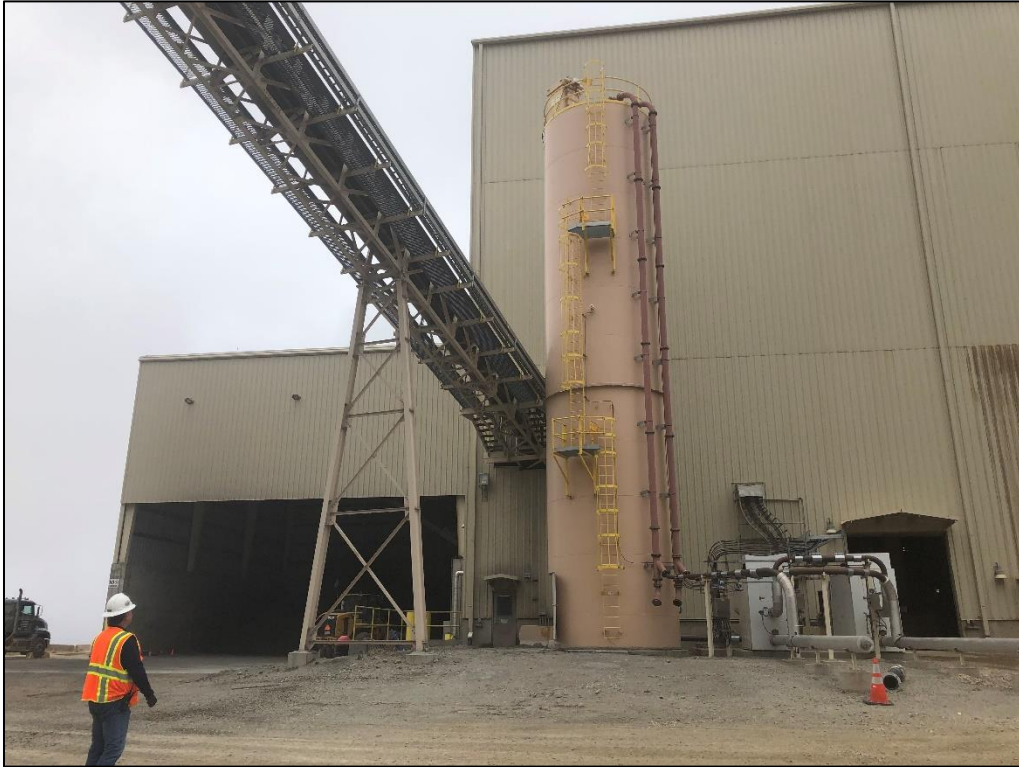
During the HGM inspection, the operator pointed out the 330 ton silo which Technical Revision No. 114 (TR-114) proposes to relocate from the southeast corner of the HGM to the Squaw Gulch Overburden Storage Area (SGOSA). The relocation of this silo will improve operational efficiency by providing a means to add either lime or cement ore prior to placement on the valley leach facilities. TR-114 proposes placing the silo adjacent to the haul road on an elevated concrete foundation. A retaining wall will be constructed, offset from the silo by approximately 45 feet. The silo will be equipped with a conveyor stretching from the bottom of the silo over the retaining wall to a dump hopper, where the lime or cement material will be discharged into the bed of a haul truck, on top of the ore. The Division is currently reviewing the operator's adequacy response for TR-114 received on May 9, 2019.

**Photo 25.** View looking west showing 330 ton silo located at southeastern edge of HGM proposed for relocation to SGOSA in TR-114.

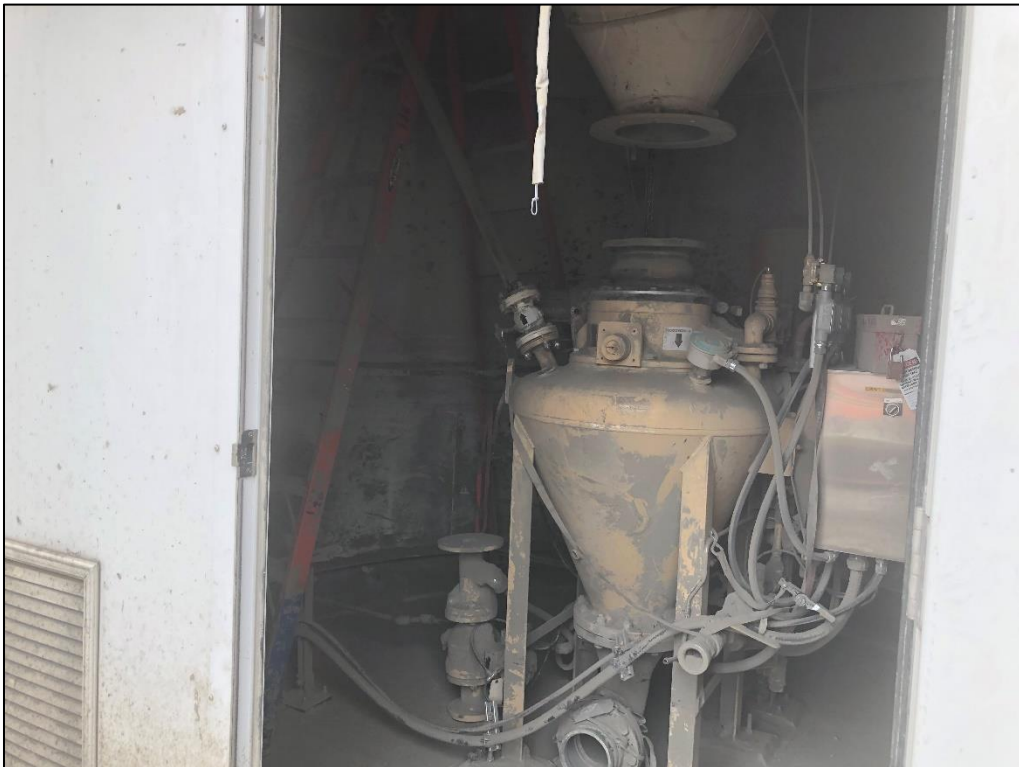
**Photo 26.** View looking inside 330 ton silo located at southeastern edge of HGM proposed for relocation to SGOSA in TR-114.
