MINERALS PROGRAM INSPECTION REPORT
PHONE: (303) 866-3567

MINE NAME: Jones Pit East	MINE/PROSPECTING ID#: M-1987-009	MINERAL: Sand and gravel	COUNTY: Prowers
INSPECTION TYPE: Monitoring	INSPECTOR(S): Amy Eschberger	INSP. DATE: March 26, 2019	INSP. TIME: 11:40
OPERATOR: Prowers County	OPERATOR REPRESENTATIVE: Mark Dorenkamp	TYPE OF OPERATION: 112c - Construction Regular Operation	
REASON FOR INSPECTION: Normal I&E Program	BOND CALCULATION TYPE: None	BOND AMOUNT: \$0.00	
DATE OF COMPLAINT: NA	POST INSP. CONTACTS: None	JOINT INSP. AGENCY: None	
WEATHER: Clear	INSPECTOR'S SIGNATURE:

M-1987-009 / Jones Pit East / Prowers County

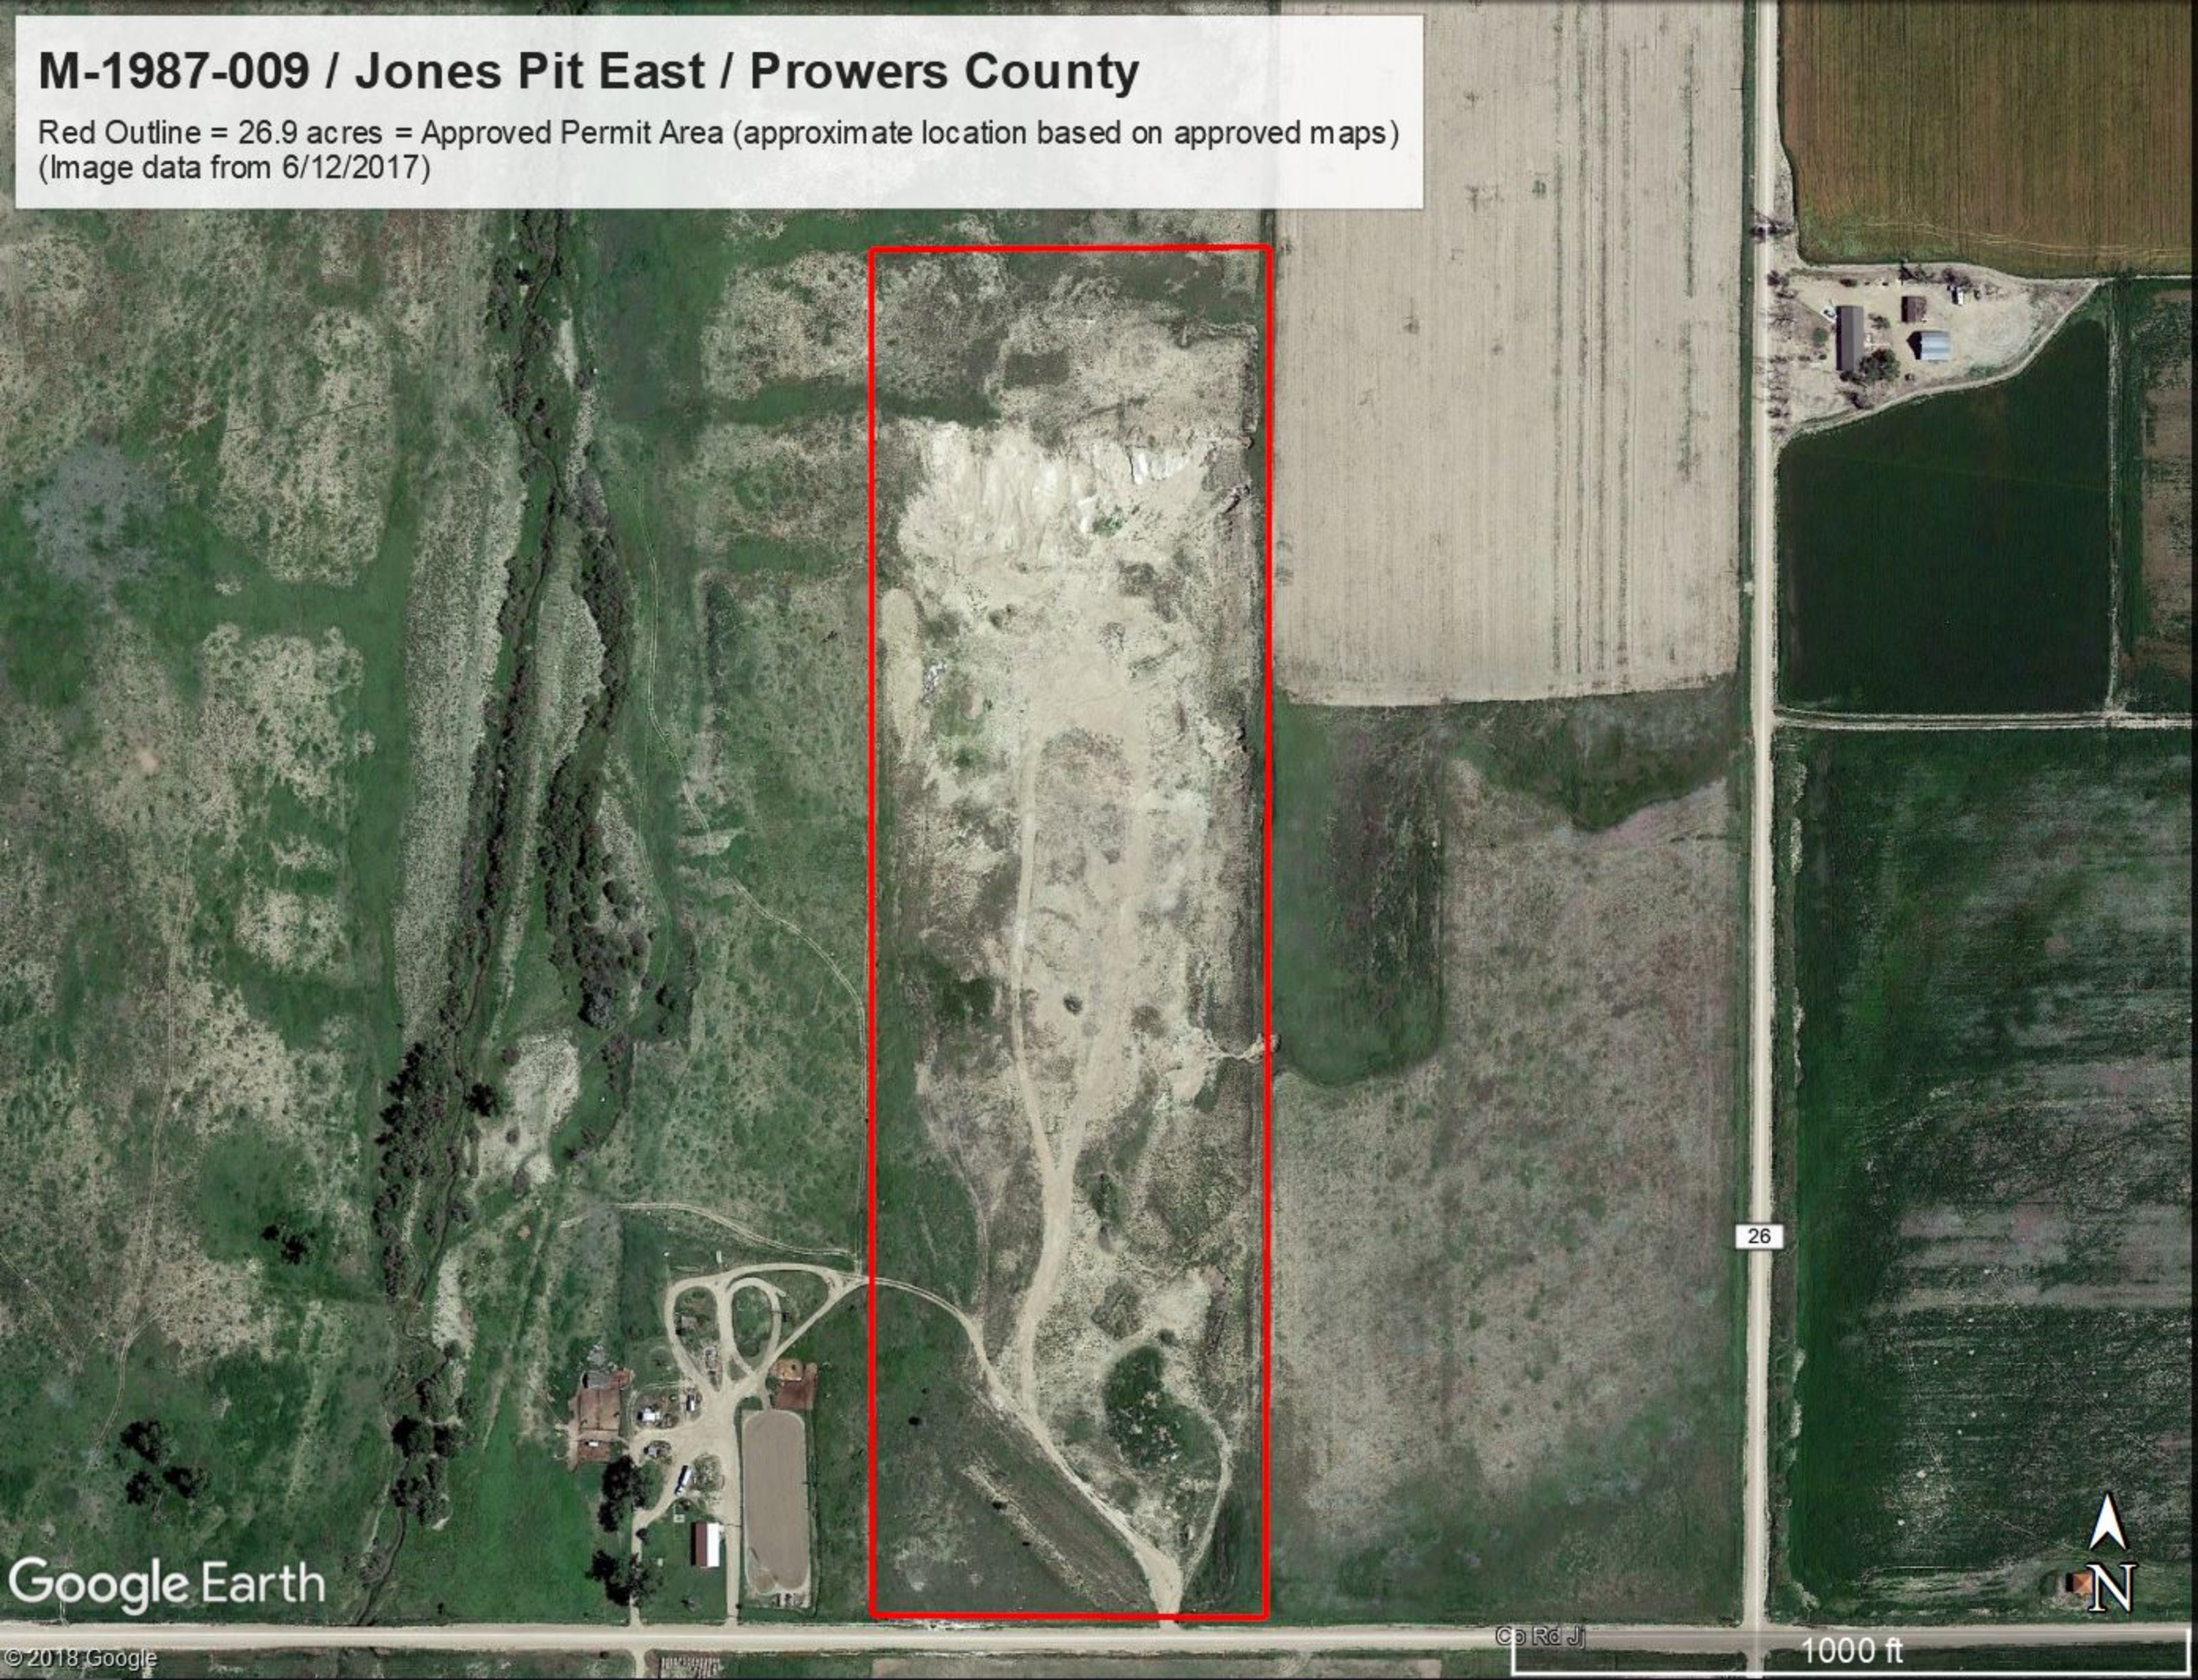
Red Outline = 26.9 acres = Approved Permit Area (approximate location based on approved maps)
(Image data from 6/12/2017)
