Solid Minerals Inspection Report

Type of Operation	3809 Plan of Operations	Project Name	Sunday Mines Complex West Sunday, Topaz
Serial Number	COC-53227, COC-52049	Company/Org.	PINON RIDGE MINING LLC PO BOX 825 NUCLA CO 81424- 0825
Inspection Date	05/29/2019	Others Present	Lucas West, CDRMS Michael Rutter, Pinon Ridge
Inspection Time	10 AM	Inspected By	James Blair
Report Date	05/31/2019	Legal	T44N, R18W, multiple sections

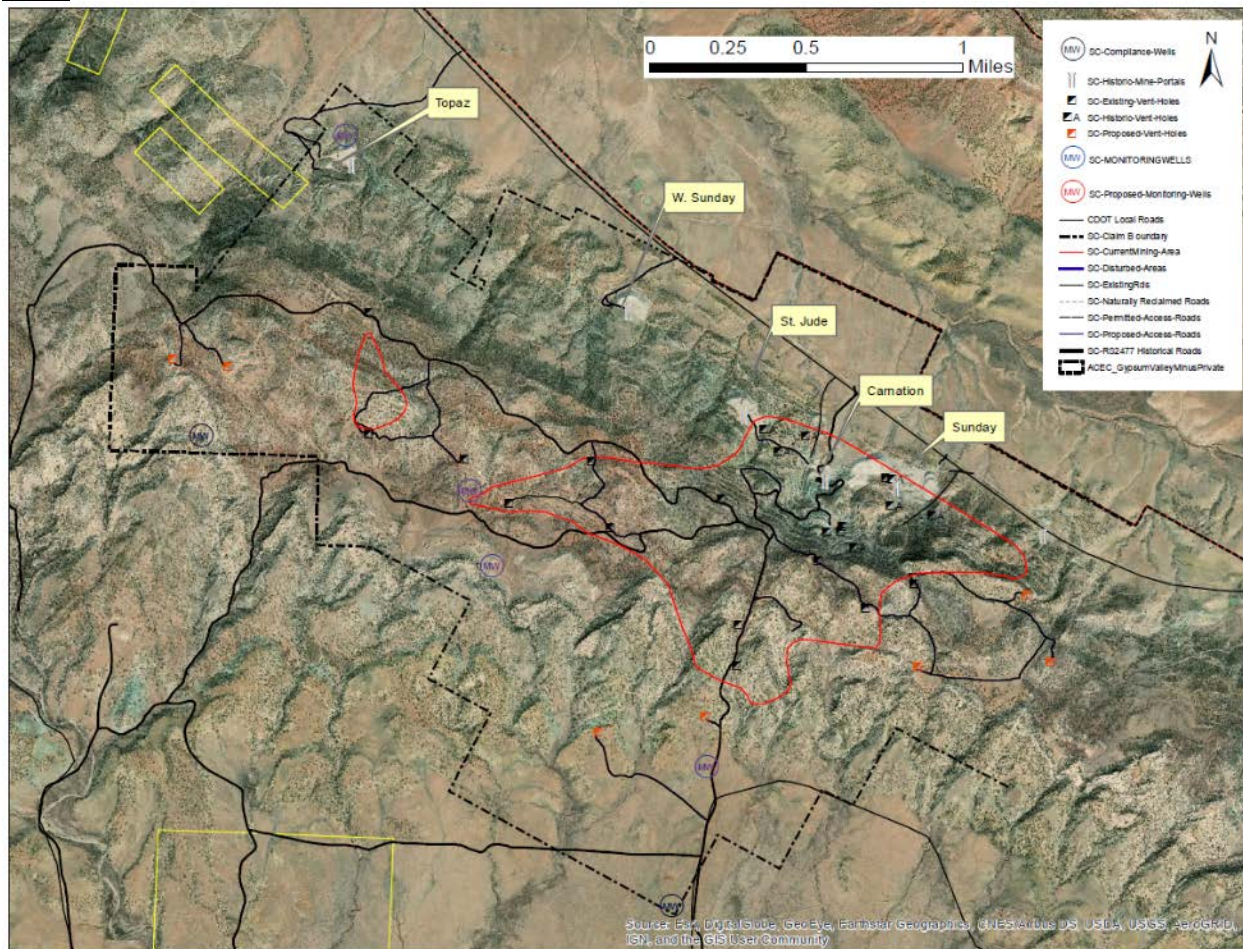
Figure 1: Aerial Photo Map Showing the Sunday Mines Complex. The Inspection was conducted in a general east to west fashion.

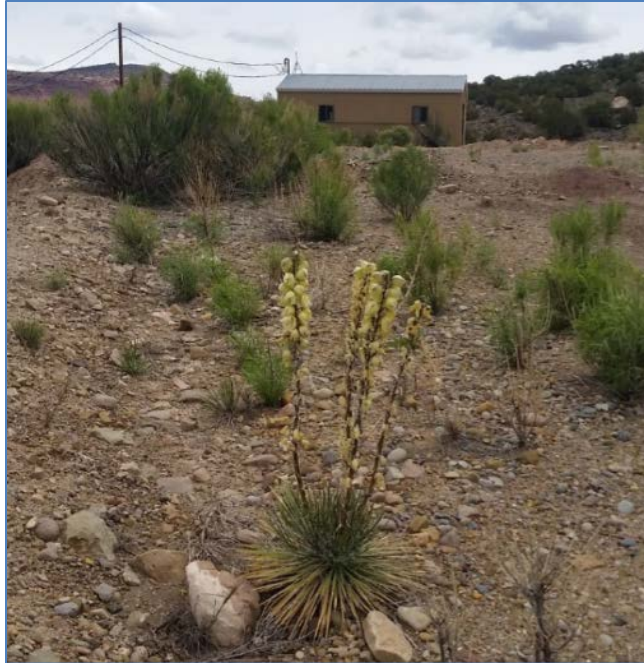
Figure 28: Volunteer narrow-leaf yucca at the Topaz Mine.
