**MINERALS PROGRAM INSPECTION REPORT**  
**PHONE: (303) 866-3567**

| <b>MINE NAME:</b><br>Refuge Pit #1 | <b>MINE/PROSPECTING ID#:</b><br>M-1989-112 | <b>MINERAL:</b><br>Sand and gravel | <b>COUNTY:</b><br>Moffat |
| <b>INSPECTION TYPE:</b><br>Monitoring | <b>INSPECTOR(S):</b><br>Amy C. Yeldell | <b>INSP. DATE:</b><br>June 11, 2019 | <b>INSP. TIME:</b><br>12:45 |

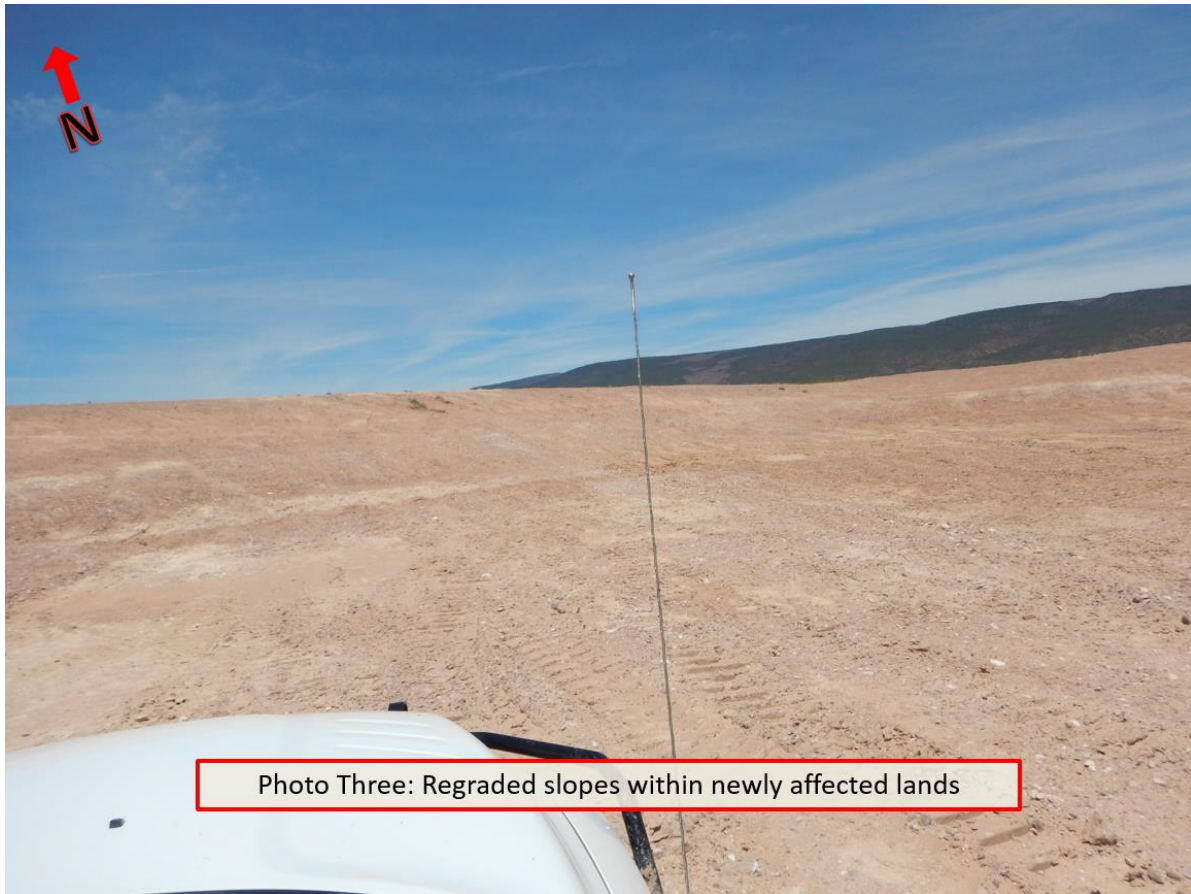
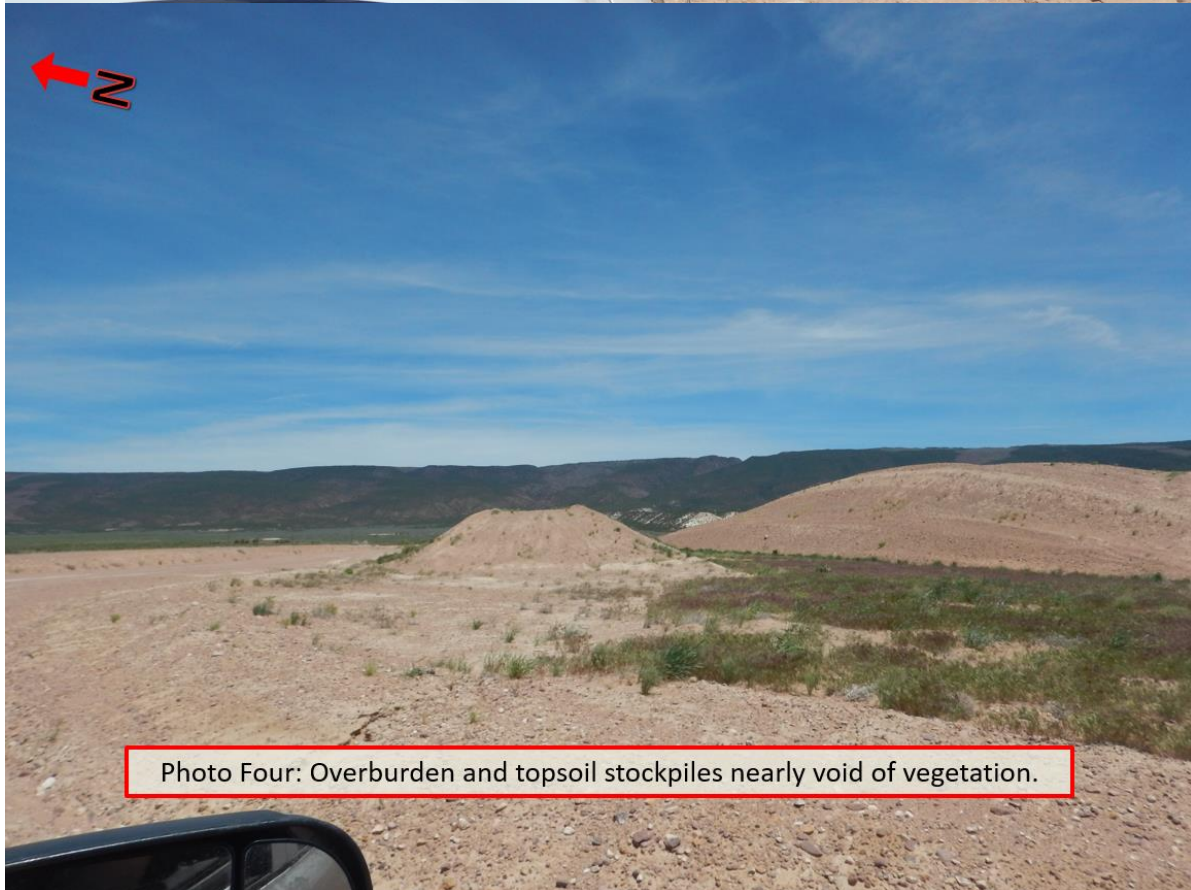
No structures, equipment or fuel were observed on site. Little to no germination was observed in the reclaimed areas of the 'original pit'. All reclaimed slopes have been properly graded to a 3:1 or less and are stable.
