MINERALS PROGRAM INSPECTION REPORT
PHONE: (303) 866-3567

MINE NAME: Amzak Pit	MINE/PROSPECTING ID#: M-2003-003	MINERAL: Gravel and sand	COUNTY: La Plata
INSPECTION TYPE: Monitoring	INSPECTOR(S): Lucas J. West	INSP. DATE: May 15, 2019	INSP. TIME: 10:35
OPERATOR: Consolidated Constructors, Inc.	OPERATOR REPRESENTATIVE: Robert Johnson, Landowner	TYPE OF OPERATION: 112c - Construction Regular Operation	
REASON FOR INSPECTION: High Priority	BOND CALCULATION TYPE: None	BOND AMOUNT: \$133,165.00	
DATE OF COMPLAINT: NA	POST INSP. CONTACTS: None	JOINT INSP. AGENCY: None	
WEATHER: Clear	INSPECTOR'S SIGNATURE:

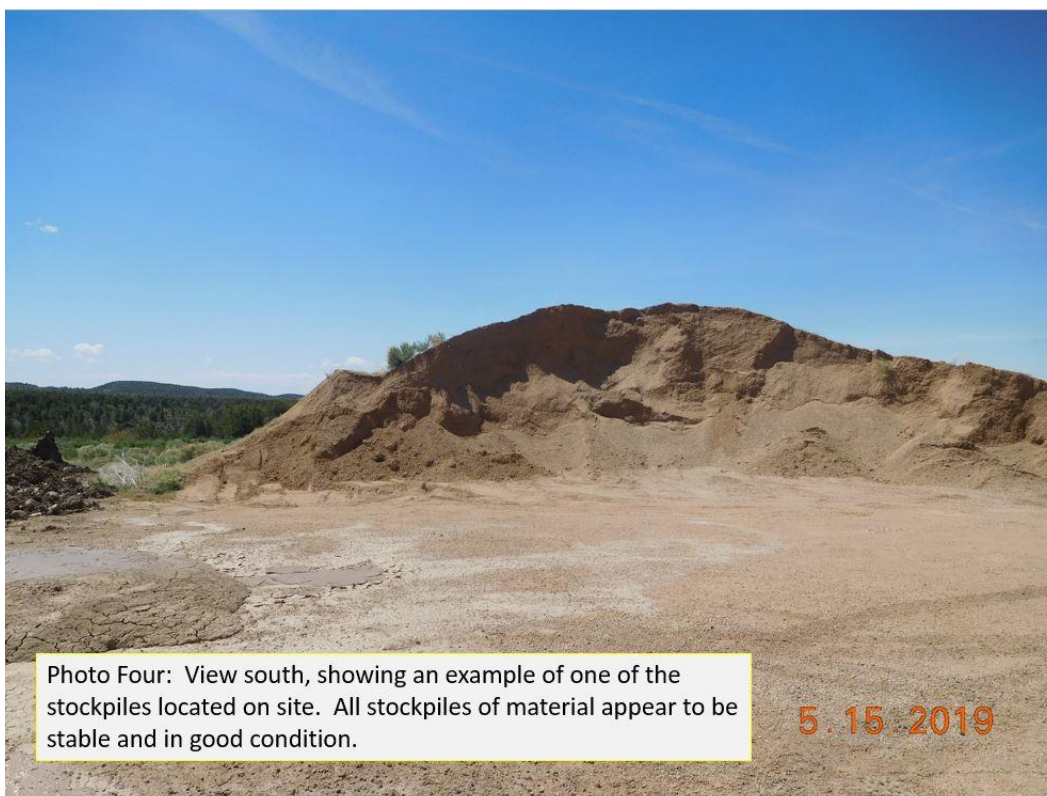
The remainder of the affected area consists of large stockpile areas of various materials. The materials stockpiles included crushed and screened material as well as stockpiles of recycled concrete and asphalt. The stockpiles are range in size from and location. All stockpiles observed appear to be stable and in good condition and examples of the stockpiles can be seen in Photos Four and Five. It appears that demolished concrete is being stockpiled on site for either recycling or disposal. Please note that the current permit does not allow for the importation of offsite fill to be used in backfilling of the pit. To incorporate that change in the permit it would need to be addressed through the Technical Revision Process.

Photo Five: View northeast, showing the large stockpile of demolished concrete on site. If this material is intended to be used as inert fill material it must be addressed through the TR process.
