COLORADO

MINERALS PROGRAM INSPECTION REPORT

MINE NAME: Wagner Rock Pit	MINE/PROSPECTING ID#: M-1999-018	MINERAL: Gravel	COUNTY: Moffat
INSPECTION TYPE: Monitoring	INSPECTOR(S): Amy C. Yeldell	INSP. DATE: June 12, 2019	INSP. TIME: 07:30
OPERATOR: Wagner Construction Inc.	OPERATOR REPRESENTATIVE: Jay Wagner	TYPE OF OPERATION: 112c - Construction Regular Operation	
REASON FOR INSPECTION: Normal I&E Program	BOND CALCULATION TYPE: Complete Bond	BOND AMOUNT: \$48,307.00	
DATE OF COMPLAINT: NA	POST INSP. CONTACTS: None	JOINT INSP. AGENCY: None	
WEATHER: Clear	INSPECTOR'S SIGNATURE:

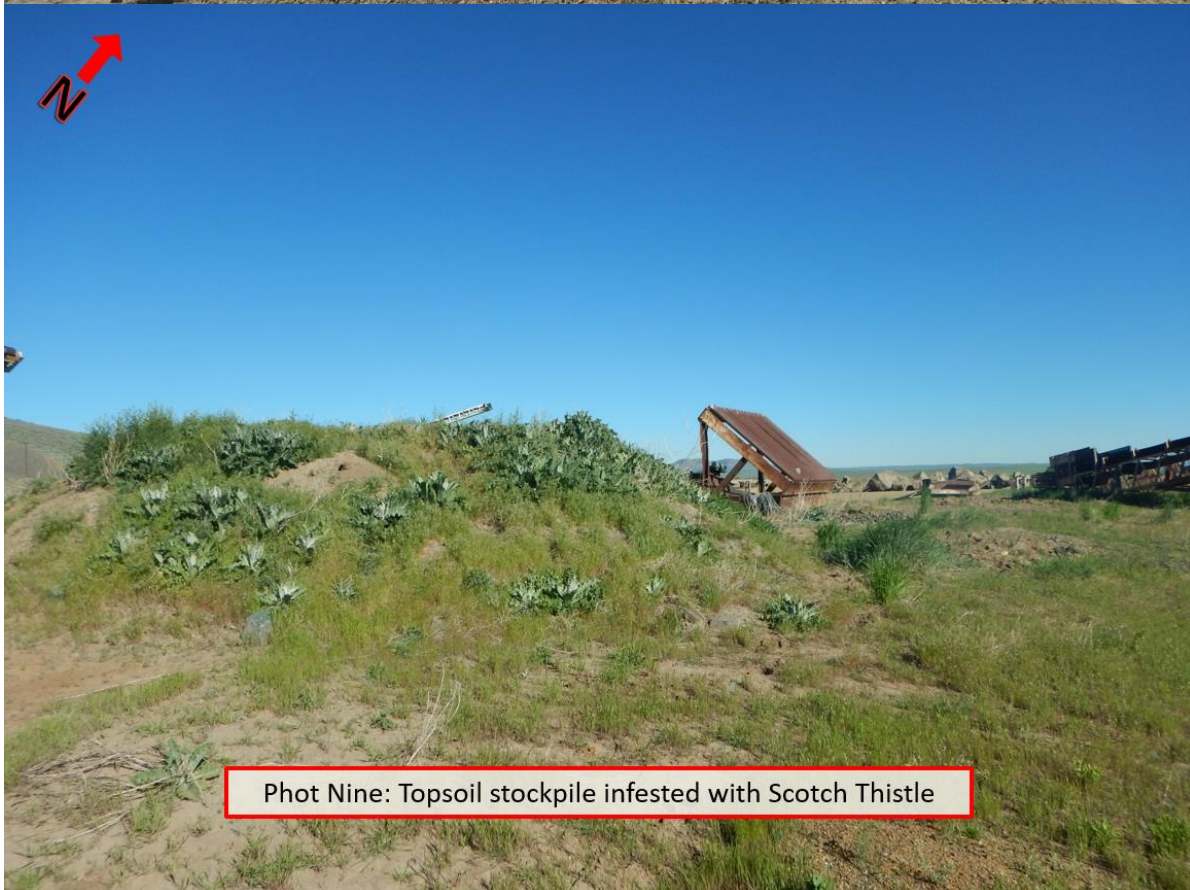
An abundance of State Listed Noxious Weeds as well as several nuisance species were observed on site. Scotch Thistle, Dalmation toadflax, Whitetop, Cheatgrass, Bull Thistle, Houndstongue, Common Mullen, Russian Thistle and Black Henbane were all prevalent site wide and in various stages of growth. The Division would like to point out that Black Henbane is listed as a Class B-Elimination species by 2020 according to the State's Department of Agriculture website. Mr. Wagner indicated that due to the wet spring, noxious weed management had been delayed. They sprayed the day before the inspection with a boom and 100 ft. hose. Some evidence of dye was observed however it was faint and less than as to be expected with such recent treatments. No evidence of wilting or mortality were observed in the treated plants. Mr. Wagner also indicated that the next day, follow up treatments would occur in the more remote areas with an ATV sprayer equipped with a hose. This site does have a noxious weed management plan in place. The plan does not discuss treatment of specific species just general methodology and defaulting to agency guidance. The two treatments a year for this site appears to be insufficient, monthly treatments during the growing season may be more appropriate. The ability to treat specific species without damaging others was discussed. Please coordinate with the county weed manager, Jesse Schroeder, to implement a more effective weed treatments. Mr. Schroeder has been Cc'd on this inspection report.
