**MINERALS PROGRAM INSPECTION REPORT**  
**PHONE: (303) 866-3567**

<b>MINE NAME:</b> Western Slope Flagstone Quarry No. 2	<b>MINE/PROSPECTING ID#:</b> M-1996-076	<b>MINERAL:</b> Gravel	<b>COUNTY:</b> Mesa
<b>INSPECTION TYPE:</b> Monitoring	<b>INSPECTOR(S):</b> Amy C. Yeldell	<b>INSP. DATE:</b> July 9, 2019	<b>INSP. TIME:</b> 18:00
<b>OPERATOR:</b> Rudolph Fontanari	<b>OPERATOR REPRESENTATIVE:</b> None	<b>TYPE OF OPERATION:</b> 112c - Construction Regular Operation	
<b>REASON FOR INSPECTION:</b> High Priority	<b>BOND CALCULATION TYPE:</b> None	<b>BOND AMOUNT:</b> \$88,251.00	
<b>DATE OF COMPLAINT:</b> NA	<b>POST INSP. CONTACTS:</b> None	<b>JOINT INSP. AGENCY:</b> State Engr. (Water Resources)	
<b>WEATHER:</b> Clear	<b>INSPECTOR'S SIGNATURE:</b>

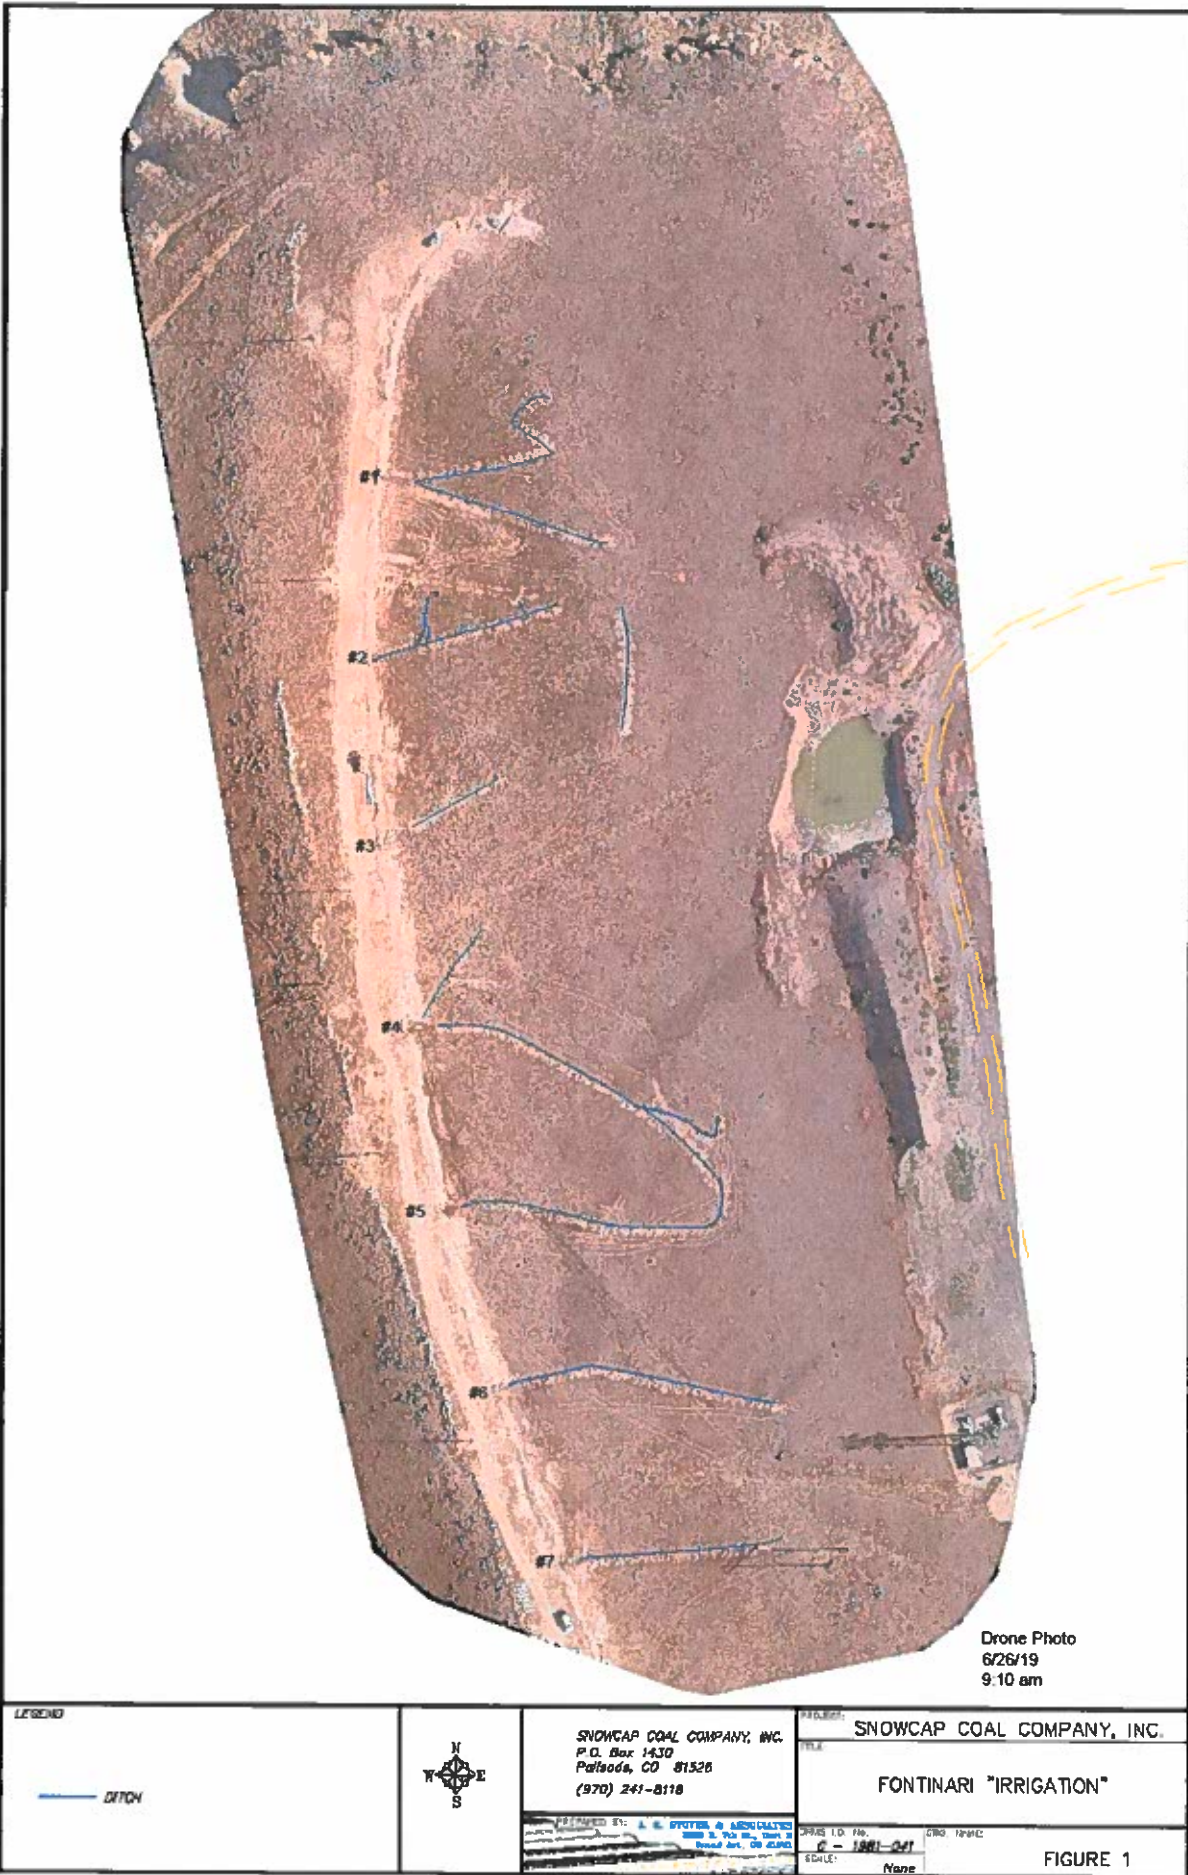
FIGURE 1

**PROBLEM/POSSIBLE VIOLATION:** Problem: The affected area boundary markers are incorrectly placed. This is a problem for failure to maintain boundary markers around the affected area as required by Section 3.1.12(2) of the rule.

As the result of an inspection problem in 2018 the Operator was required to delineate the permit boundary. In areas where topography was unsafe and unsuitable for mining the Operator indicated that the permit boundary would be inset. At the time the Division approved this as a reasonable practice. Upon site inspection the permit boundary marker was placed well within the permit boundary on flat land. This mis-identification of the permit boundary delineates the irrigated areas as being outside of the mine permit boundary which is not the case. The incorrectly delineated permit boundary is cited as an inspection problem. The Operator shall place boundaries on the mine permit boundary, regardless of the mining feasibility. Alternatively the Operator may request an acreage reduction of un-affected lands thus reducing the permit boundary to that which is delineated on the ground and/or suitable for mining. The Operator shall provide photo documentation that boundary markers have been properly placed on the mine permit boundary by the corrective action deadline listed on page two of this report. If the Operator wishes to request an acreage reduction the request must be made prior to the corrective action date, however the problem will not be abated until the revision is approved.
