**MINERALS PROGRAM INSPECTION REPORT**  
**PHONE: (303) 866-3567**

<b>MINE NAME:</b> Henderson Mine	<b>MINE/PROSPECTING ID#:</b> M-1977-342	<b>MINERAL:</b> Molybdenum	<b>COUNTY:</b> Clear Creek, Grand
<b>INSPECTION TYPE:</b> Monitoring	<b>INSPECTOR(S):</b> Stephanie J. Mitchell	<b>INSP. DATE:</b> June 12, 2019	<b>INSP. TIME:</b> 09:00
<b>OPERATOR:</b> Climax Molybdenum Company	<b>OPERATOR REPRESENTATIVE:</b> Aaron Hilshorst	<b>TYPE OF OPERATION:</b> 112d-3 - Designated Mining Operation	
<b>REASON FOR INSPECTION:</b> Normal I&E Program	<b>BOND CALCULATION TYPE:</b> Partial Bond	<b>BOND AMOUNT:</b> \$37,993,785.00	
<b>DATE OF COMPLAINT:</b> NA	<b>POST INSP. CONTACTS:</b> None	<b>JOINT INSP. AGENCY:</b> None	
<b>WEATHER:</b> Clear	<b>INSPECTOR'S SIGNATURE:</b>

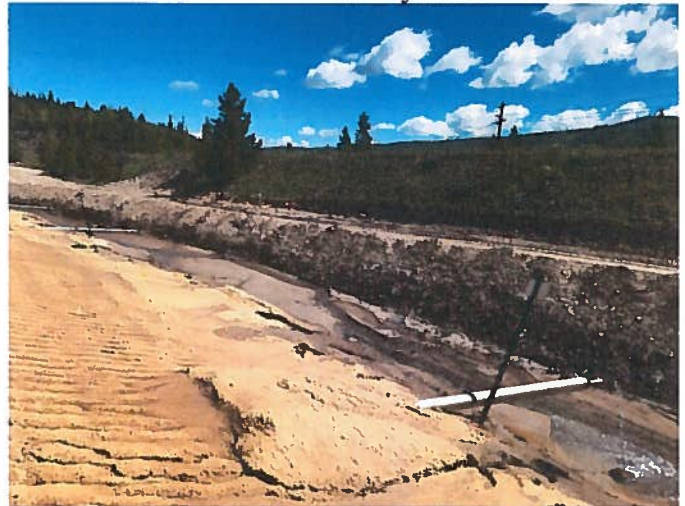
East Branch Dam Repair

On April 9, 2019, Henderson staff informed the Division of a sink hole along the left abutment of the East Branch Dam. Henderson excavated the area to locate the pipe. Appropriate notice and permits were received from Grand County to operate in County Road 3 and the pipe was replaced. The area was regraded and was not seeded. The Division recommends seeding and mulching the area that was excavated and regraded to reduce erosion.
