**COLORADO**Division of Reclamation,
Mining and Safety

MINERALS PROGRAM INSPECTION REPORT**PHONE: (303) 866-3567**

MINE NAME: Ordway Pit	MINE/PROSPECTING ID#: M-2006-054	MINERAL: Sand and gravel	COUNTY: Crowley
INSPECTION TYPE: Surety-Related Inspection	INSPECTOR(S): Patrick Lennberg	INSP. DATE: July 18, 2019	INSP. TIME: 08:00
OPERATOR: Ordway Feedyard Ltd. Liability Co.	OPERATOR REPRESENTATIVE: Tony Warnock	TYPE OF OPERATION: 112c - Construction Regular Operation

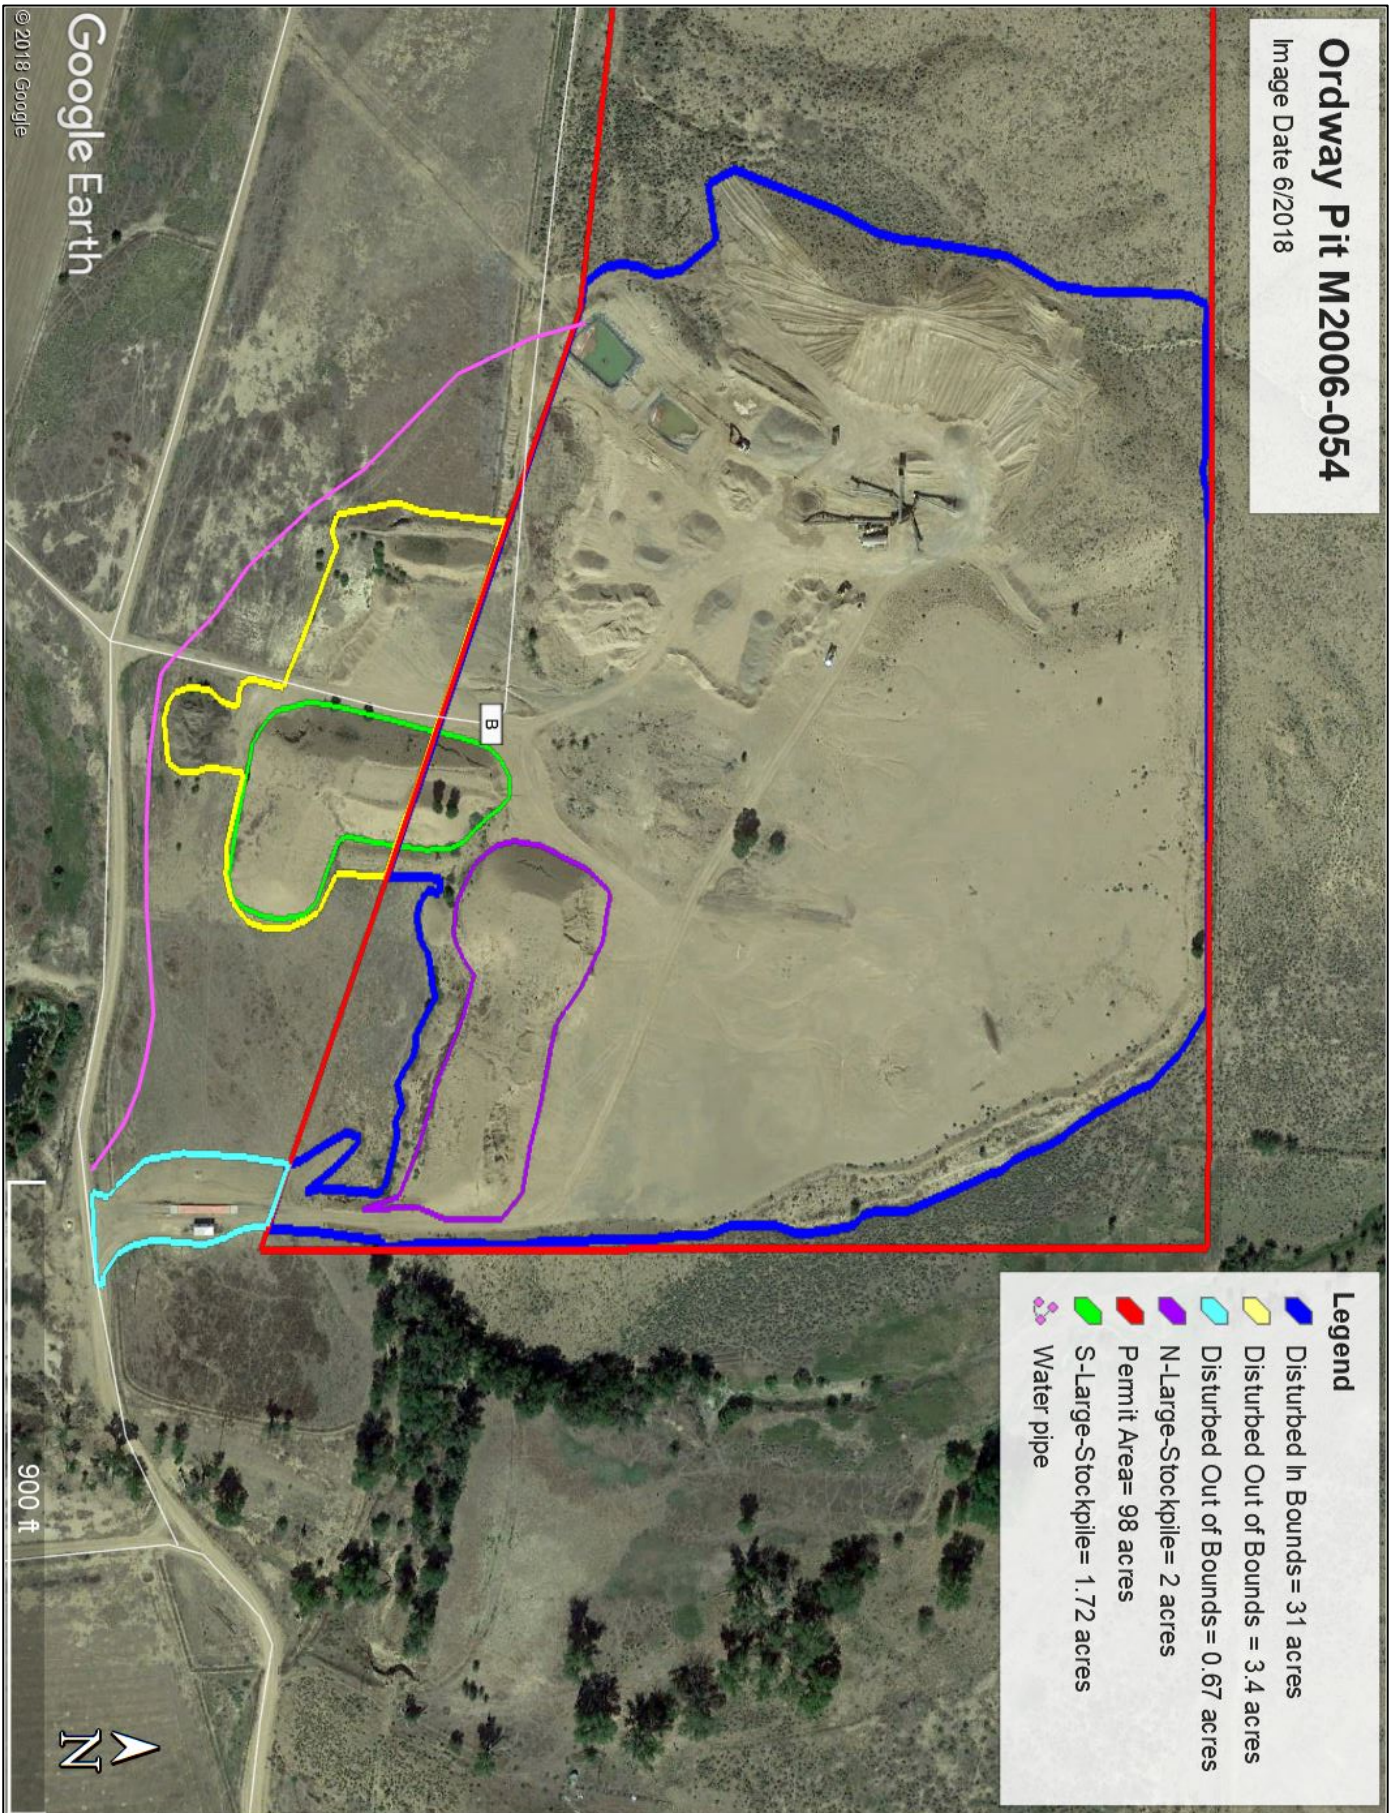
Photo 22: Looking from the top of the southern pile, beyond the permit boundary, to the well water pipe marked in yellow
