MINERALS PROGRAM INSPECTION REPORT
PHONE: (303) 866-3567

MINE NAME: Clay Pit No. 21	MINE/PROSPECTING ID#: M-2009-060	MINERAL: Clay (general)	COUNTY: Moffat
INSPECTION TYPE: Monitoring	INSPECTOR(S): Amy C. Yeldell	INSP. DATE: July 16, 2019	INSP. TIME: 11:30
OPERATOR: Moffat County	OPERATOR REPRESENTATIVE: None	TYPE OF OPERATION: 112c - Construction Regular Operation	
REASON FOR INSPECTION: Normal I&E Program	BOND CALCULATION TYPE: None	BOND AMOUNT: \$0.00	
DATE OF COMPLAINT: NA	POST INSP. CONTACTS: None	JOINT INSP. AGENCY: None	
WEATHER: Clear	INSPECTOR'S SIGNATURE:

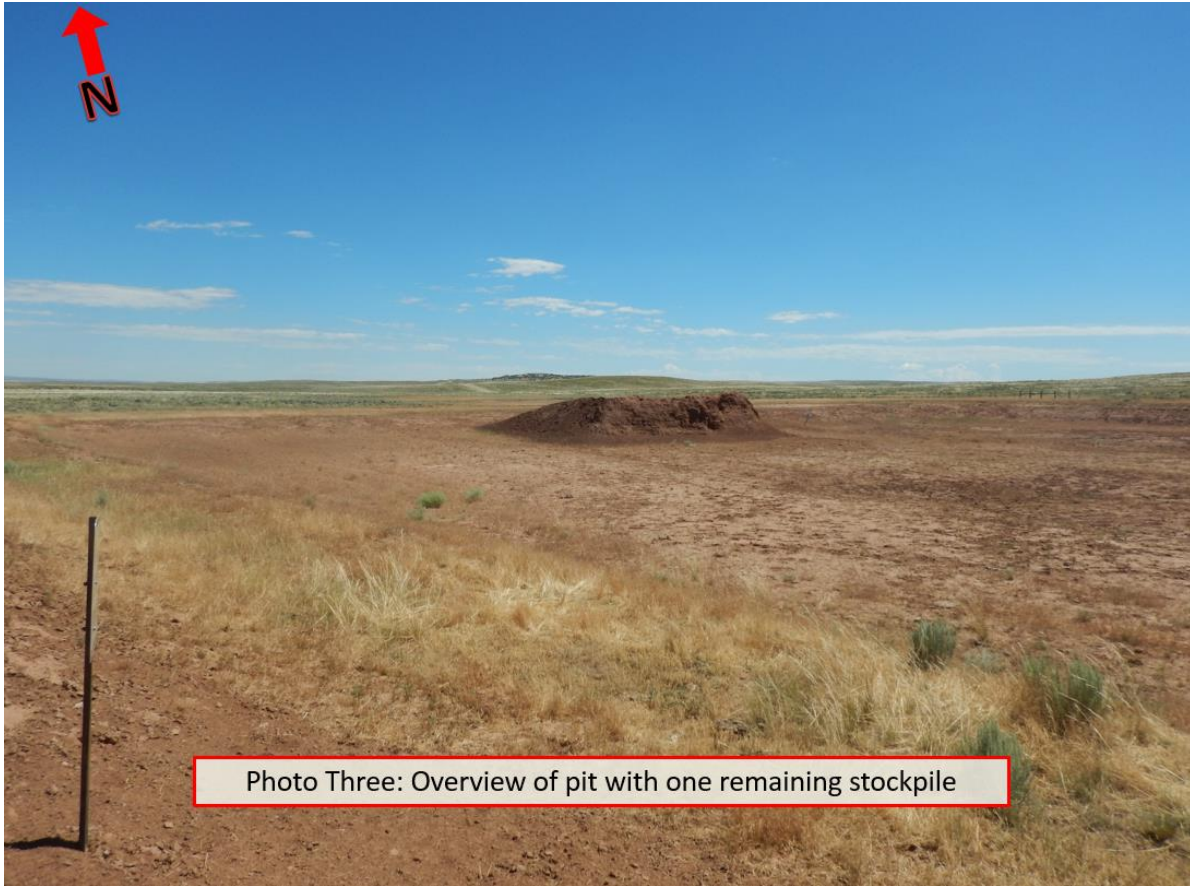
The topsoil pile is located on the western side of the mine. The topsoil and overburden piles are clearly marked with signage to prevent accidental loss. No erosion was observed. All slopes within the pit have been graded to a 3H: 1V or less. The site a bowl with the pit floor that has been mined to a depth of approximately 10'.

Photo Two: Topsoil on western side
