MINERALS PROGRAM INSPECTION REPORT
PHONE: (303) 866-3567

MINE NAME: Tuttle Pit No 1	MINE/PROSPECTING ID#: M-1992-007	MINERAL: Borrow material for	COUNTY: Moffat
INSPECTION TYPE: Monitoring	INSPECTOR(S): Amy C. Yeldell	INSP. DATE: July 17, 2019	INSP. TIME: 08:30
OPERATOR: Moffat County	OPERATOR REPRESENTATIVE: Tim Dilldine	TYPE OF OPERATION: 112c - Construction Regular Operation	
REASON FOR INSPECTION: Normal I&E Program	BOND CALCULATION TYPE: None	BOND AMOUNT: \$0.00	
DATE OF COMPLAINT: NA	POST INSP. CONTACTS: None	JOINT INSP. AGENCY: None	
WEATHER: Clear	INSPECTOR'S SIGNATURE:

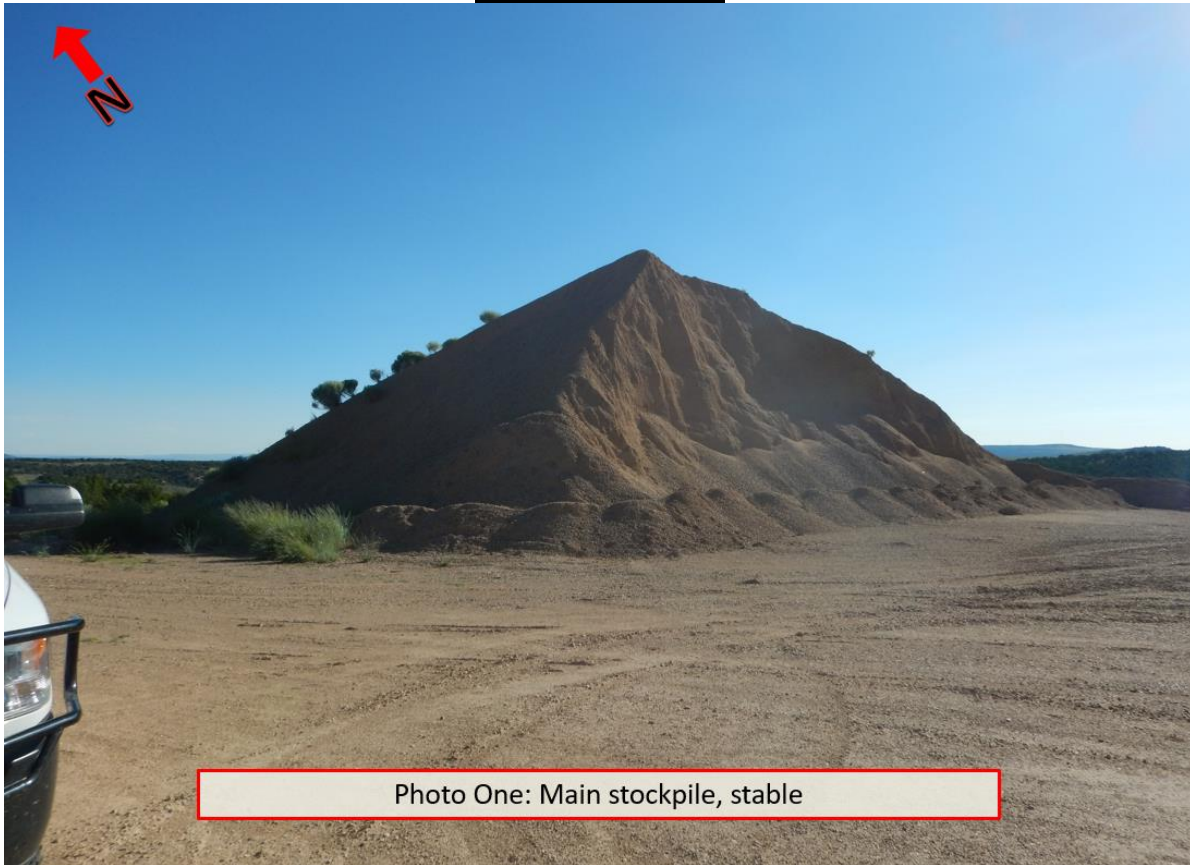
The site was inactive at the time of the inspection and appears to be relatively unchanged as compared to the last inspection. No equipment or fuel is stored on site. There are two main large stockpiles that have volunteer shrub growth. Stockpiled material is stable with no erosion. The sediment retention pond and slopes along the south/east have excellent vegetative cover. The pit floor remains bare of vegetation and no weeds were observed. There is some minor riling of the main southern highwall however grading would likely do more damage. The slope is at a 2H: 1 V or less and stable.
