**MINERALS PROGRAM INSPECTION REPORT**  
**PHONE: (303) 866-3567**

<b>MINE NAME:</b> Martin Pit 1-A	<b>MINE/PROSPECTING ID#:</b> M-1990-140	<b>MINERAL:</b> Sand and gravel	<b>COUNTY:</b> Moffat
<b>INSPECTION TYPE:</b> Monitoring	<b>INSPECTOR(S):</b> Amy C. Yeldell	<b>INSP. DATE:</b> July 16, 2019	<b>INSP. TIME:</b> 14:00
<b>OPERATOR:</b> Duran & Pearce Contractors, Inc.	<b>OPERATOR REPRESENTATIVE:</b> None	<b>TYPE OF OPERATION:</b> 112c - Construction Regular Operation	
<b>REASON FOR INSPECTION:</b> Normal I&E Program	<b>BOND CALCULATION TYPE:</b> Partial Bond	<b>BOND AMOUNT:</b> \$34,770.00	
<b>DATE OF COMPLAINT:</b> NA	<b>POST INSP. CONTACTS:</b> None	<b>JOINT INSP. AGENCY:</b> None	
<b>WEATHER:</b> Clear	<b>INSPECTOR'S SIGNATURE:</b>

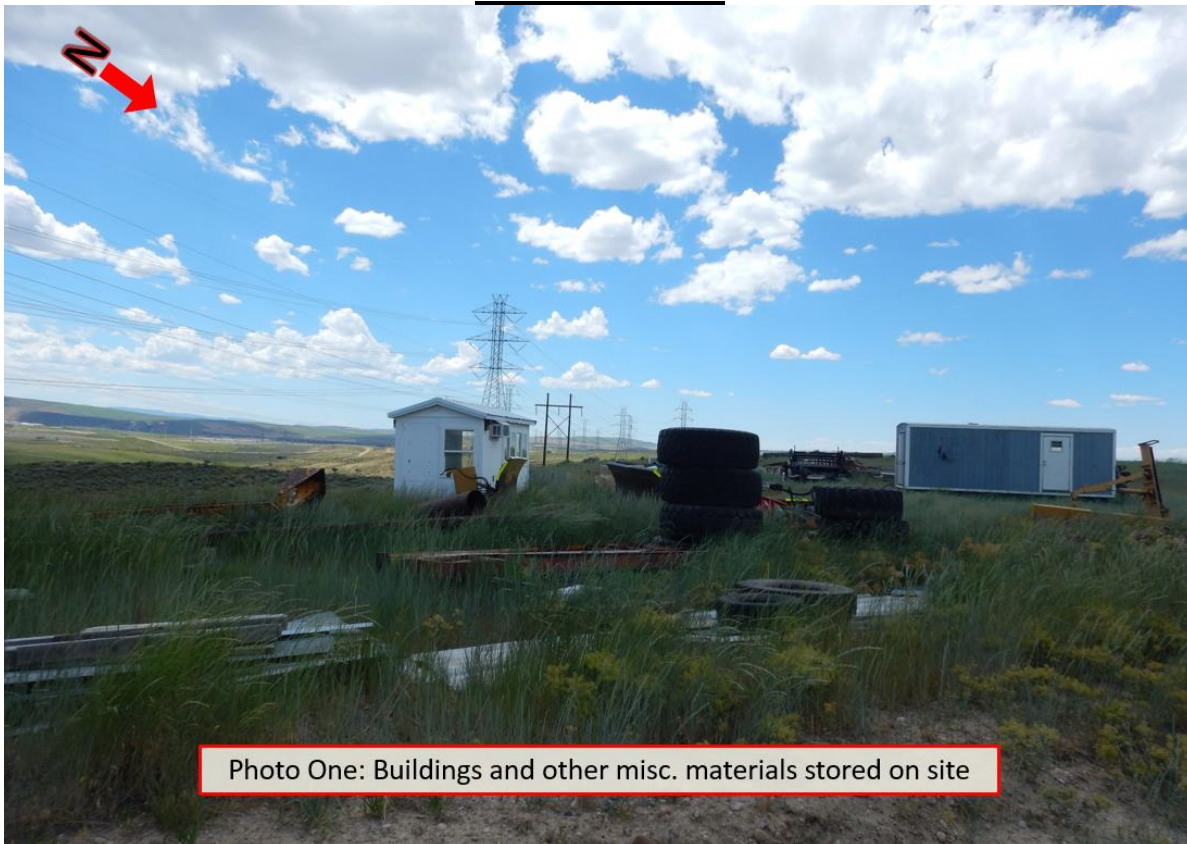
The Operator appears to be stockpiling additional concrete and asphalt. The majority of imported material appears to be clean however rebar, pex and other non-inert materials were observed to be mixed in. The Division estimates that stockpiles of imported materials are potentially greater than the volume of the currently excavated pit. The mining plan states that approximately 100 tons of imported material will be backfilled each year. This is in addition to the 10,000 CY of overburden to be replaced per 2-3 acres as stated in the reclamation plan. The Division anticipated that if the pit were to be reclaimed right now the majority of this imported material would need to be disposed of offsite. Excessive stockpiling of import material is cited as inspection problem due to the inability to complete reclamation as per the approved reclamation plan. The Operator shall provide the Division with an estimate of the current volume of imported material on site by the corrective action date. The Division will use this volume when calculating the reclamation cost estimate as the volume to be hauled off-site for disposal. The Operator was informed in the last inspection report that additional importation would require the Division to bond for off-site disposal.

**PROBLEM/POSSIBLE VIOLATION:** Problem: The Division anticipated that if the pit were to be reclaimed right now the majority of the stockpiled imported material would need to be disposed of offsite as the stockpiled volume exceeds the amount to be used for structural backfill. Excessive stockpiling of import material is cited as inspection problem due to the inability to complete reclamation as per the approved reclamation plan.
