MINERALS PROGRAM INSPECTION REPORT
PHONE: (303) 866-3567

MINE NAME: West Sunday	MINE/PROSPECTING ID#: M-1981-021	MINERAL: Uranium and vanadium	COUNTY: San Miguel
INSPECTION TYPE: Monitoring	INSPECTOR(S): Lucas J. West	INSP. DATE: August 5, 2019	INSP. TIME: 12:32
OPERATOR: Pinon Ridge Mining LLC	OPERATOR REPRESENTATIVE: None	TYPE OF OPERATION: 112d-3 - Designated Mining Operation	
REASON FOR INSPECTION: Normal I&E Program	BOND CALCULATION TYPE: None	BOND AMOUNT: \$85,036.00	
DATE OF COMPLAINT: NA	POST INSP. CONTACTS: None	JOINT INSP. AGENCY: None	
WEATHER: Clear	INSPECTOR'S SIGNATURE:

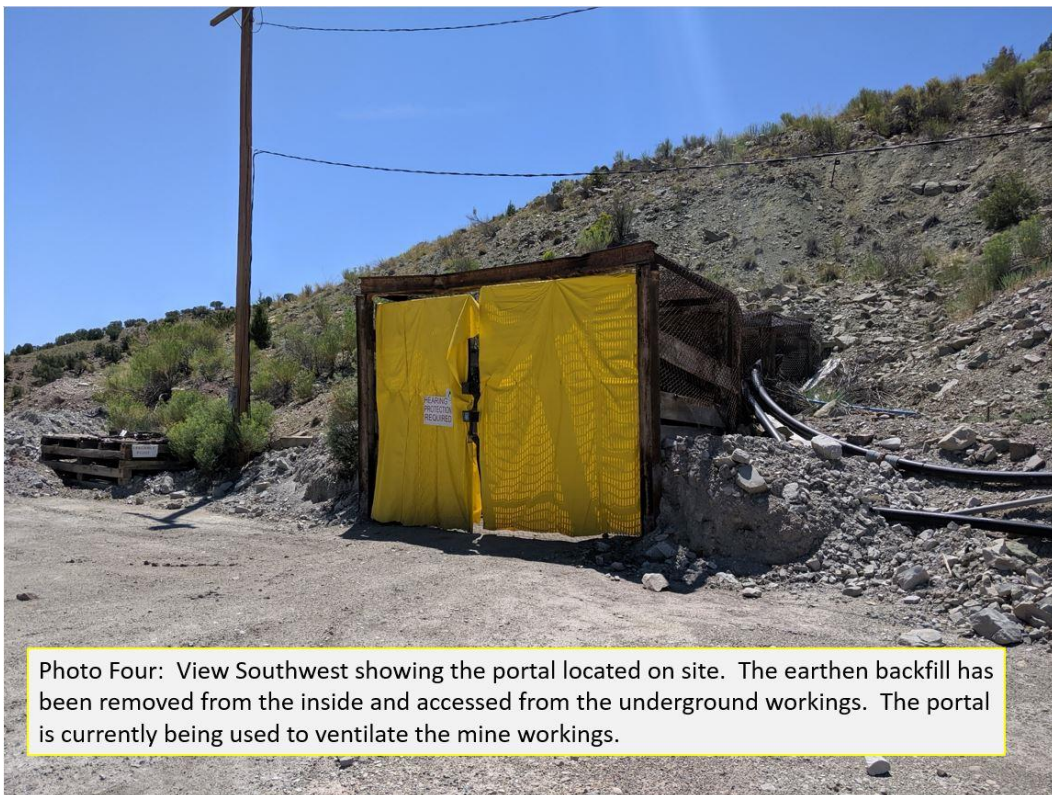
All work and shop appeared to be in good condition as seen in Photos Two and Three. The shop and storage facility in Photo Two was discovered to be unsecure, with the bay door opened. According to the operator there appeared to be no signs of theft or damage to the structure. The office facility was secured, and no signs of attempted unauthorized entry were noted on that facility. The portal located on site has been opened to be used as ventilation for the underground workings of the entire Sunday Complex. The earthen backfill material has been removed but the gates remain locked to prevent unauthorized entry. The portal with its locked gates can be seen in Photo Four. Two fuel storage containers were observed on site but were empty and appear to have not been utilized in some time. Various other debris was observed on site however it was stored in an orderly fashion and was not a concern at this time. The main pad and work area was in good condition, evidence of weed management during the growing season was observed. The whole site exhibits positive drainage and no erosional issues were observed at this time. Some areas around the perimeter of the pad area have begun to revegetate themselves with volunteer species.
