MINERALS PROGRAM INSPECTION REPORT
PHONE: (303) 866-3567

MINE NAME: Ducray Pit #2	MINE/PROSPECTING ID#: M-2019-035	MINERAL: Borrow material	COUNTY: Mesa
INSPECTION TYPE: Preoperation Inspection	INSPECTOR(S): Amy C. Yeldell	INSP. DATE: August 14, 2019	INSP. TIME: 08:15
OPERATOR: Martinez Western Constructors Inc.	OPERATOR REPRESENTATIVE: None	TYPE OF OPERATION: 110c - Construction Limited Impact	
REASON FOR INSPECTION: Preoperation Inspection	BOND CALCULATION TYPE: None	BOND AMOUNT: \$6,447.00	
DATE OF COMPLAINT: NA	POST INSP. CONTACTS: None	JOINT INSP. AGENCY: None	
WEATHER: Clear	INSPECTOR'S SIGNATURE:

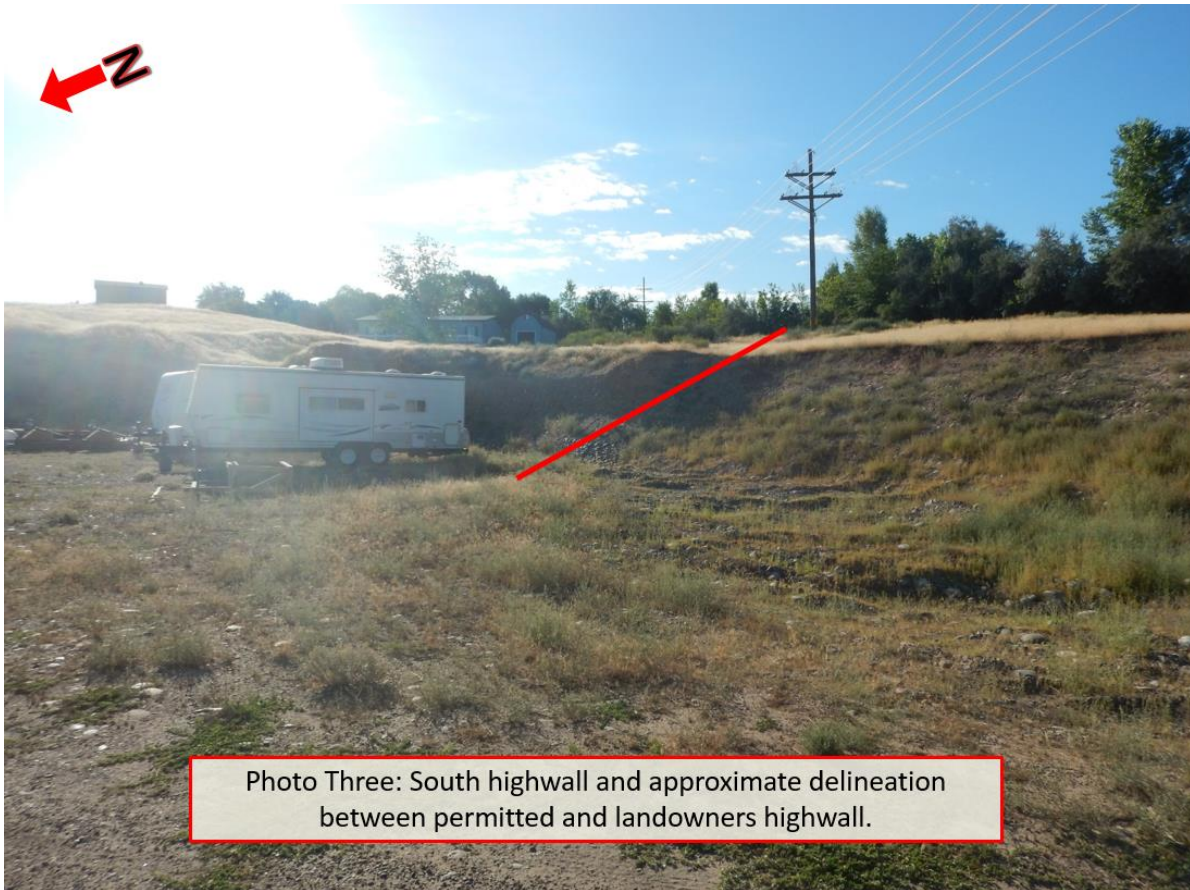
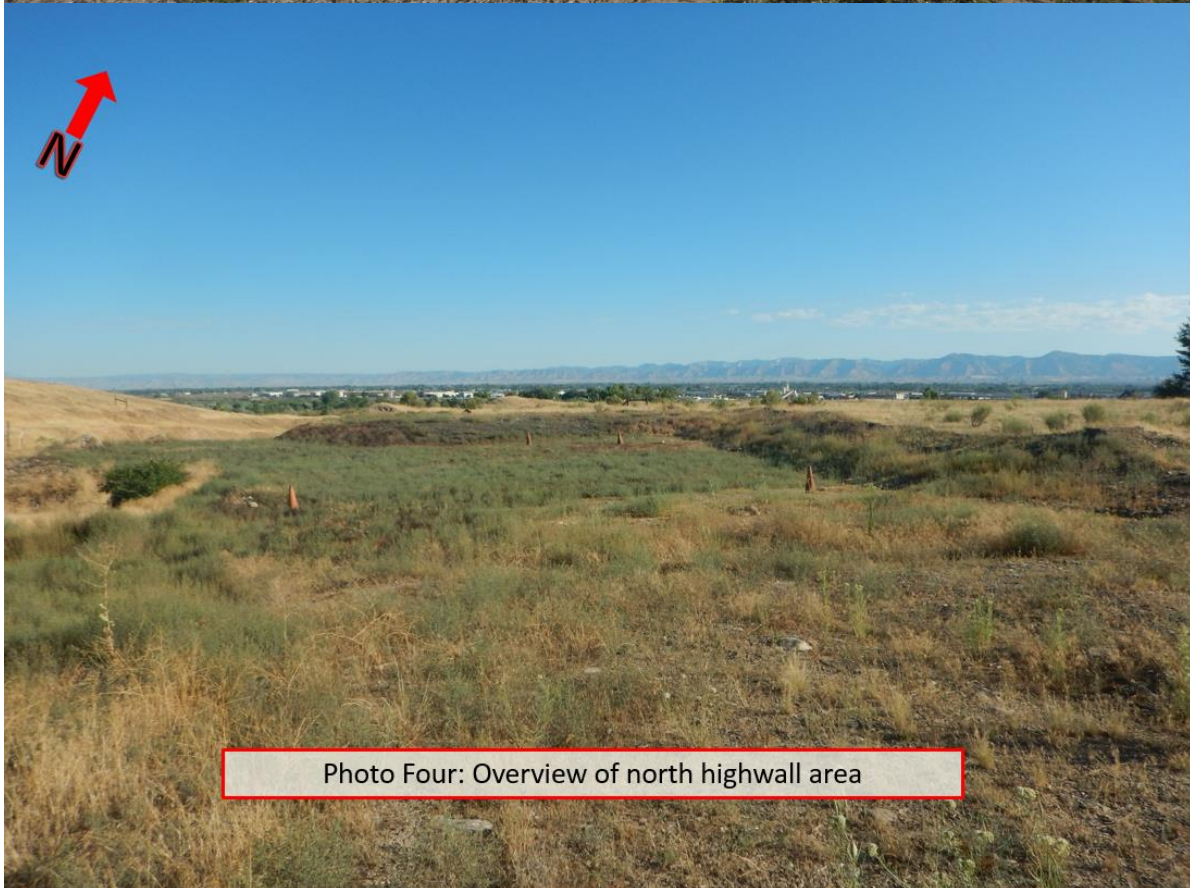
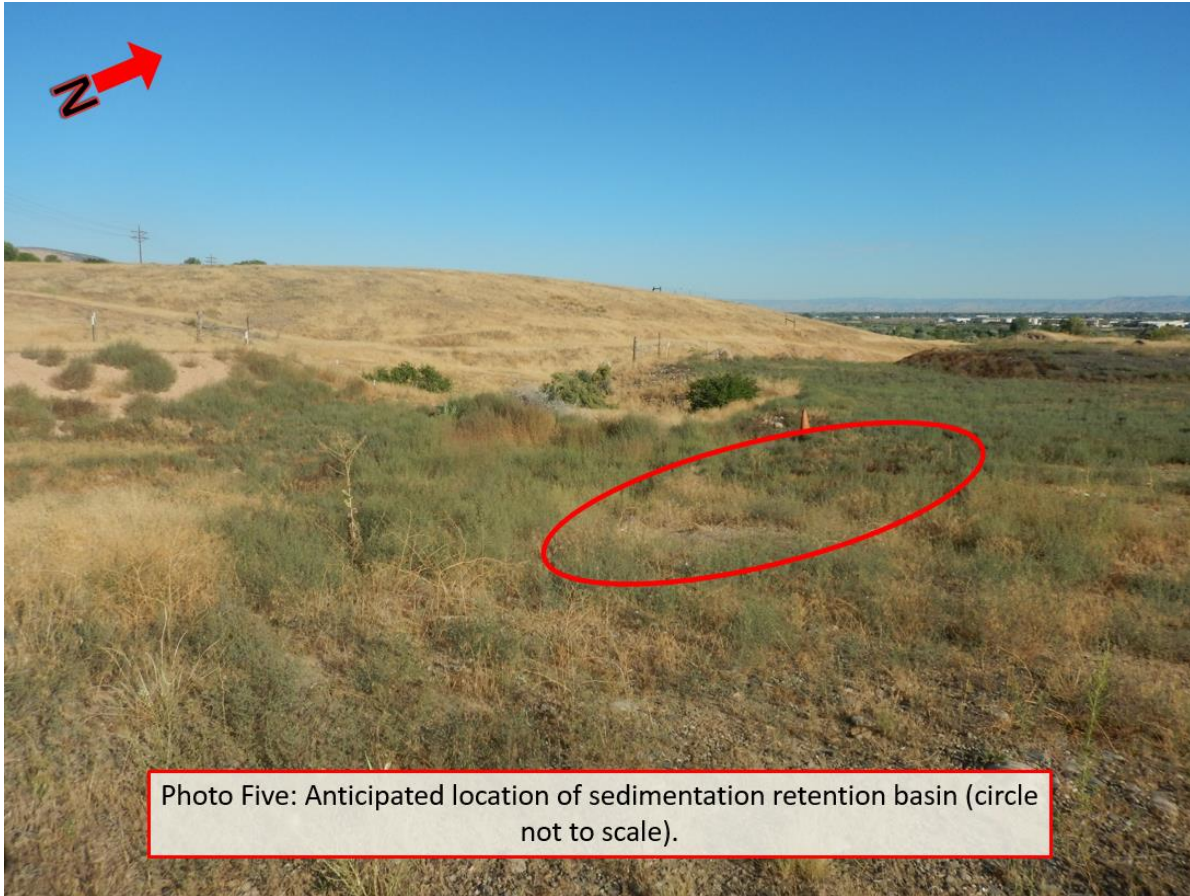
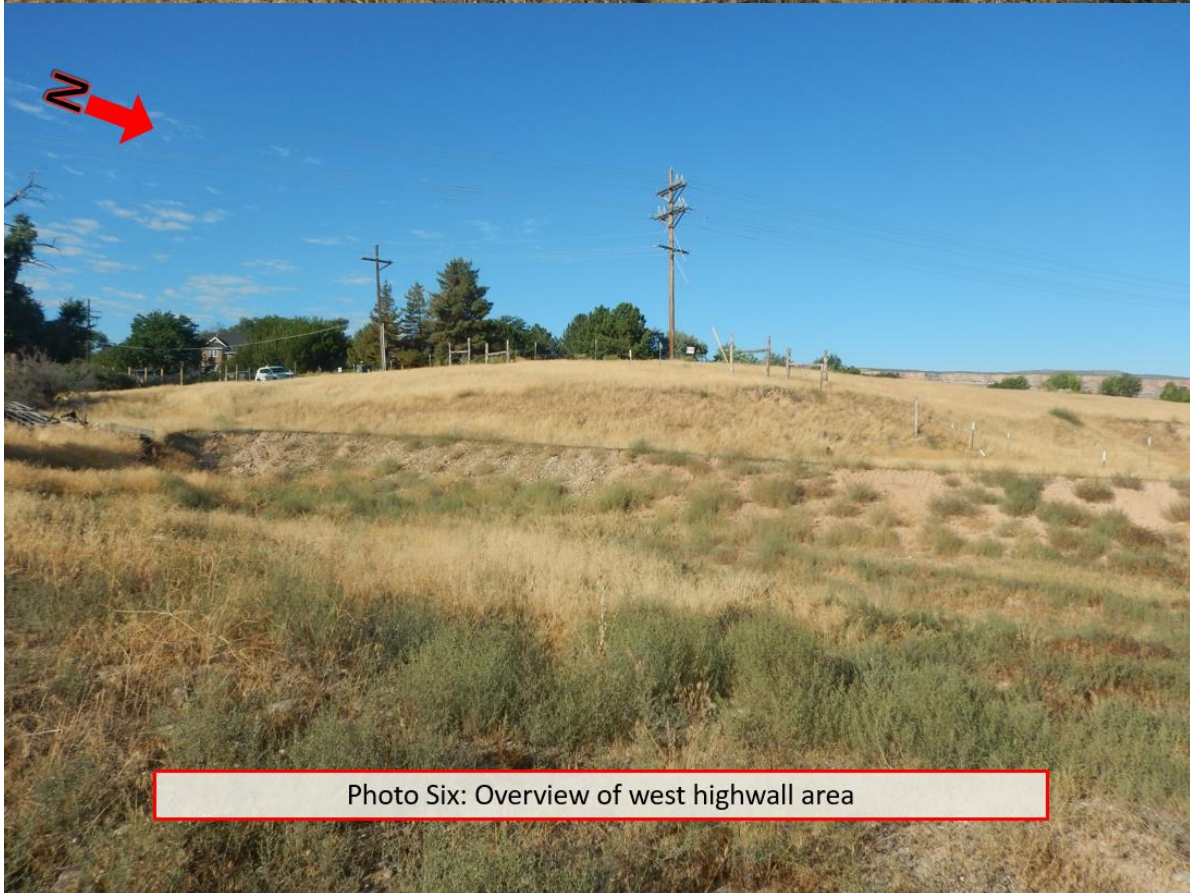
The Applicant has not yet constructed the proposed sediment retention pond or other associated BMP features. In the absence of BMP features the site appears to be stable with no erosion or sedimentation observed. On a positive note the established vegetation in the disturbed areas desirable or not has served as a BMP feature. Vegetation helps to anchor soil as well as disperse concentrated flows into sheet flow increasing infiltration and decrease the overall erosive potential of surface flows.
