**MINERALS PROGRAM INSPECTION REPORT**  
**PHONE: (303) 866-3567**

| <b>MINE NAME:</b><br>Fort Lyon - State Pit No. 1 | <b>MINE/PROSPECTING ID#:</b><br>M-2001-097 | <b>MINERAL:</b><br>Limestone (general) | <b>COUNTY:</b><br>Bent |
| <b>INSPECTION TYPE:</b><br>Monitoring | <b>INSPECTOR(S):</b><br>Amy Eschberger | <b>INSP. DATE:</b><br>September 11, 2019 | <b>INSP. TIME:</b><br>13:15 |

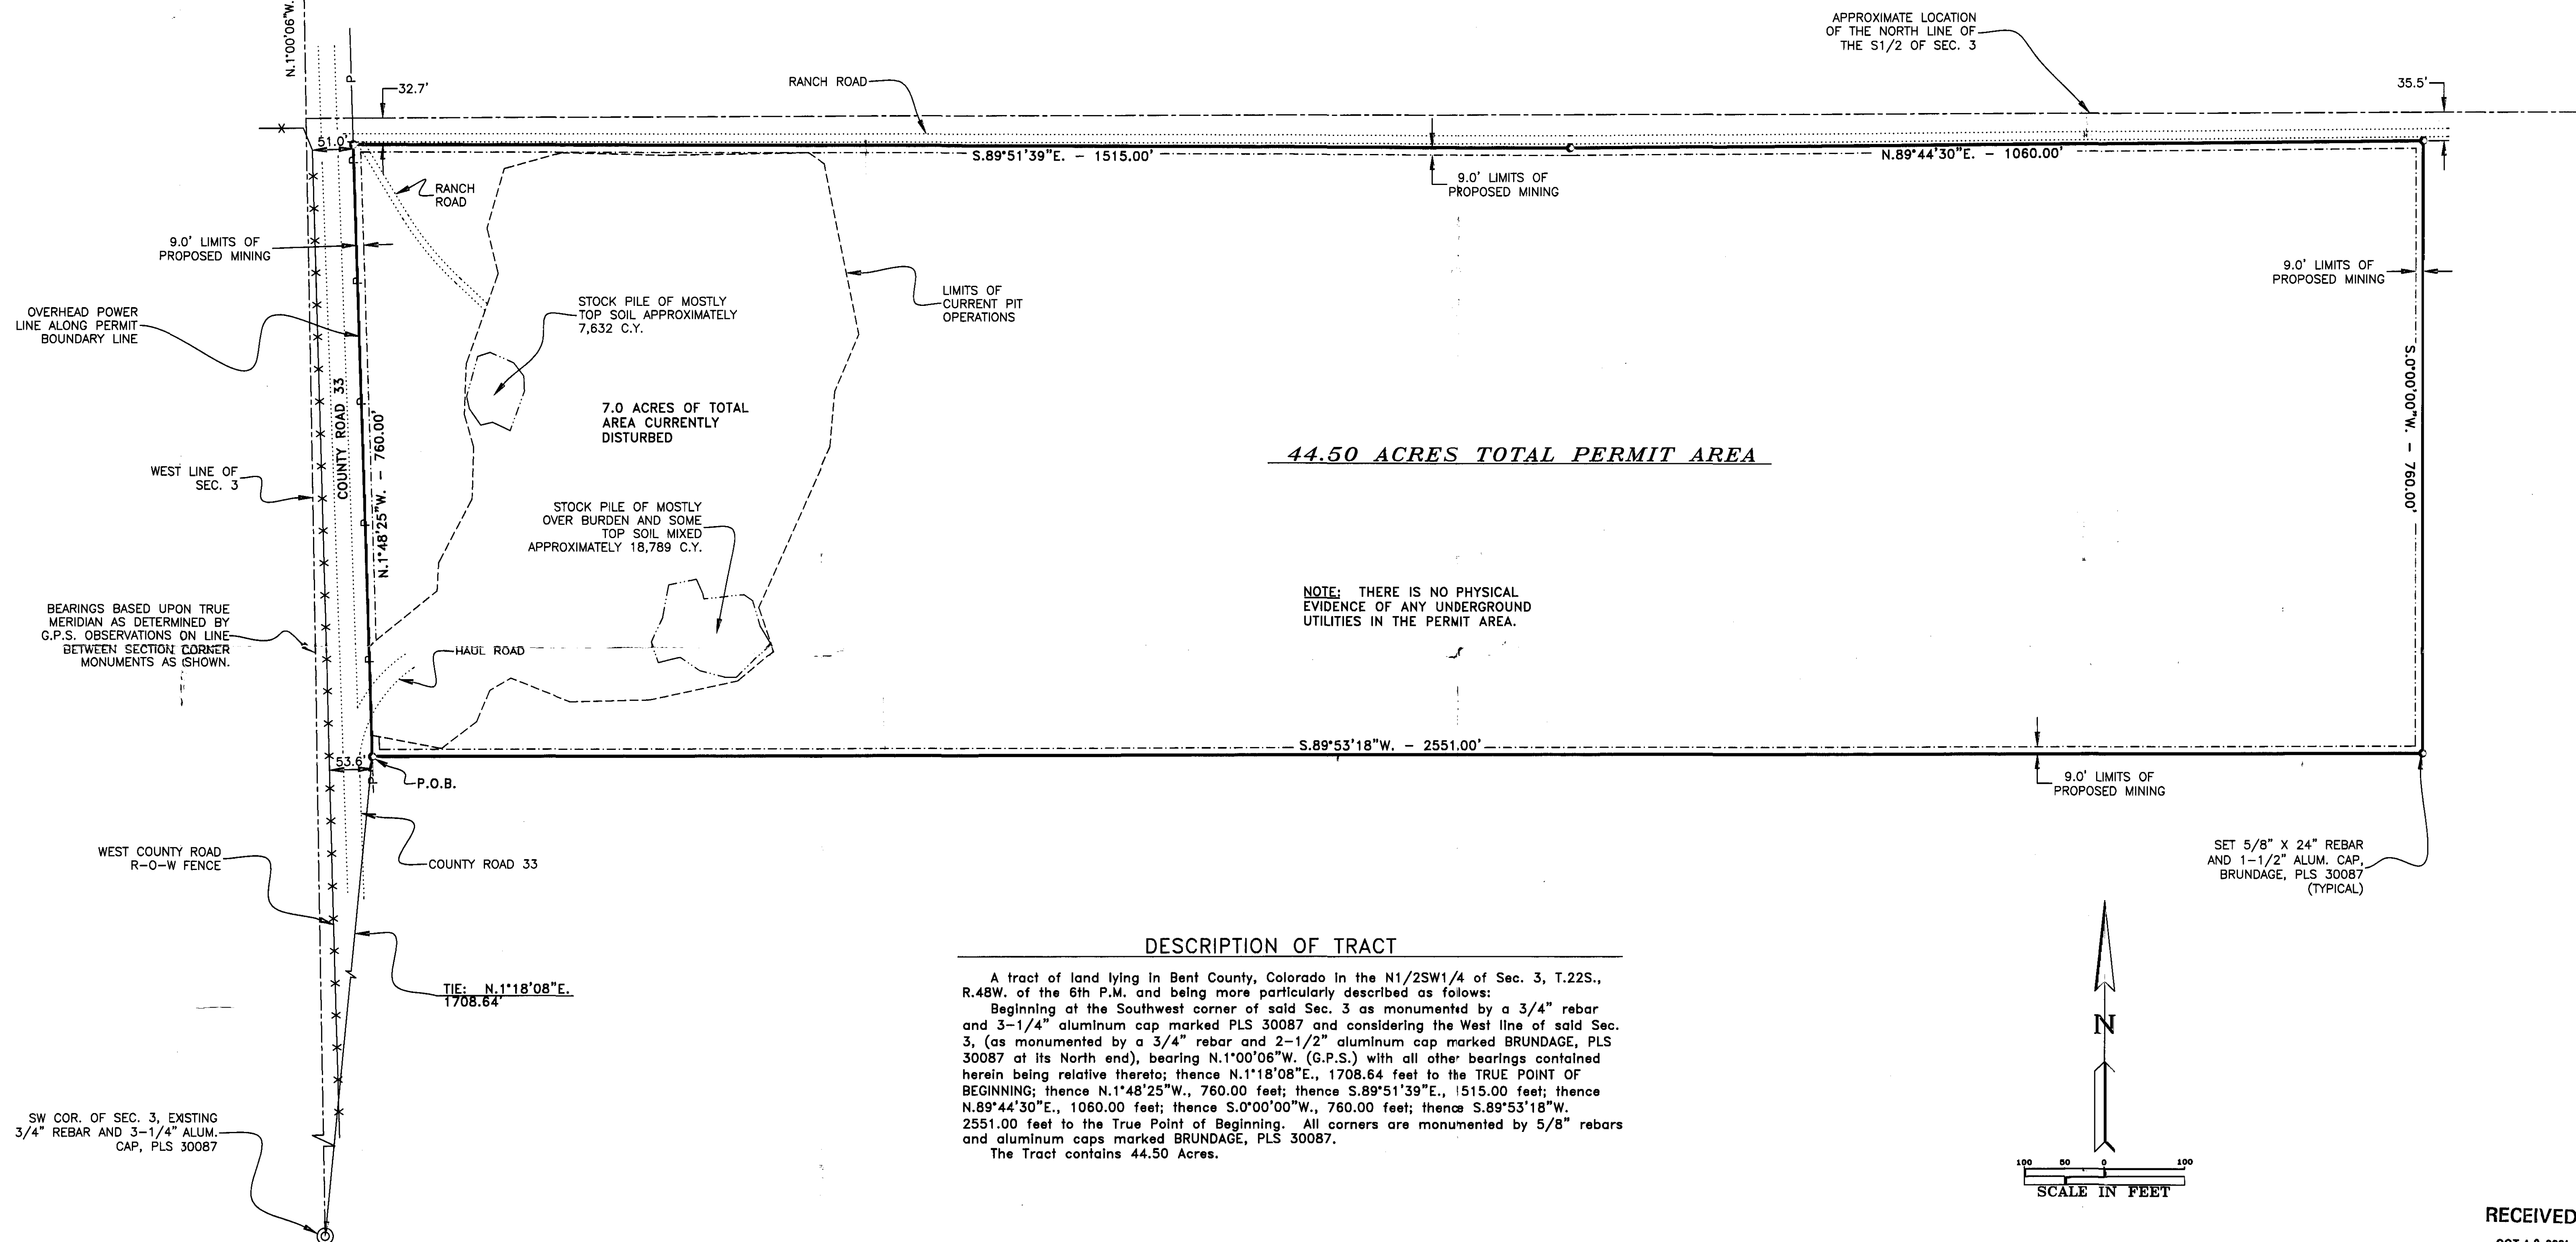
This is a 112c operation permitted for 44.5 acres (see enclosed Exhibit C Mining Plan Map) to mine limestone for maintenance of the operator's Fort Lyons Canal and associated road system. The operator was required to obtain a permit for this site in 2001 after the Mined Land Reclamation Board found the operator to be mining without a permit. According to the permit file, the operation had been mining the site since 1996, and upon renewal of its lease agreement with the CSLB, realized that obtaining a mining permit for the operation was a condition of the lease. The operator self-reported its findings and worked with the Division to obtain compliance for the operation. At that time, the Division estimated approximately 7 acres had been disturbed.

northern and southwestern boundaries), the Division recommends the operation be very careful during mining and reclamation activities to not disturb land outside these boundaries.
