MINERALS PROGRAM INSPECTION REPORT
PHONE: (303) 866-3567

MINE NAME: Golden Wonder Mine	MINE/PROSPECTING ID#: M-1978-091-UG	MINERAL: Gold	COUNTY: Hinsdale
INSPECTION TYPE: Monitoring	INSPECTOR(S): Stephanie J. Mitchell	INSP. DATE: June 19, 2019	INSP. TIME: 12:00
OPERATOR: LKA International Inc.	OPERATOR REPRESENTATIVE:	TYPE OF OPERATION: 110d - Designated Limited Impact

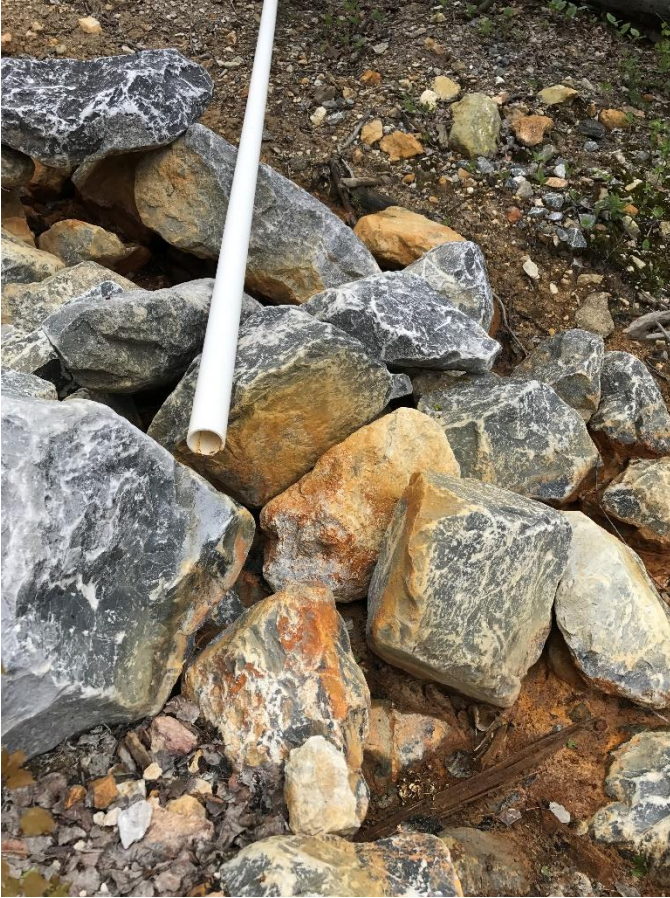
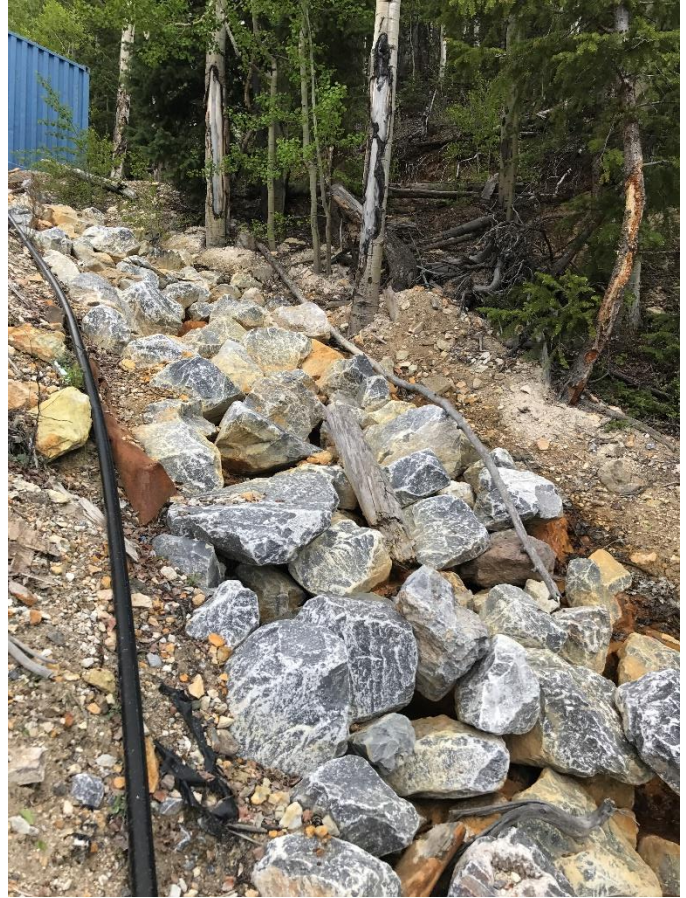
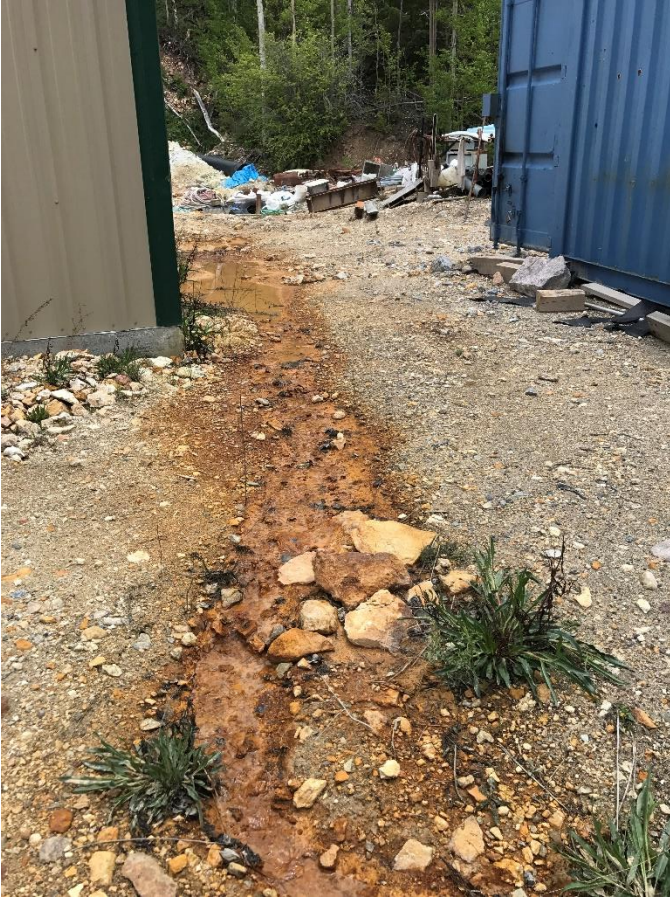
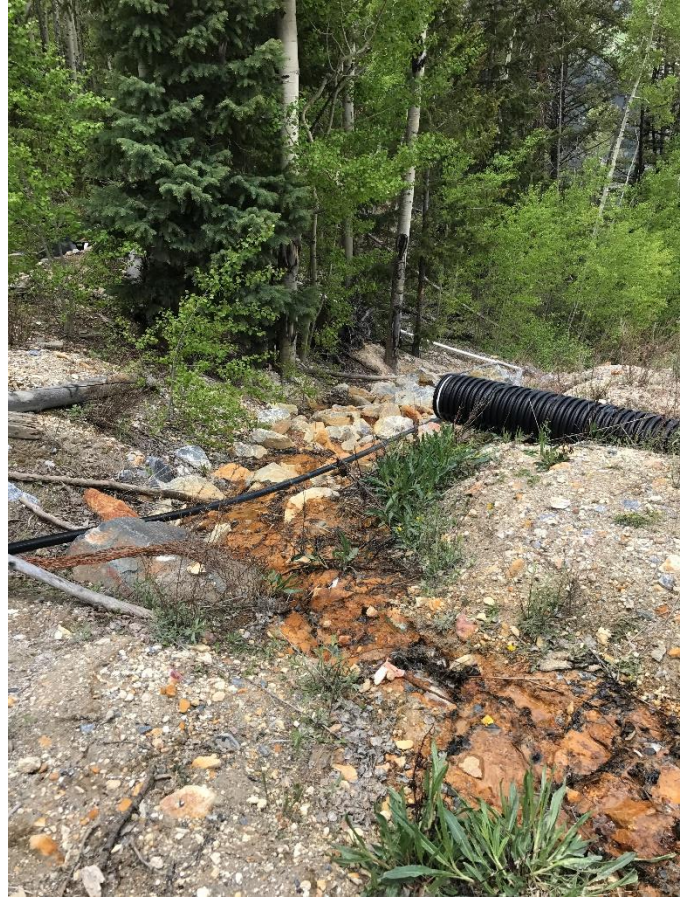
PROBLEM/POSSIBLE VIOLATION: Problem: The operator failed to prevent disturbances to the hydrologic balance through not providing samples indicating the effectiveness of the water treatment system located on the mine bench.

Water Treatment System- Water not entering
system (Dry)
