MINERALS PROGRAM INSPECTION REPORT
PHONE: (303) 866-3567

MINE NAME: Hobo 2	MINE/PROSPECTING ID#: M-2017-044	MINERAL: Gemstones	COUNTY: San Juan
INSPECTION TYPE: Monitoring	INSPECTOR(S): Lucas J. West	INSP. DATE: September 25, 2019	INSP. TIME: 09:35
OPERATOR: McFarland Enterprises, Inc.	OPERATOR REPRESENTATIVE: Keith McFarland	TYPE OF OPERATION: 110(1) - Hard Rock Limited Impact	
REASON FOR INSPECTION: Normal I&E Program	BOND CALCULATION TYPE: None	BOND AMOUNT: \$10,000.00	
DATE OF COMPLAINT: NA	POST INSP. CONTACTS: None	JOINT INSP. AGENCY: None	
WEATHER: Clear	INSPECTOR'S SIGNATURE:

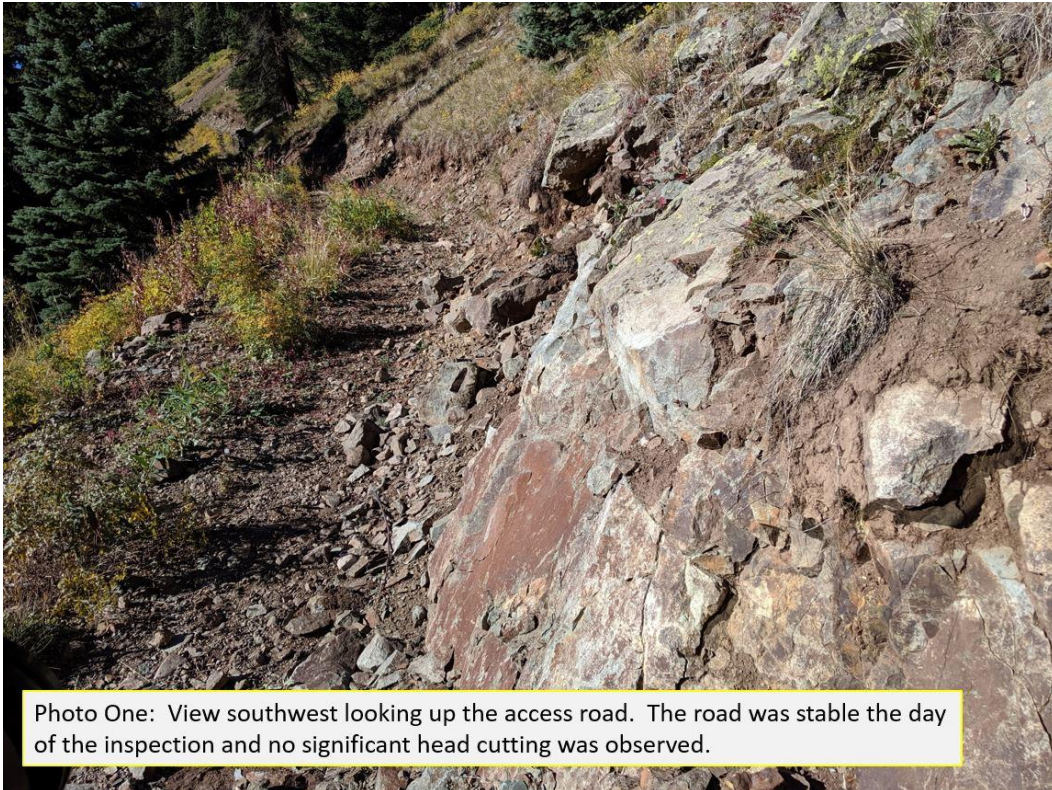
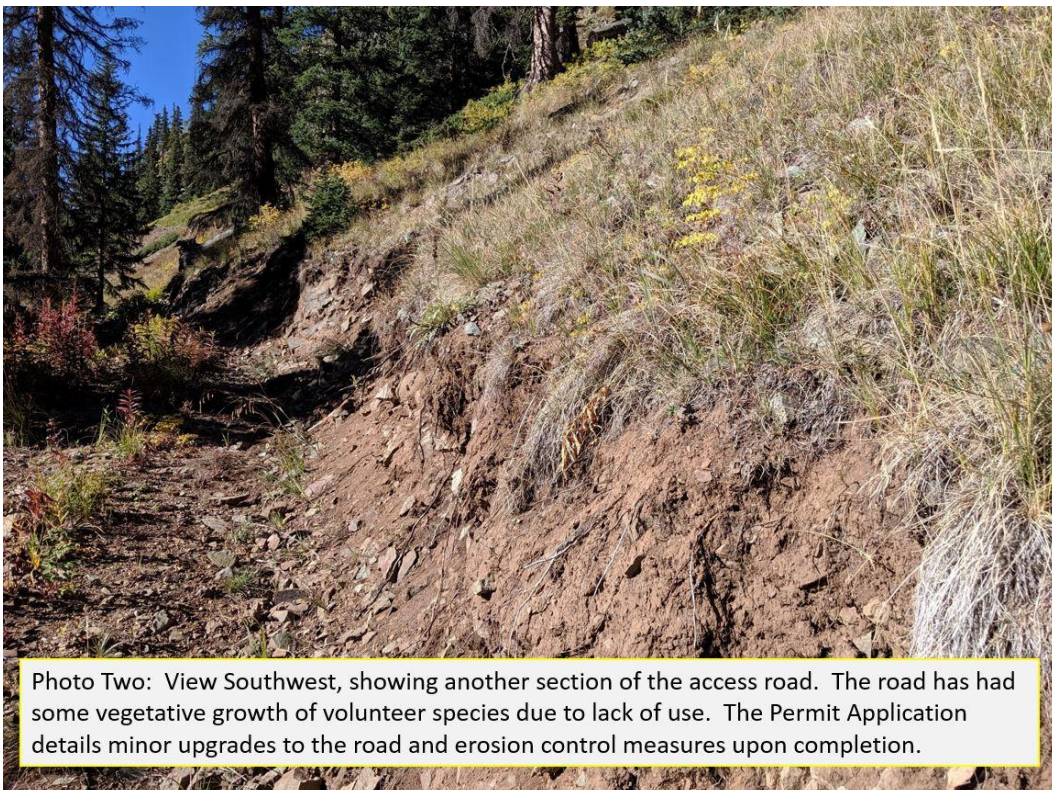
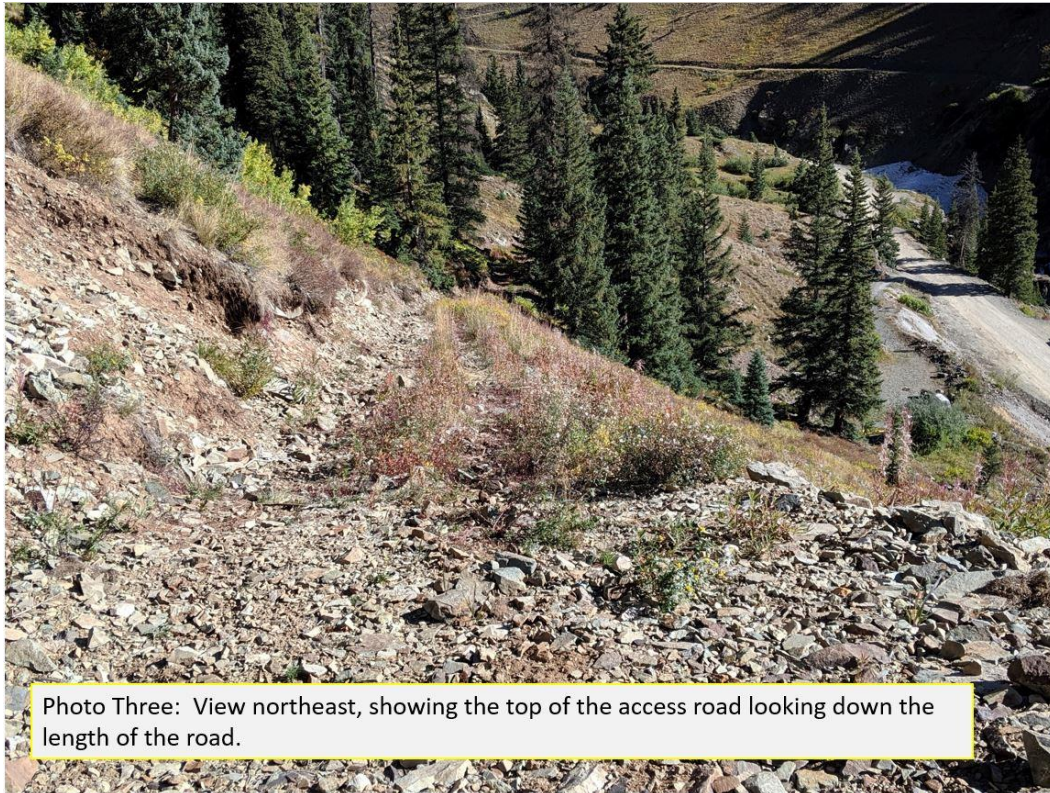
The main purpose of this inspection was to monitor the status of the site, as the permitting process is completed. The access road leading up to the portal from the Toltec Tunnel area appears to be stable and in good condition. No significant signs of settling, slumping or erosion were noted at this time. The initial area of concern, the uphill side of the road, also appears to be stable at this time. Photos One through Three show the condition of the road. The portal pad and work area appear to be in the same condition as the previous inspection. The Portal shed structure has collapsed due to excessive snow loading. Some of the building materials and debris has been removed from the site however some of the material that is reusable still remains. A written request to rebuild the structure this season has been submitted and approved however due to weather delays the repairs will not be able to be completed until the coming spring. The collapsed portal shed and portal can be seen in Photo Four.
