MINERALS PROGRAM INSPECTION REPORT
PHONE: (303) 866-3567

MINE NAME: Pueblo East Pit	MINE/PROSPECTING ID#: M-1906-015	MINERAL: Sand and gravel	COUNTY: Pueblo
INSPECTION TYPE: Monitoring	INSPECTOR(S): Patrick Hennberg	INSP. DATE: October 17, 2019	INSP. TIME: 1000
OPERATOR: Continental Materials Corporation	OPERATOR REPRESENTATIVE: Bruce Humphries	TYPE OF OPERATION: 112c - Construction Regular Operation	
REASON FOR INSPECTION: <input type="checkbox"/> Normal <input type="checkbox"/> Program		BOND CALCULATION TYPE: Complete Bond	
DATE OF COMPLAINT: <input type="checkbox"/> A		BOND AMOUNT: \$2,200.00	
WEATHER: Clear		JOINT INSP. AGENCY: None	
INSPECTOR'S SIGNATURE:

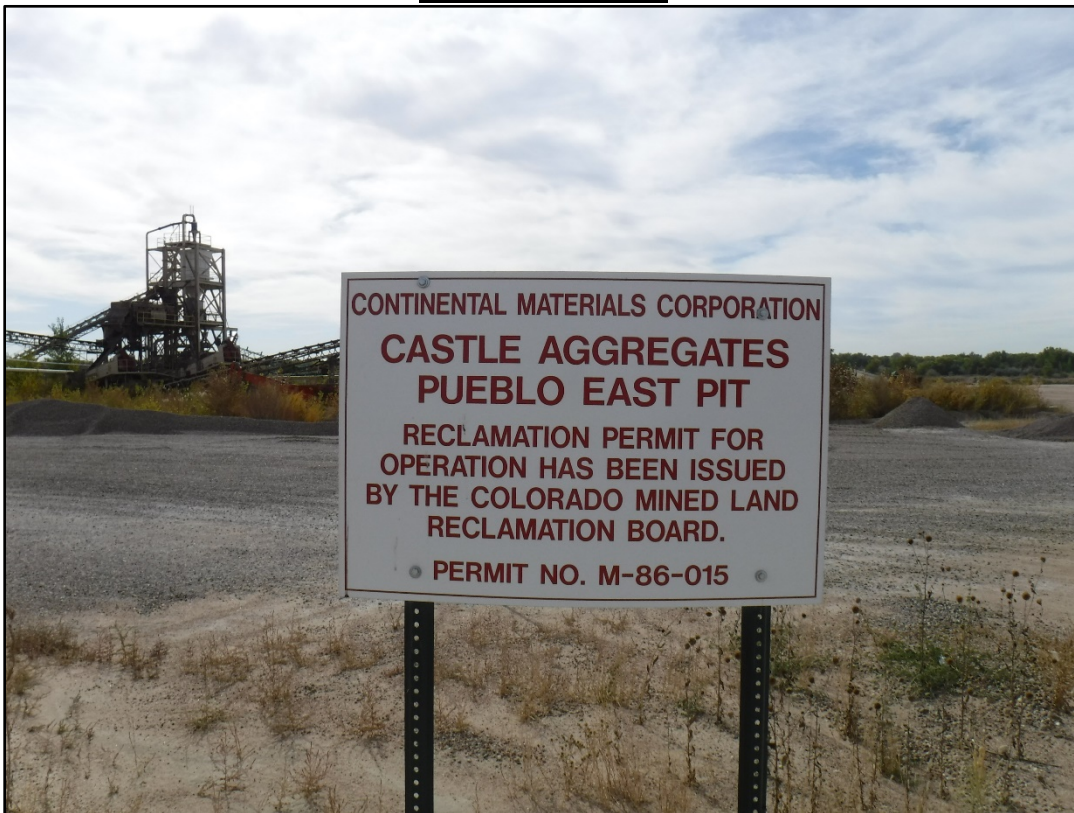
Photo 1: Mine sign at entrance mine site near batch plant

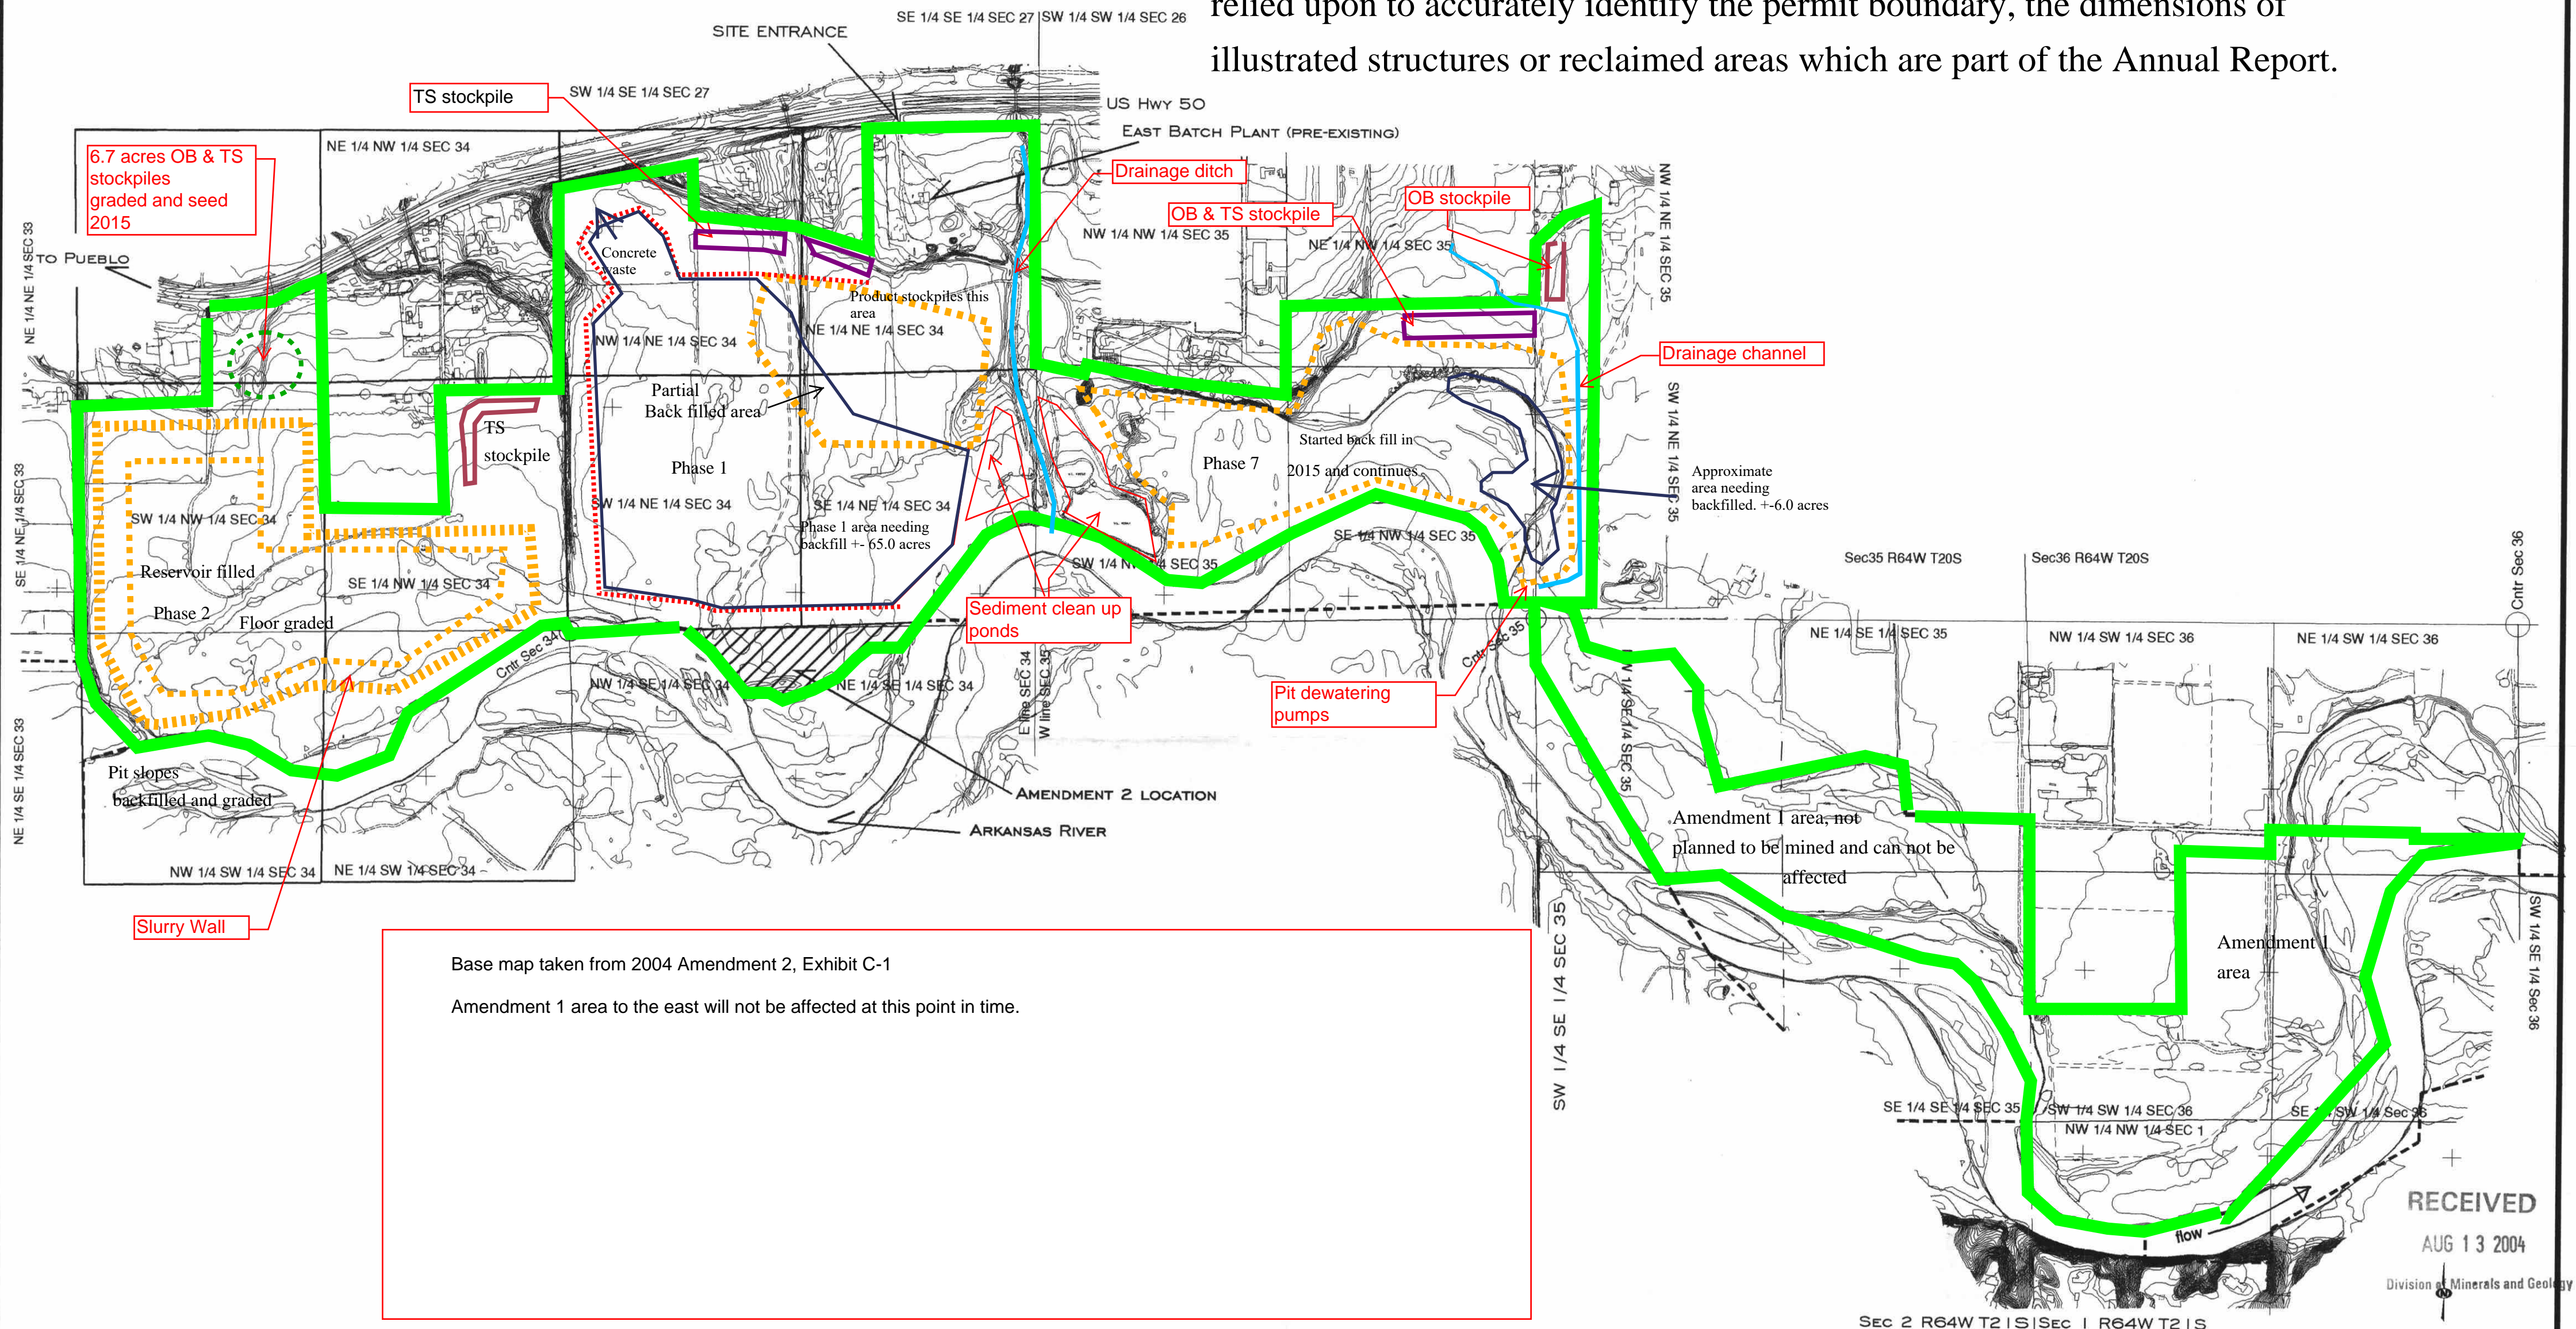
2019 Annual Report Map
November 7, 2019

Currently, Phase 1 has a few material stockpiles that are being sold. In 2017 Technical Revision 4 (TR-04) was approved and allowed for the importation of inert fill to be used as backfill. Currently cement truck cleanout material is being used as backfill. As shown in Figure 1 there is approximately 65 acres of exposed groundwater that requires backfilling. The actual depth of the exposed groundwater is not known at this time. According to the reclamation plan approved in Amendment 4 (AM-04) it is assumed that 26 feet of backfill material will be required to get approximately 2 to 3 feet above the groundwater elevation. The slopes of the pit will be graded to 3:1 or flatter. The floor of the basin will be graded to slope to the southeastern corner where an outfall structure will be located to discharge to the river. The post-mining land use for Phase 1 is to be wildlife habitat. Topsoil will be spread 6 to 12 inches on the side slopes. The floor will be left barren for a period of two years to allow for invasion of desired vegetation. If the desired vegetation fails to establish then cottonwood trees and willows will be planted. There are two sediment clean out ponds, totaling about 9 acres, will have to be backfilled above groundwater. At this time it does not appear that there is sufficient backfill and topsoil remaining onsite to complete reclamation, therefore material will have to be imported. The Operator is currently searching for potential sources of backfill.
