Greg Lewicki And Associates, PLLC

RE: Pride of America Mine, Colorado Stone Quarries, M-1999-058, October 2019 Diesel Spill Incident Report and Mitigation and Remediation Plan; Minerals Program Inspection Report, October 24, 2019; Follow-up Notice Requirements

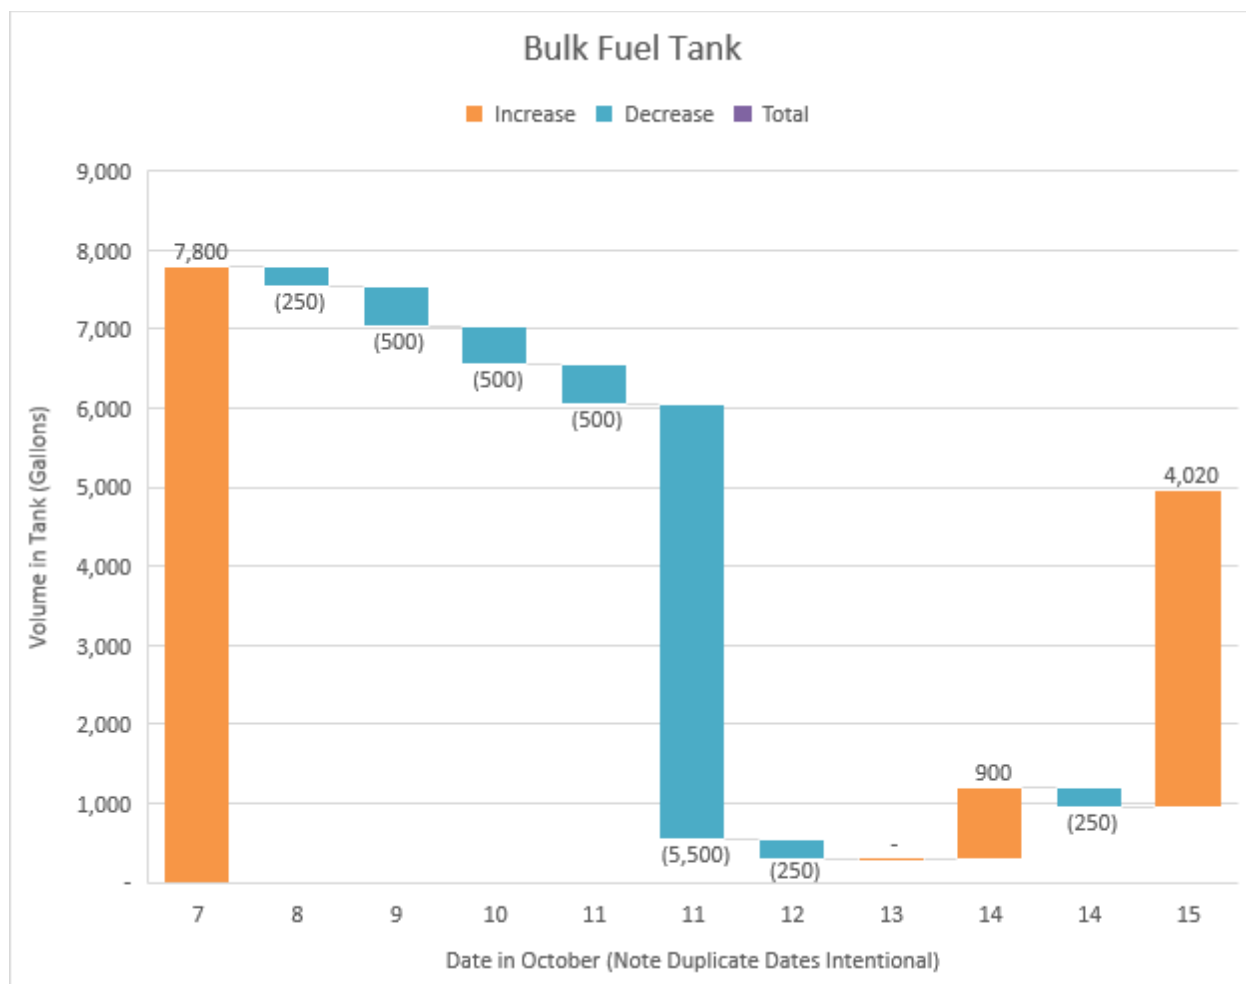
On Monday, October 14th, CSQ staff re-measured the fuel level in the bulk tank and realized that the Saturday reading of the fuel level gauge was incorrect and that 7 inches, not 7 feet, of fuel had been present in the tank. Calculations were completed and resulted in the determination that ~5,500 gallons of diesel was missing from the 12,000 gallon tank. Figure 7 details the daily fuel volume in the bulk fuel tank from October 7 through

October 15 in graphic form. Values of 500 gallons are used as the average amount consumed on a full production day, while an average of 250 gallons are consumed on low production day, such as weekends.

Figure 7. Waterfall chart of the fuel status within the 12,000 gallon dyed diesel generator tank from October 8 through October 15, 2019.

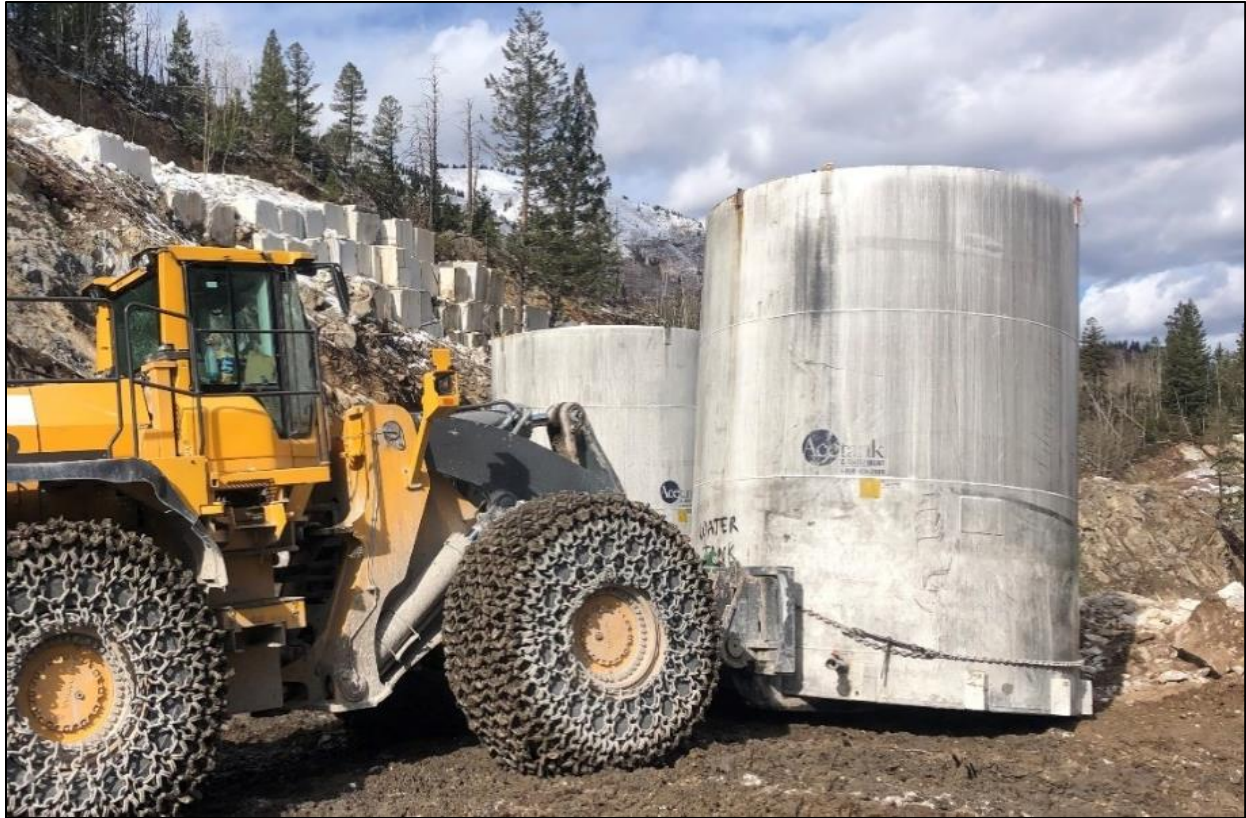
gallon water truck, were placed at the road level above the sump area to accommodate a heavy return of pumped water in the event that flushing resulted in a large push of water through the fill into the sump (Figure 9 and Figure 10). The Clean Harbors water tanker was also placed in the same location to receive the first load of pumped water.

Figure 9. Water tank placement to receive pumped sump water. Photo captured Wednesday, October 23, 2019; view to the north.

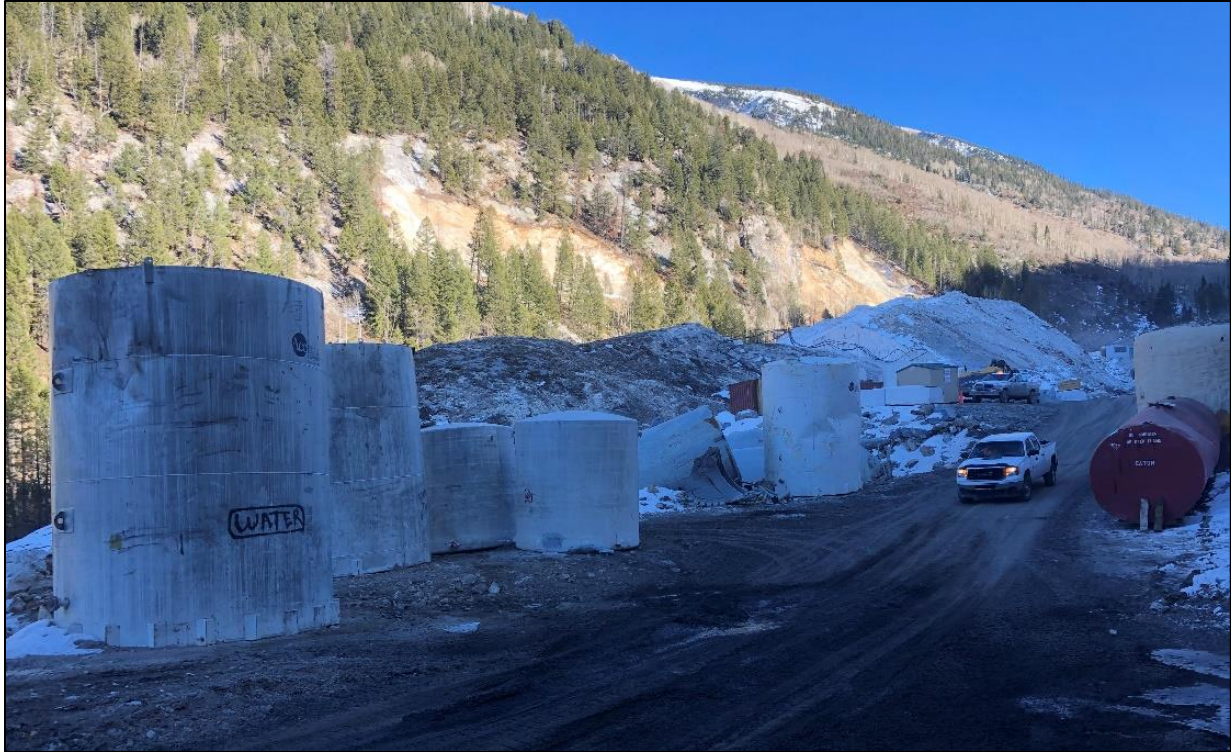
Figure 10. Water tank placement to receive pumped sump water. Photo captured Thursday, November 14, 2019; view to the south-southeast.

By mid-afternoon, the immediately available tank space provided by CSQ was exhausted and plans began to collect and repair other water tanks located throughout the site; final tank arrangements are shown in Figure 10. A total of ~70,000 gallons of tank space was made available, not including mobile water trucks and tankers. Immediate calls were made to HRL requesting that more water tankers and water trucks be deployed to the site to collect additional water. One 20,000 gallon frac tank was ordered by HRL and delivered to the site at loadout. Over the course of the evening, the site's water truck transported multiple 4,000 gallon loads of contaminated water from the pump, and also from the filled tanks on the haul road, to the frac tank. Also, around mid-afternoon, snowfall and wind speeds began to rise while temperatures continued to drop. The resultant ~10-25°F temperatures with wind chills into the negative Fahrenheit values created an extremely difficult outside working environment. The rate of inflow to the sump did not slow at any time during the first days pumping efforts and, near the close of business on October 29th, it became apparent that more tank space would be needed to accommodate the rate of pumped water from the sump throughout the night.

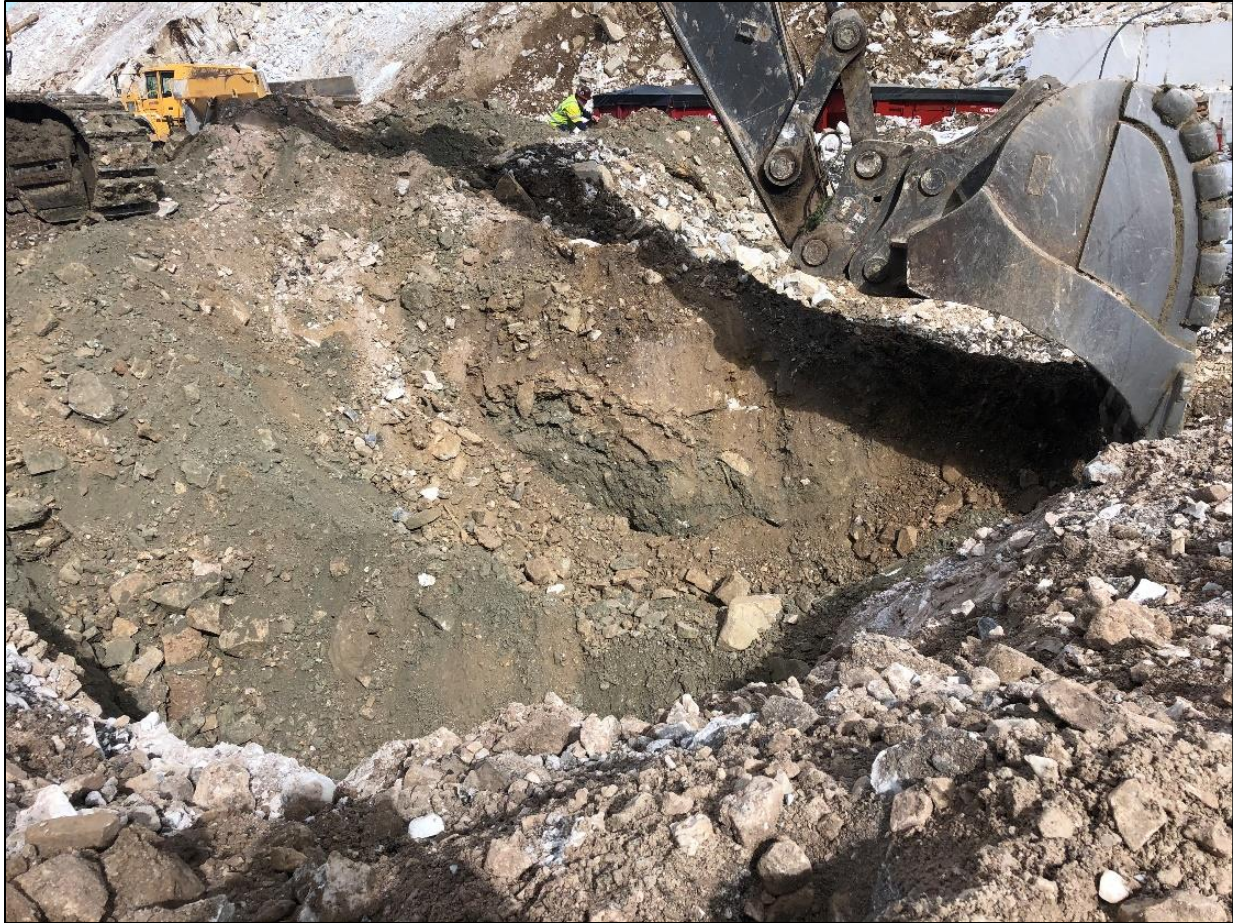
Two holes were dug near the generator Conex to determine potential pathways for diesel to enter and potentially saturate the fill near the generators (Figure 11). One hole was located at the center of the northern face and a second adjacent to the western Conex face. Both holes were within 10 feet of the generator Conex. The western hole yielded diesel soaked soil to a depth of 2.5-3 feet and was observed via smell and mild staining. The northern hole yielded diesel soaked soil to a depth of 2.5-3 feet with less distinct, but still detectable, diesel odor at a depth of approximately 12 feet below the pad surface. It was determined due to the mild presence of diesel odor at depth that the northern hole would serve as the input location for water flushing, simple green injection, and final seasonal fill remediation of a Micro-Blaze application.

Figure 11. Northern hole prepared for clean water flushing input directly adjacent to the generator Conex (out of frame to the right). Photo captured October 23, 2019; view to the east; man in yellow for scale.

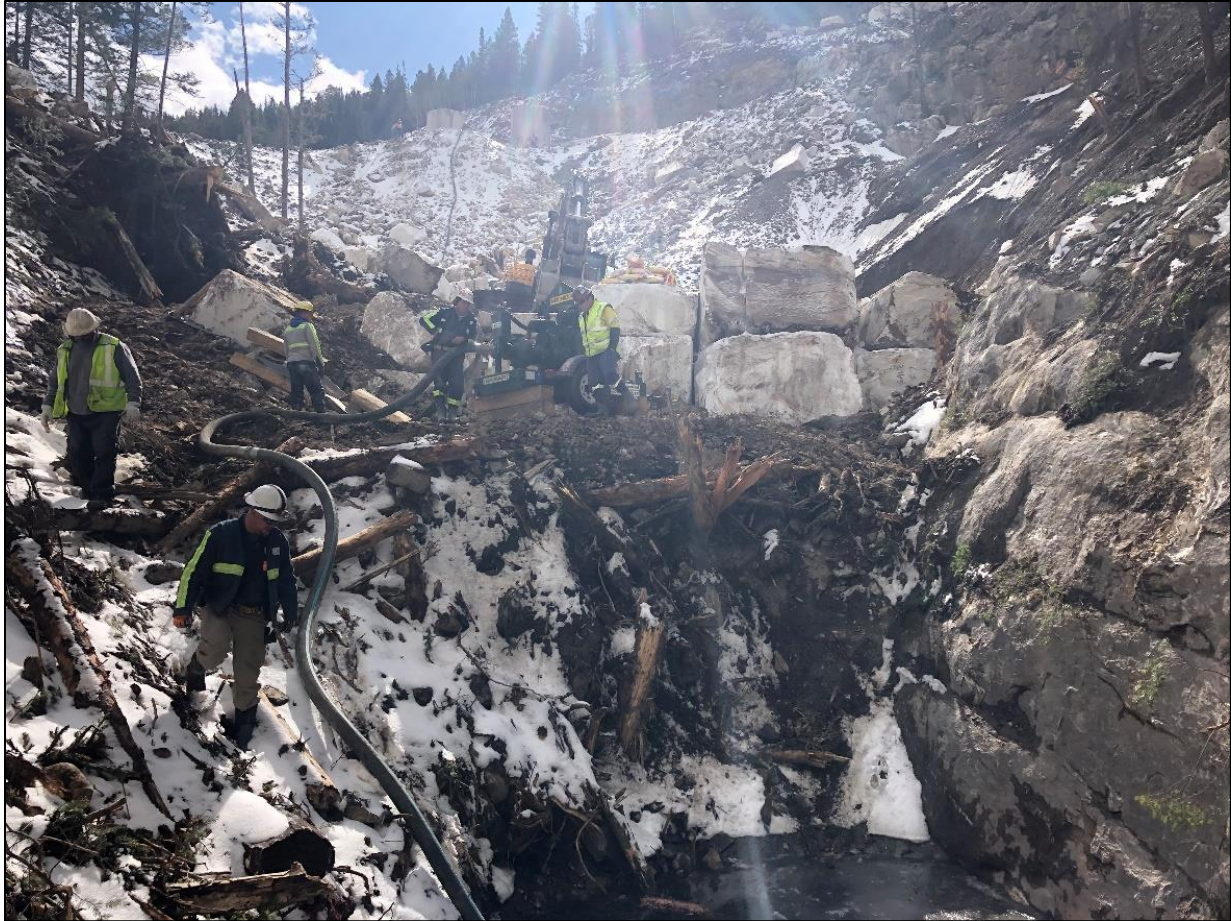
On Thursday, October 24th, two pumps of roughly equal size were delivered by Rain for Rent. The first pump was tested and worked (Figure 12). The second pump did not work as it was rated for high flow and low pressure – the opposite required in this environment. Rain for Rent replaced that pump on the same day. The third Rain for Rent pump was the largest pump available in the Rain for Rent fleet.

Figure 12. View of the Rain for Rent pumped that was checked and worked on October 24, 2019. Notice the hose running up the colluvium slope shown in the background to the tank located along the northern extent of the haul road. Photo captured October 23, 2019; view to the west-southwest.

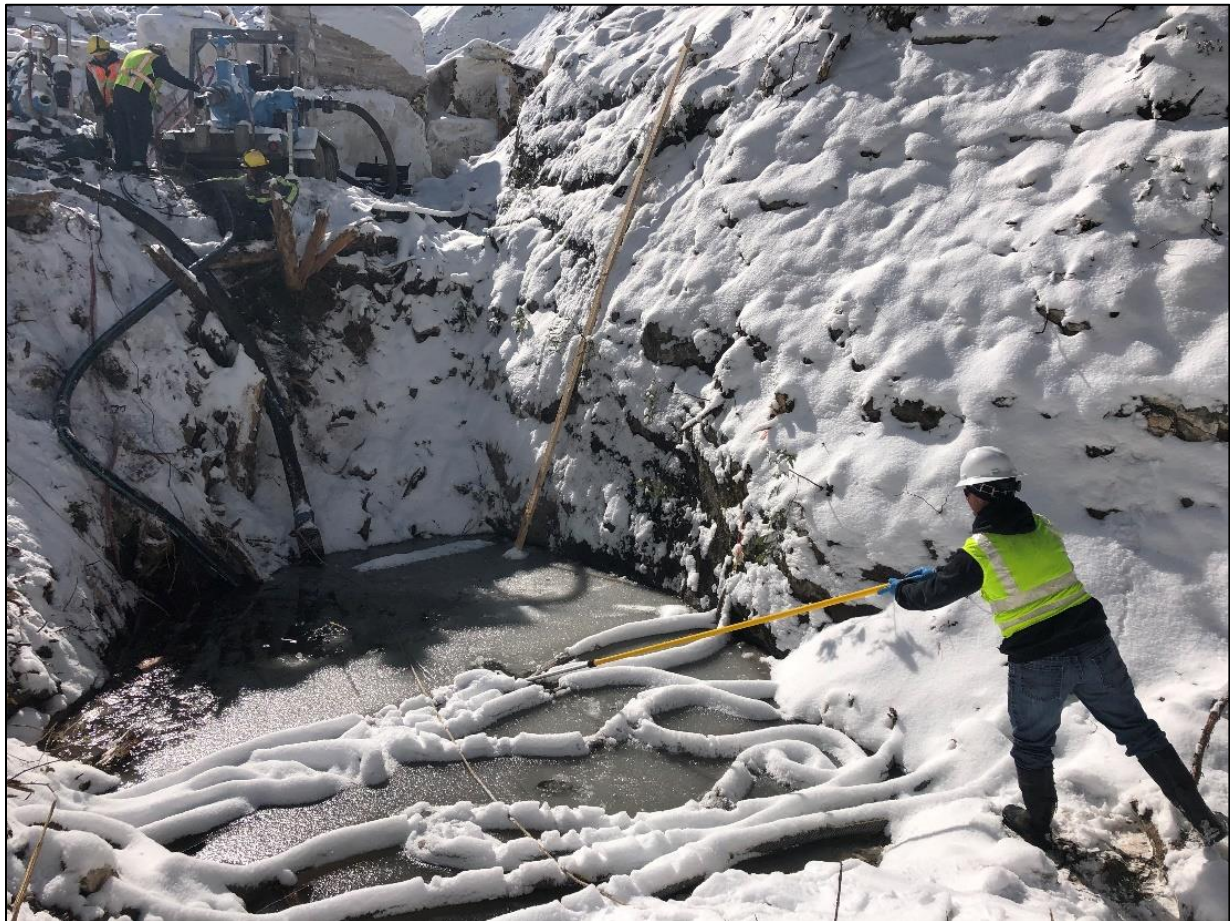
HRL conducted baseline sampling for diesel in 8 locations, including one off-site location at the confluence of Yule Creek and the Crystal River (Figure 13). These sample locations are shown on the map in Appendix E. Diesel odor was only detected in one location – the sump. No other visual cues of diesel were observed at any other sampling locations. HRL was also consulted regarding changes to the flushing and pumping plan.

Figure 13. HRL personnel baseline sampling the sump. Photo captured October 28, 2019; view to the west-southwest.

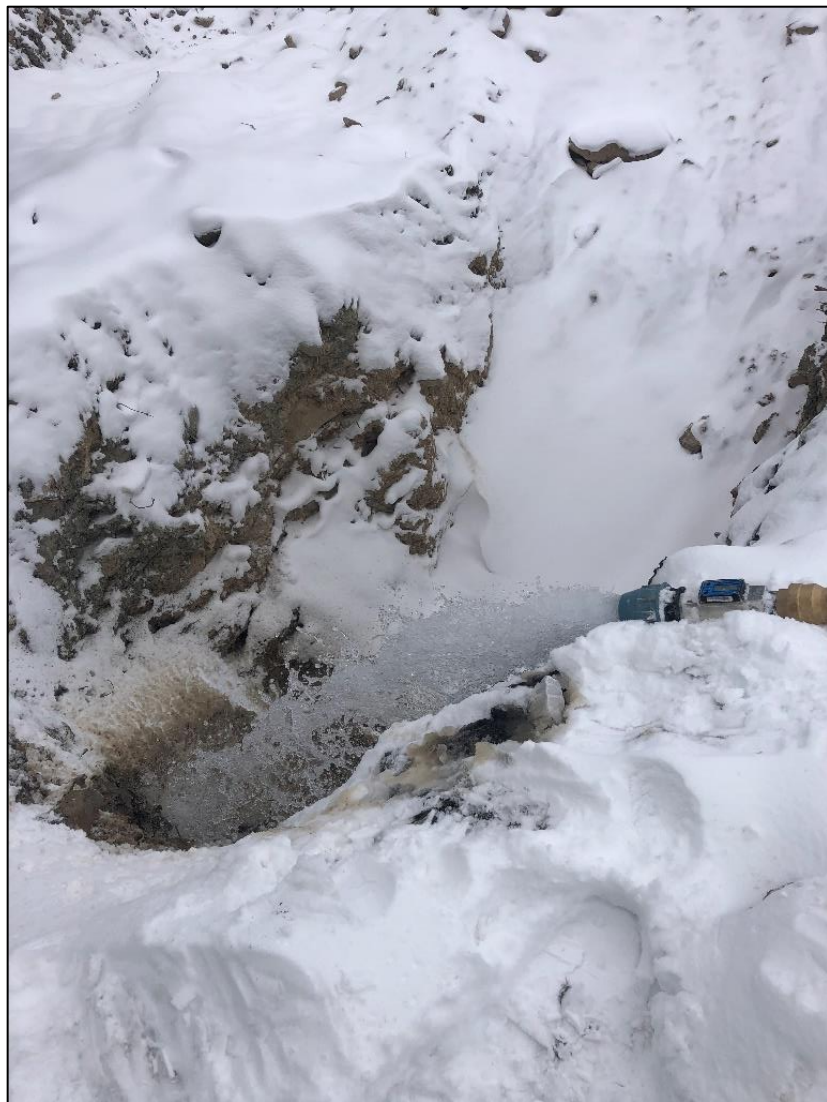
Figure 14. Flush of 5,015 gallons of clean water into the hole featured in Figure 10; notice the totalizing flow meter at the hose end. Photo captured October 29, 2019.

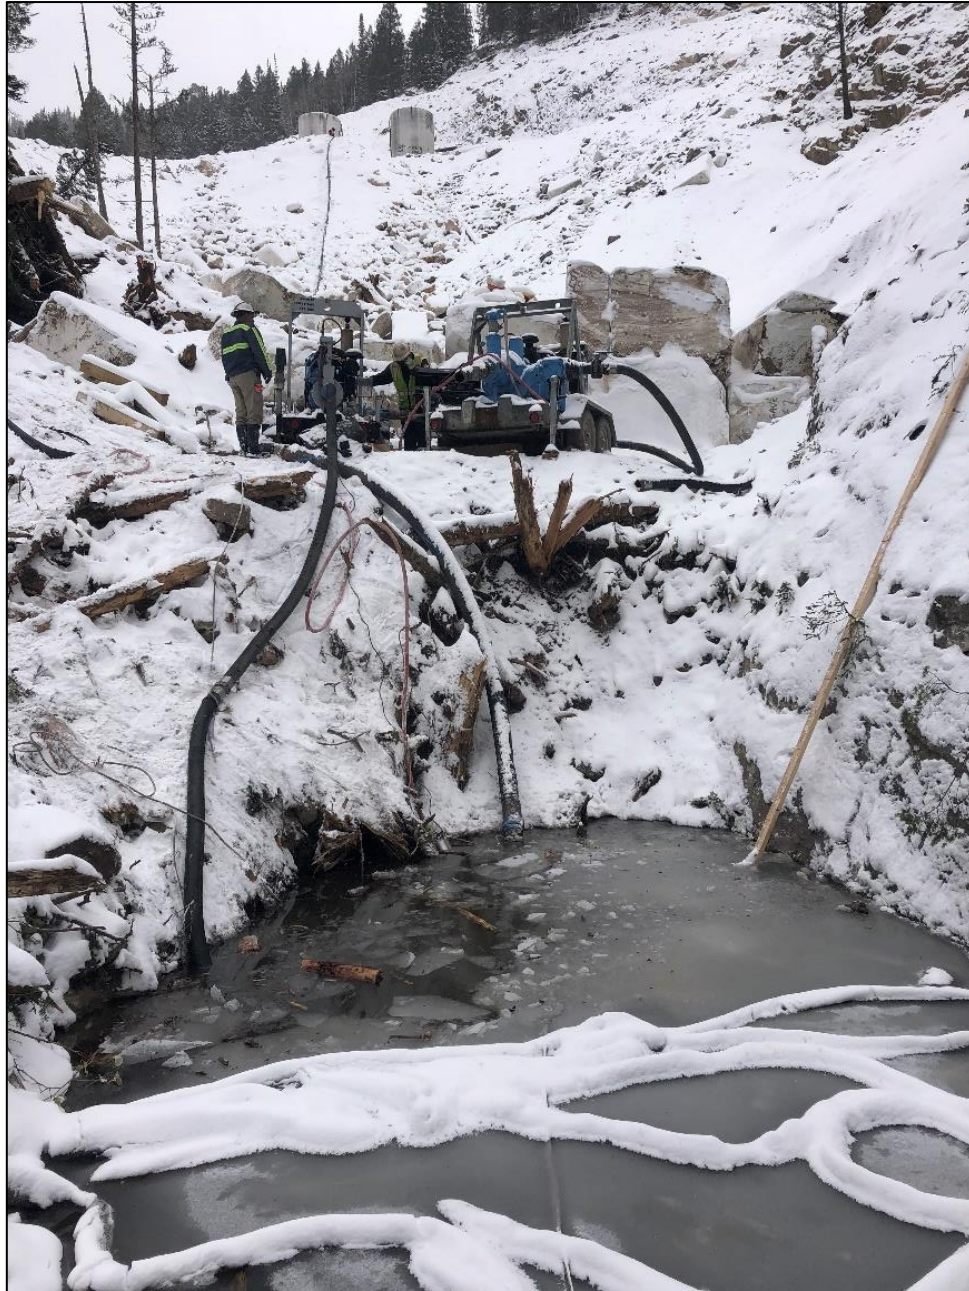
Figure 15. Sump with visual level rise post flushing; notice the 2x4 in the right of the frame. Photo captured October 29, 2019; view to the west-southwest.

Once it was determined that the sump had risen almost a foot within the hour following initiation of flushing, it became immediately apparent that pumping needed to begin promptly. (This realization nullified the previous hypothesis that no flow would result from pumping water through the road fill.) Constant pumping efforts were initiated and ceased only when the hoses were transferred between tanks as they were filled. After two hours of pumping, it was determined that flow into the sump was occurring at a rate of 5,000 gallons an hour based on the amount of water collected in the tanks located on the haul road.

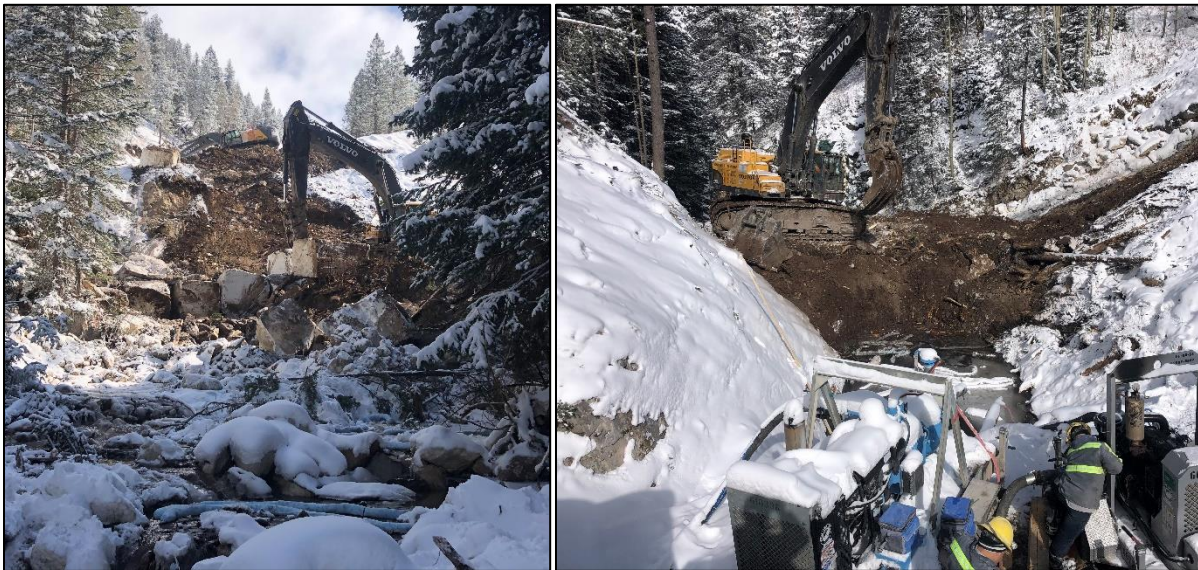
During the night, the sump rose to a height of 6 feet and allowed for clean water to infiltrate the taller berm while trapping the surface diesel sheen within the sump (Figure 18). As a result, work began the following morning, Thursday, October 31st, to further fortify and compact the berm at the northern edge of the sump (Figure 19). Marble blocks were installed along the northern edge of the sump to strength the berm and in preparation of much stronger spring melt flows that Yule Creek experiences annually. Soil and crushed marble fines were mixed and compacted along the south face of the berm to further concentrate any diesel particulates in the sump while allowing clean water to flow through. Additional booms were deployed down gradient in Yule Creek to further capture any potential diesel in Yule Creek (Figure 20).

Figure 19. Berm rebuilding following emergency berm refortification the night before. Left image view to the south from beside Yule Creek; right image view to the north-northeast from the pump pad. Photos captured October 30, 2019.

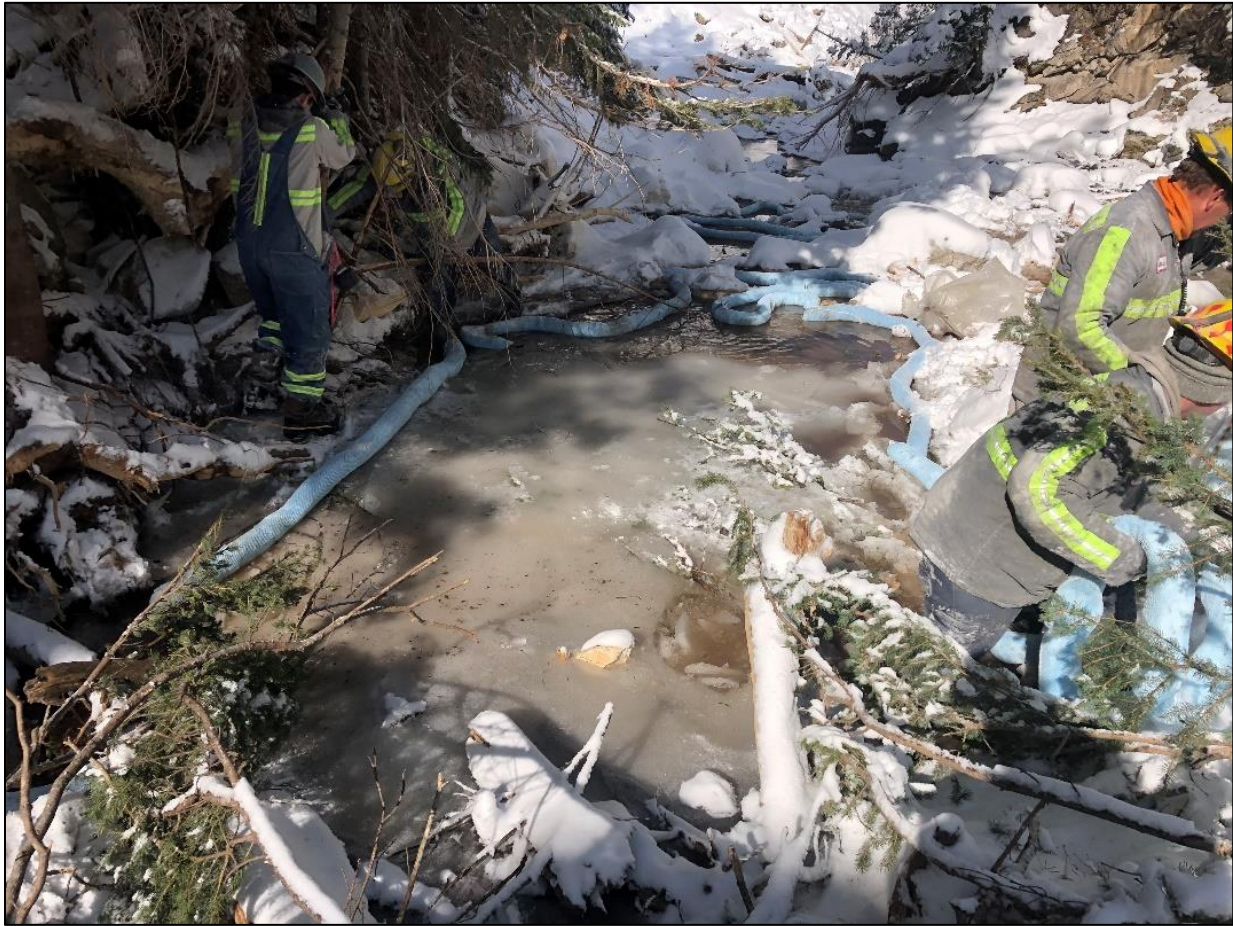
Figure 20. Additional boom deployment in Yule Creek. Photo from October 30, 2019; view to the north.

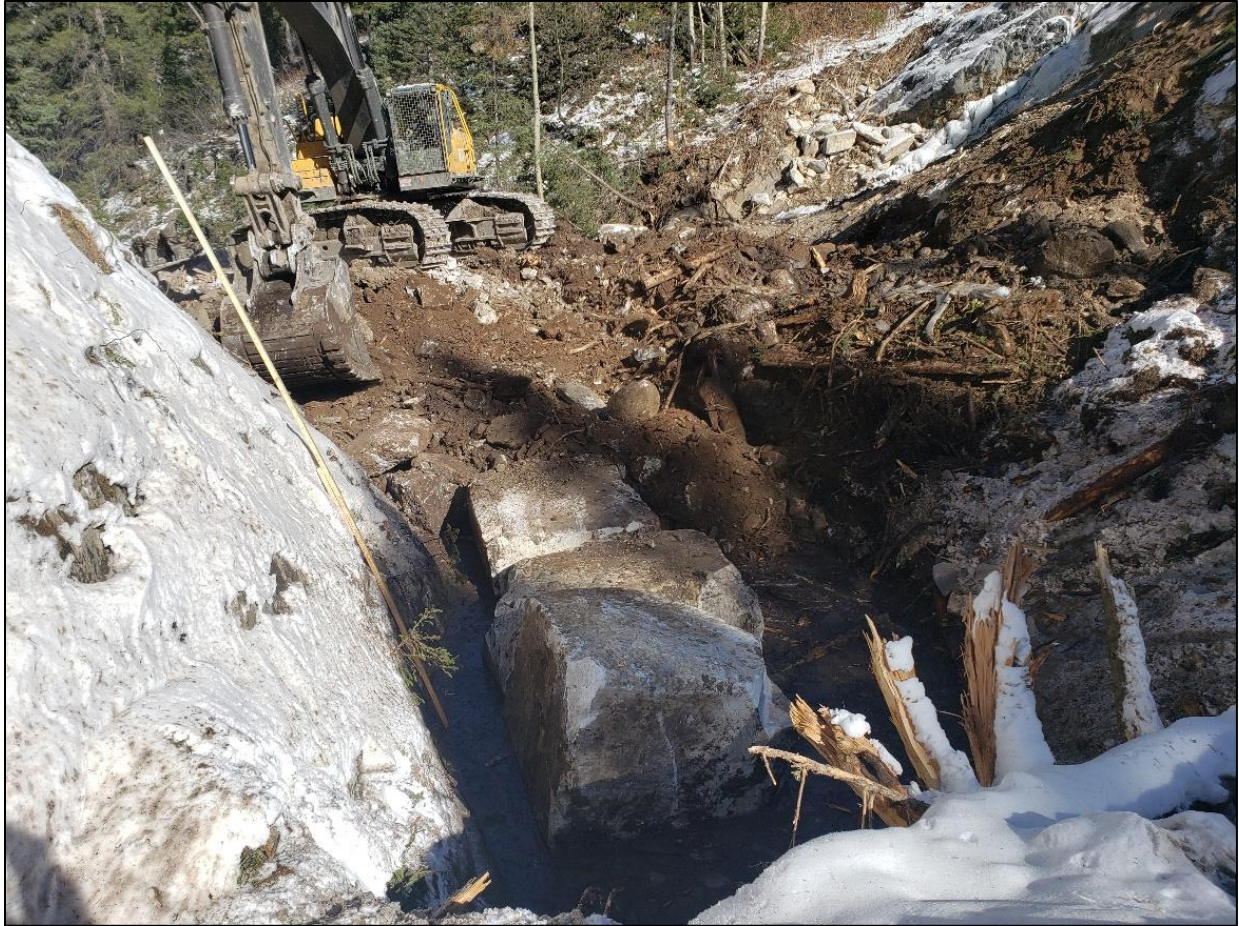
Following confirmation with HRL regarding future water sampling of the sump, on Friday, November 1st, the sump was partially filled with marble blocks and soil to facilitate the transport of the excavator used to buildup and fortify the sump berm (Figure 23). Prior to filling with marble blocks and loose soils, the ice, debris and soil along the eastern edge of the sump was removed and stockpiled above the sump area for removal once soil import was approved. Fresh soil was placed in the sump and will be segregated for removal during installation of HRL's long-term water sampling and remediation plan for the sump. The final HRL designed long-term sampling plan will be provided once it is completed by HRL and confirmed by CSQ and GLA. Rough estimates of long-term sampling includes bi-monthly (2x) sampling of the to-be-installed monitoring wells, sump and surface waters through spring and summer 2020 during peak runoff. Sampling will occur across all areas on a monthly basis during the winter months as dictated by safe access. Two totes of Micro-Blaze were delivered to the site. Implementation of Micro-Blaze treatment will be conducted by HRL. HRL committed to completing an application plan, facilitating the application, and monitoring the immediate and long-term results of the Micro-Blaze application. The installation of bioremediation ports and the initial surface sprayed application of Micro-Blaze occurred on Thursday, November 14th and Friday, November 15th. The HRL Bioremediation Treatment Plan is included in Appendix F.

Figure 23. Temporary fill and marble blocks within the sump. Photo captured November 1, 2019; view to the east.

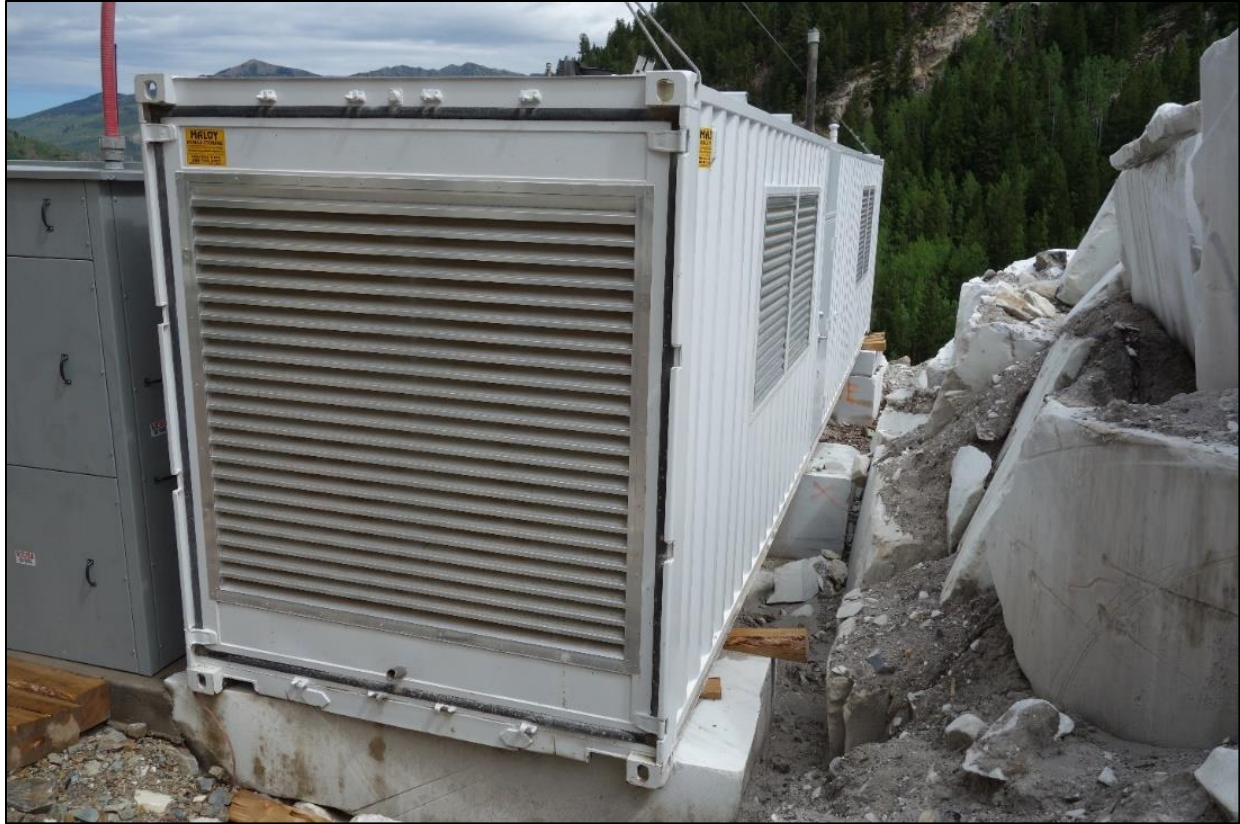
In the initial 2019 installation outside Portal #4, the elevation of the top of the day tank vent was at approximately the middle of the bulk tank and was also within the Conex. The intended plumbing design requires that the top of the vent pipe be higher than the ‘elbow’ of the return piping into the bulk tank, i.e. above the top of the bulk tank elevation (Figure 1.A.). Figure 24 shows the original 2014 installation of the primary power generators outside Portal #4. The vent pipe of the day tank can be seen in the middle of the photo exiting the roof of the Conex. The vent pipe would partially fill until the overflow begins to flow into the bulk tank via the return flow piping (Figure 1.A.). Both the day tank and the bulk tank would need to overflow for any of the tank vents to overflow. The design of the 2014 and 2019 installation does not provide secondary containment for fuel transfers if the elevations of the tanks, transfer lines, or tank vents are changed.

Figure 24. Image of the 2014 primary generator Conex set up. Photo captured August 5, 2014; view to the northeast.

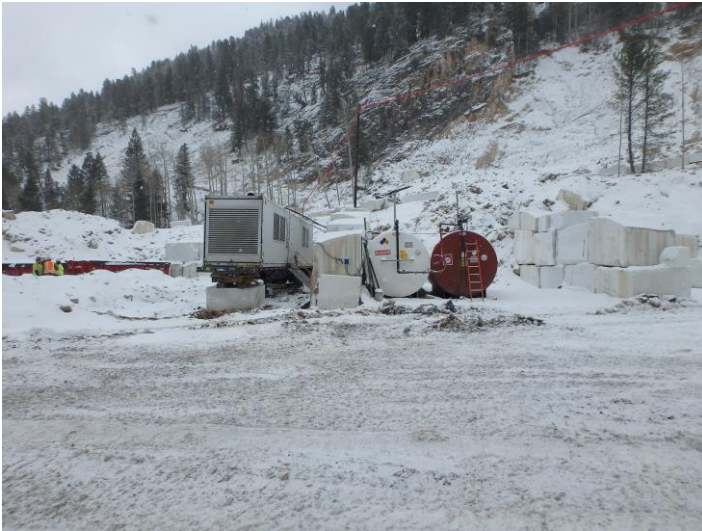
Figure 1: Generator unit and two associated fuel tanks

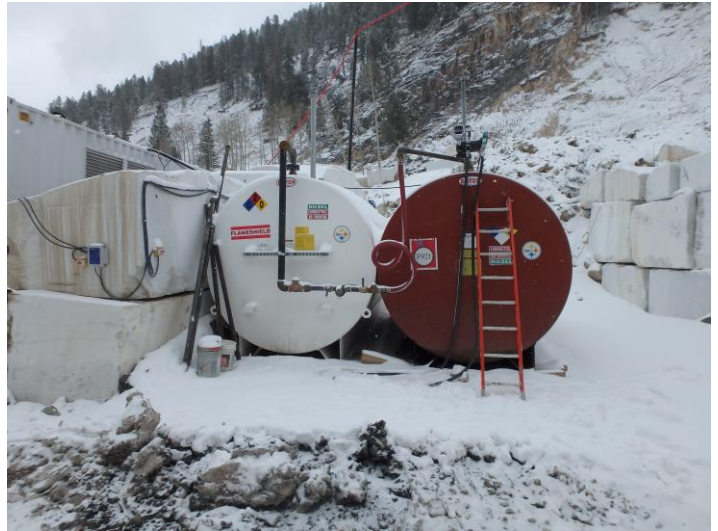
Figure 2: Fuel tanks for generator

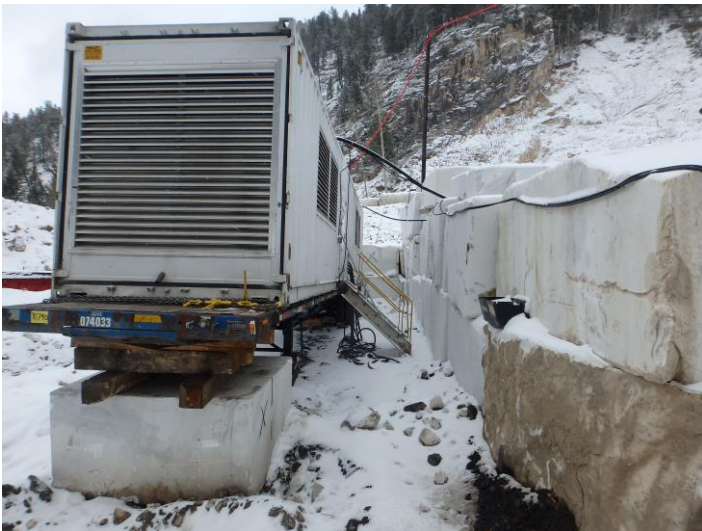
The diesel fuel day tank located in the generator trailer on the generator pad was not being maintained in a manner to prevent leakage. Over the weekend the diesel fuel tank leaked approximately 5500 gallon. The electric float system for the day tank was faulty and stuck open allowing the diesel fuel to keep flowing into the tank. The diesel fuel was allowed to leak out of the relief valve for approximately 20 hours.

Figure 3: Generator unit in which leak occurred

17. Action to Terminate
The mine operator repaired the electric float system by adjusting the voltage. Also the relief valve was replaced and fittings resealed. When tested the diesel day tank did not leak diesel fuel.

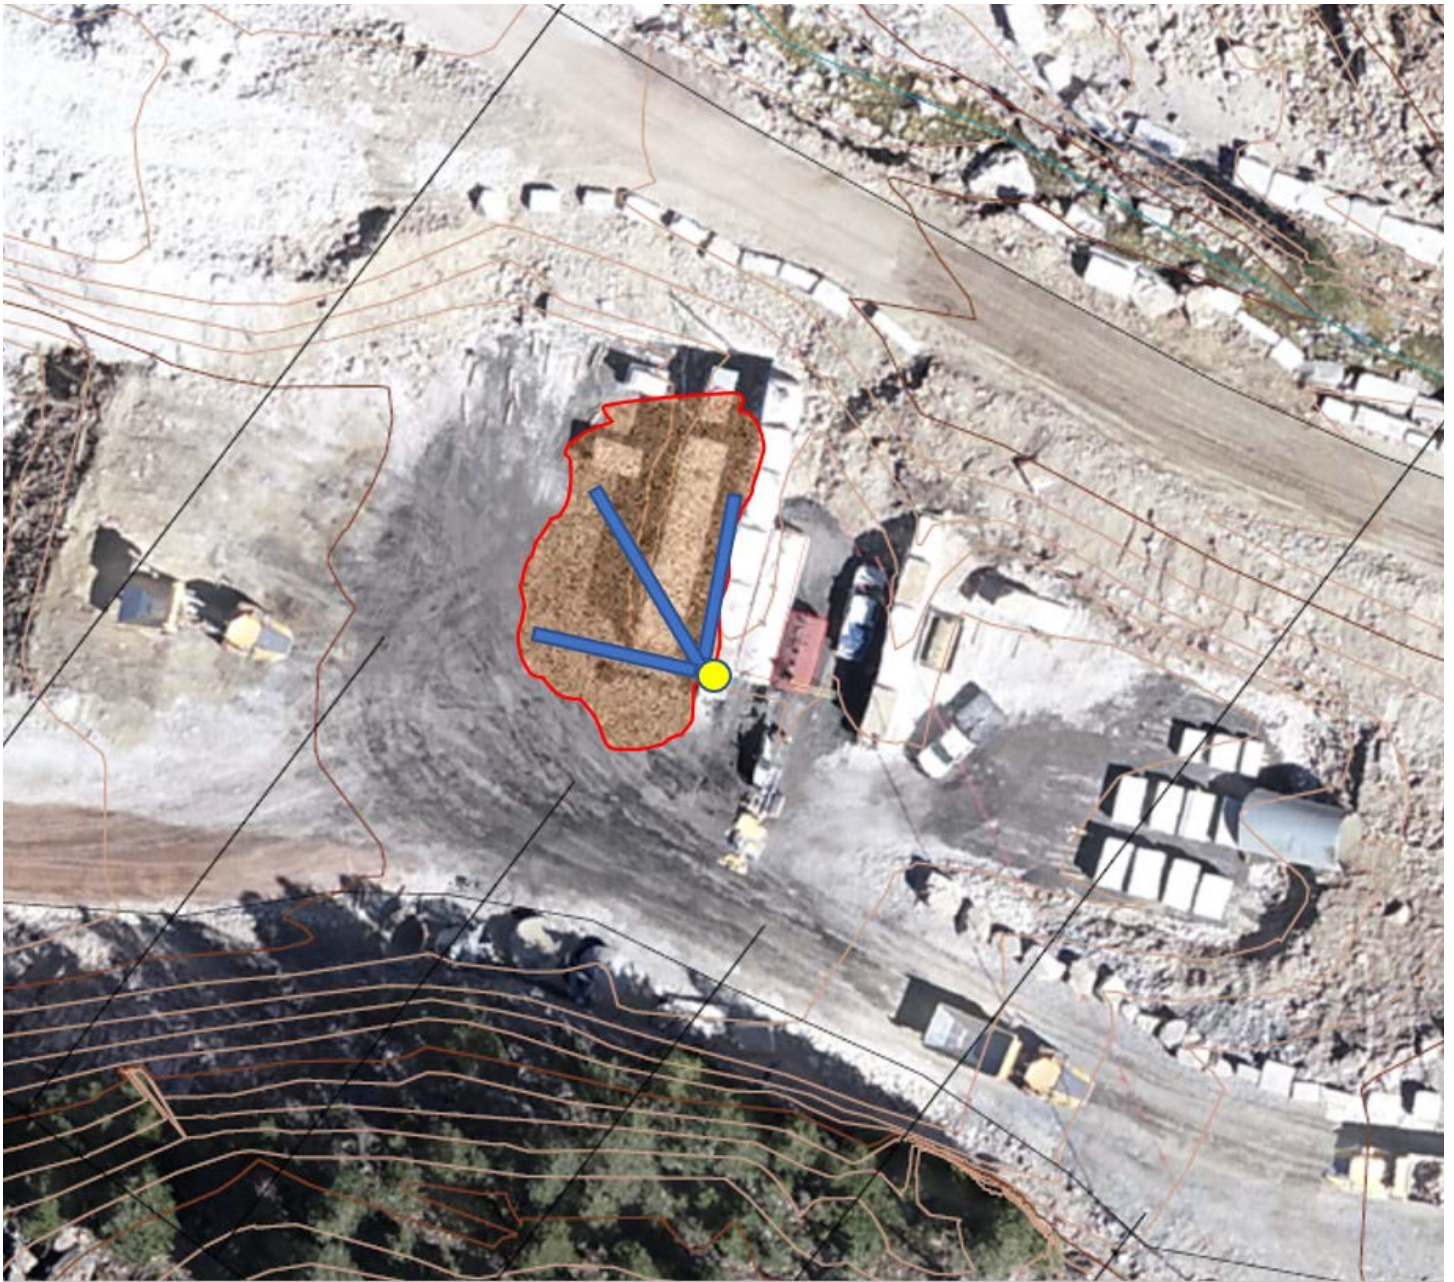
Figure 2: Treatment System Injection Port Design

The treatment system will be backfilled with 3/4-inch washed gravel providing protection and preventing a compacted oxygen depleted environment (See Figure 2).
