RE: State Pit; DRMS File No. M-1990-112; Inaccurate Annual Reports

MINERALS PROGRAM INSPECTION REPORT

MINE NAME: State Pit	MINE/PROSPECTING ID#: M-1990-112	MINERAL: Gravel	COUNTY: Pueblo
INSPECTION TYPE: Monitoring	INSPECTOR(S): Elliott R. Russell	INSP. DATE: February 28, 2018	INSP. TIME: 09:00
OPERATOR: Fremont Paving & Redi-Mix, Inc.	OPERATOR REPRESENTATIVE: Jodi Schrieber	TYPE OF OPERATION: 112c - Construction Regular Operation

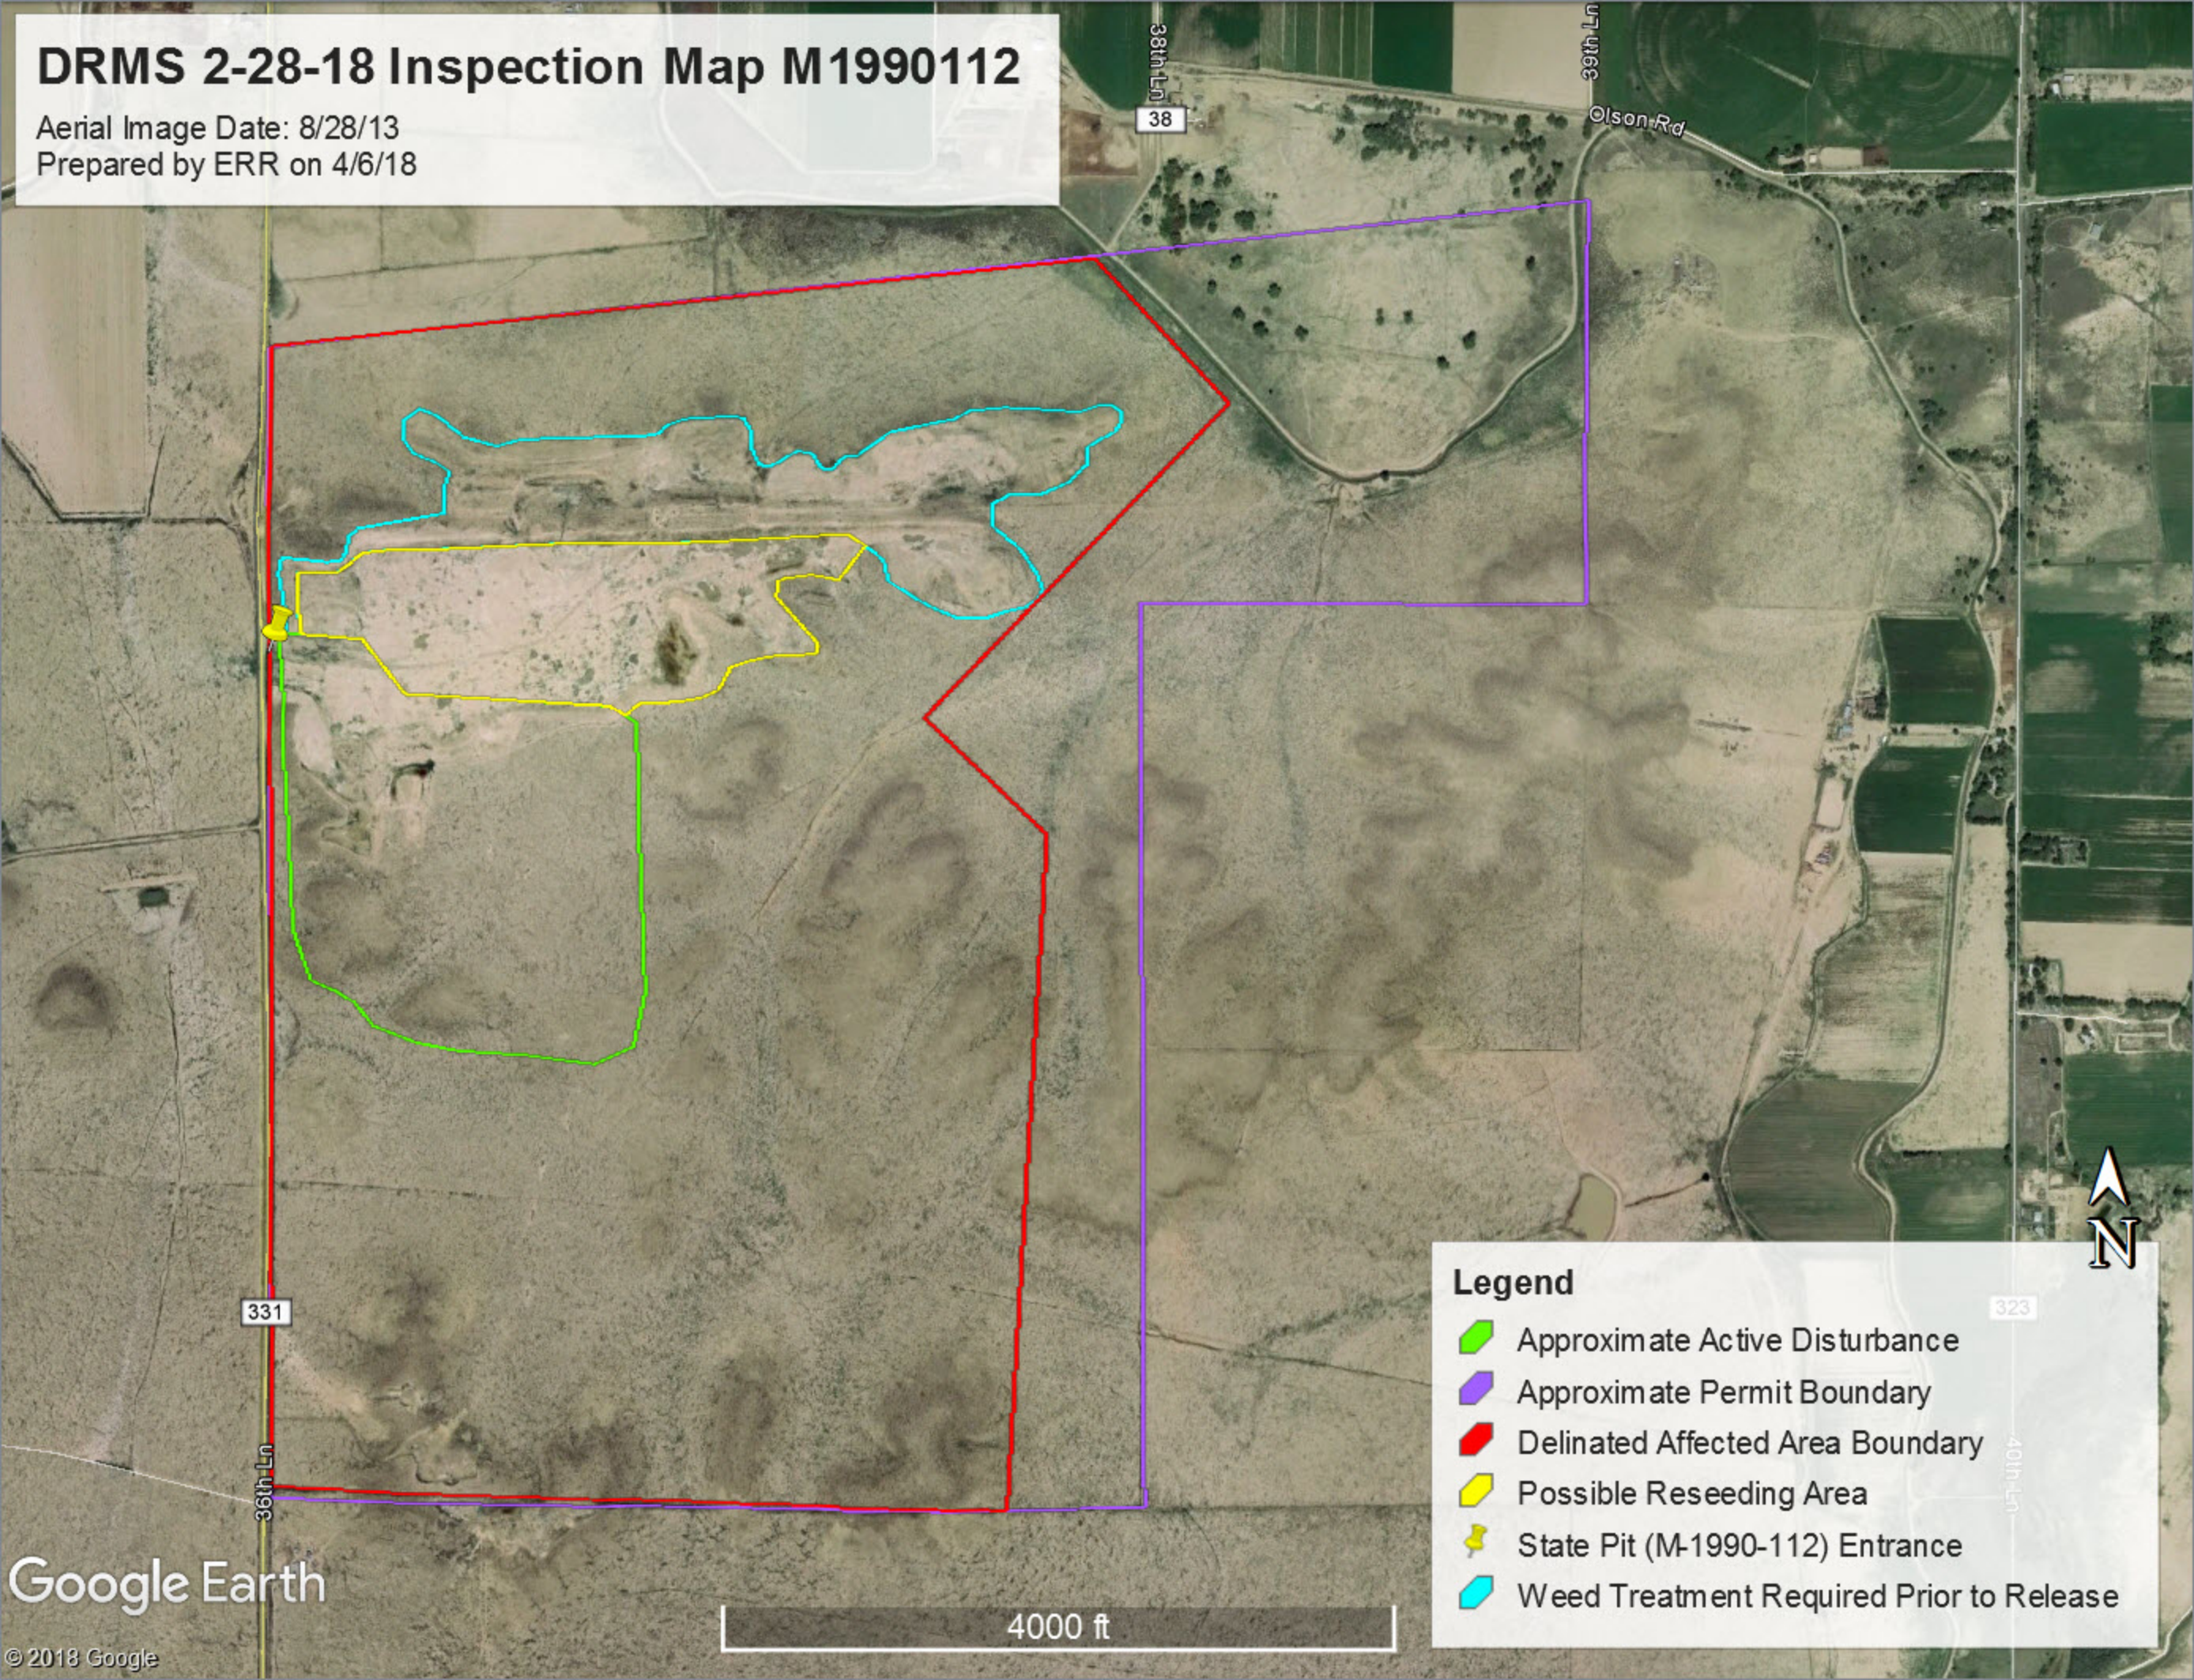
DRMS 2-28-18 Inspection Map M1990112

COMPLIANCE PROBLEM #3: Tamarisk (salt cedar) trees are present within or have volunteered into the permit area and are becoming established. This is a problem for failure to employ weed control methods for a state listed noxious weed species within the permitted area, and to reduce the spread of weeds to nearby areas as required by Rule 3.1.10(6). Additional details regarding this compliance problem are provided in this inspection report.

- B. Mining outside of the boundary: Ms. Kern indicated the northeast portion of the disturbance could be outside of the boundary. The northern portion of the permit was mined by previous Operators until roughly 2004. This area is in final reclamation and the Operator has stated no further mining will re-disturb this area as the operation is now advancing to the south. The Division inspected the northeast area of the permit and observed no evidence of disturbance beyond the affected lands boundary (**Photos 1 & 2**). Additionally, the Division acquired GPS data of the affected area boundary and compared that to a Google Earth aerial image to confirm all mining disturbances have remained within the affected area boundary.
