Re: Bowie Resources, LLC, Bowie No. 2 Mine  
Coal Mine Waste Banks & Instrumentation Monitoring  
Pond Quarterly Inspections  
Permit C-1996-083

**BOWIE RESOURCES, LLC**  
**Bowie No. 2 Mine**  
**Coal Mine Waste Bank Nos. 1, 2, & 3 Inspections –3rd Quarter 2019**

Subject: Summary of Instrumentation Monitoring  
3<sup>rd</sup> Quarter 2019  
Bowie Coal Waste Disposal Area No. 2  
Paonia, Colorado

**SUBJECT: Summary Report, 3rd Quarter 2019, Inclinator and Active Vibrating Wire Piezometer Data July – September 2019, Bowie Mine #2 Coal Waste Disposal Area (CWDA) #2**

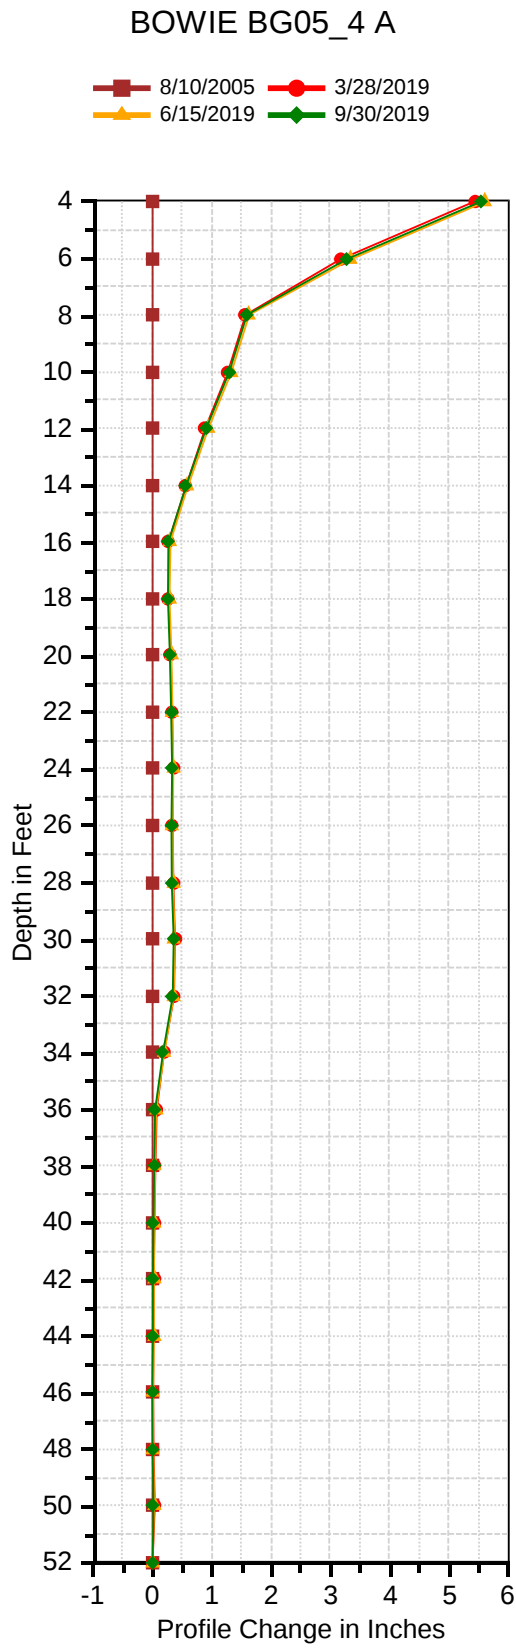
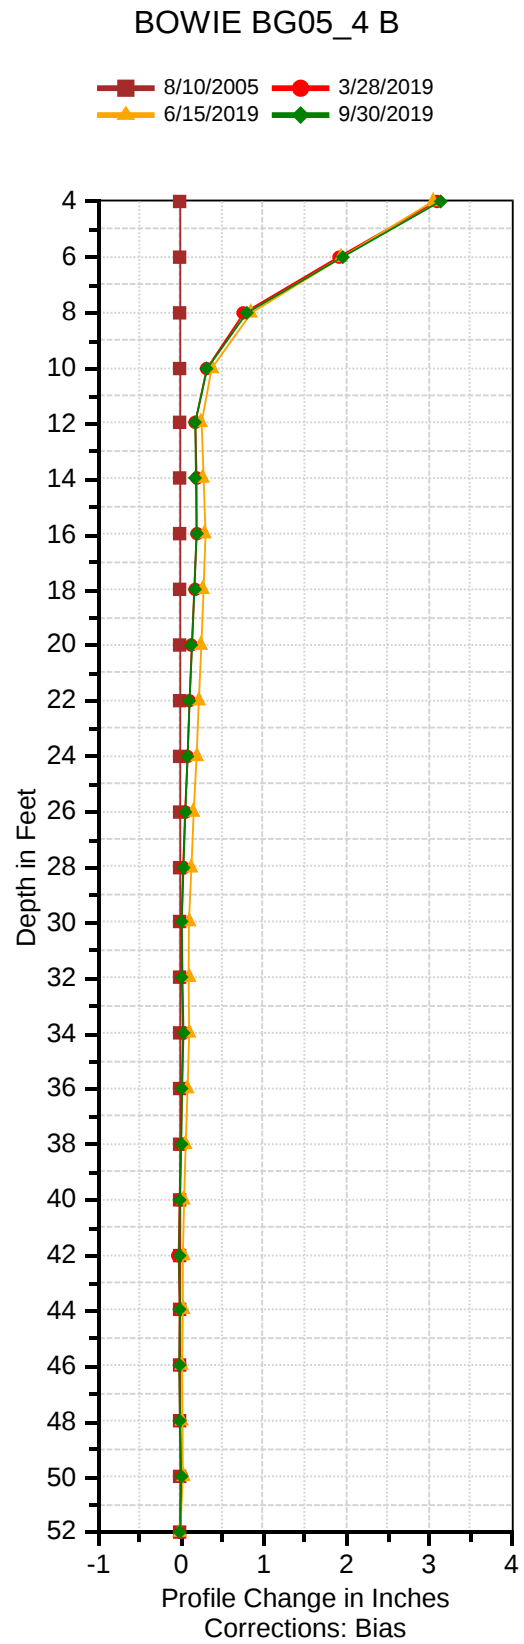
# Figure 3 - Inclinator Displacement Curves

Three inclinometers, designated BG05-4, BG05-5, and BG05-7, were installed at CWDA #2 in August 2005. The inclinometers were installed through the coal refuse and approximately 20 feet into the native foundation soils. The physical locations of the inclinometers are shown on the attached Instrumentation Site Plan (Map 1). Baseline readings were taken on 8/10/05 and subsequent readings have generally been taken quarterly since that time. Displacement curves for each of the three inclinometers for the current and the prior three readings are presented as attachments to this letter in Figure 3. Axis "A" reflects deformation with depth in the direction of anticipated movement (downslope), while Axis "B" is orthogonal to Axis A.
