MINERALS PROGRAM INSPECTION REPORT
PHONE: (303) 866-3567

MINE NAME: Hawkeye Mine	MINE/PROSPECTING ID#: M-1978-311	MINERAL: Uranium and vanadium	COUNTY: San Miguel
INSPECTION TYPE: Monitoring	INSPECTOR(S): Lucas West	INSP. DATE: November 21, 2019	INSP. TIME: 09:05
OPERATOR: Gold Eagle Mining, Inc.	OPERATOR REPRESENTATIVE: Kyle Turley, Navarro	TYPE OF OPERATION: 110d - Designated Limited Impact	
REASON FOR INSPECTION: Normal I&E Program	BOND CALCULATION TYPE: None	BOND AMOUNT: \$100.00	
DATE OF COMPLAINT: NA	POST INSP. CONTACTS: None	JOINT INSP. AGENCY: None	
WEATHER: Clear	INSPECTOR'S SIGNATURE:

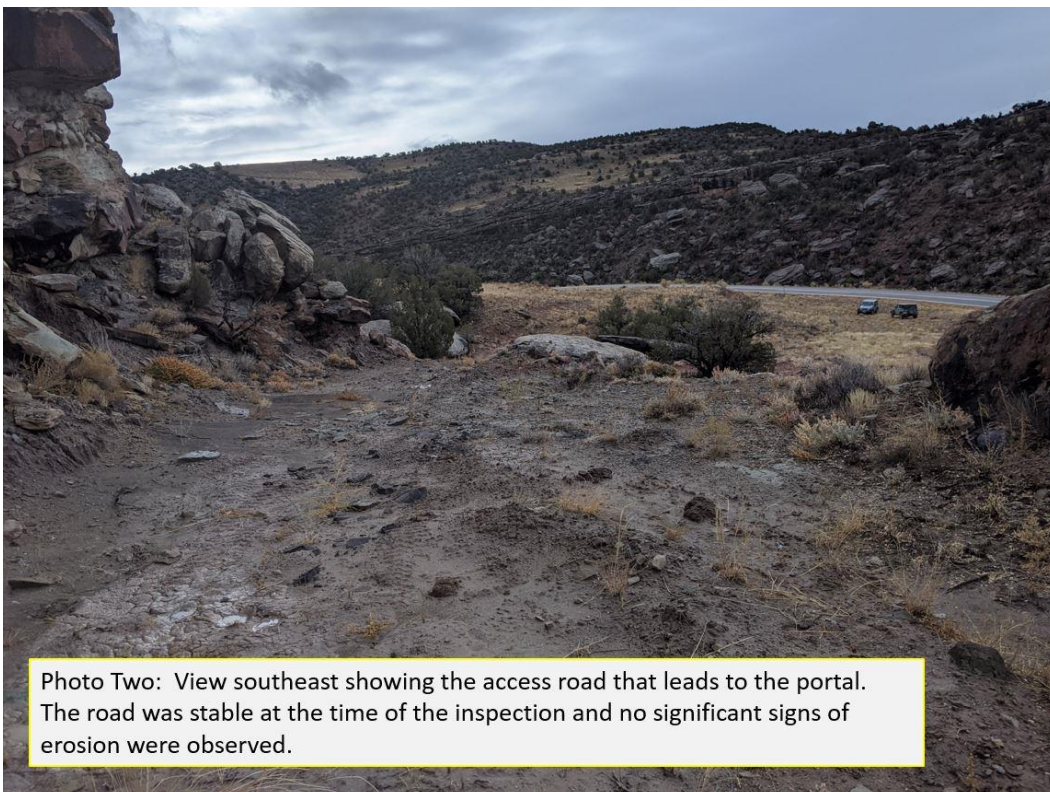
The site contains a secured portal onsite leading to the underground workings that is closed with a welded steel closure. The portal closure, seen in Photo One, is stable and in good condition. It shows no signs of vandalism or attempted unauthorized entry. The access road leading to the portal is equipped with various storm water control structures and appears to be stable. The access road can be seen in Photo Two. Adjacent to the portal is a natural drainage leading down toward the county road. The storm water controls lead through the site, down the natural drainage to a small "sediment pond" near the County Road. The sediment pond is well vegetated to dissipate flows and was in good condition. The previously observed noxious weeds on site were not observed during this inspection. Further monitoring should be conducted to ensure they do not return during the spring.
