MINERALS PROGRAM INSPECTION REPORT
PHONE: (303) 866-3567

MINE NAME: Orlando Pit	MINE/PROSPECTING ID#: M-2001-106	MINERAL: Sand and gravel	COUNTY: Huerfano
INSPECTION TYPE: Monitoring	INSPECTOR(S): Patrick Lennberg	INSP. DATE: December 12, 2019	INSP. TIME: 10:00
OPERATOR: Huerfano County	OPERATOR REPRESENTATIVE: Bill Brunelli	TYPE OF OPERATION: 112c - Construction Regular Operation	
REASON FOR INSPECTION: Normal I&E Program		BOND CALCULATION TYPE: None	BOND AMOUNT: \$0.00
DATE OF COMPLAINT: NA		POST INSP. CONTACTS: None	JOINT INSP. AGENCY: None
WEATHER: Windy	INSPECTOR'S SIGNATURE:

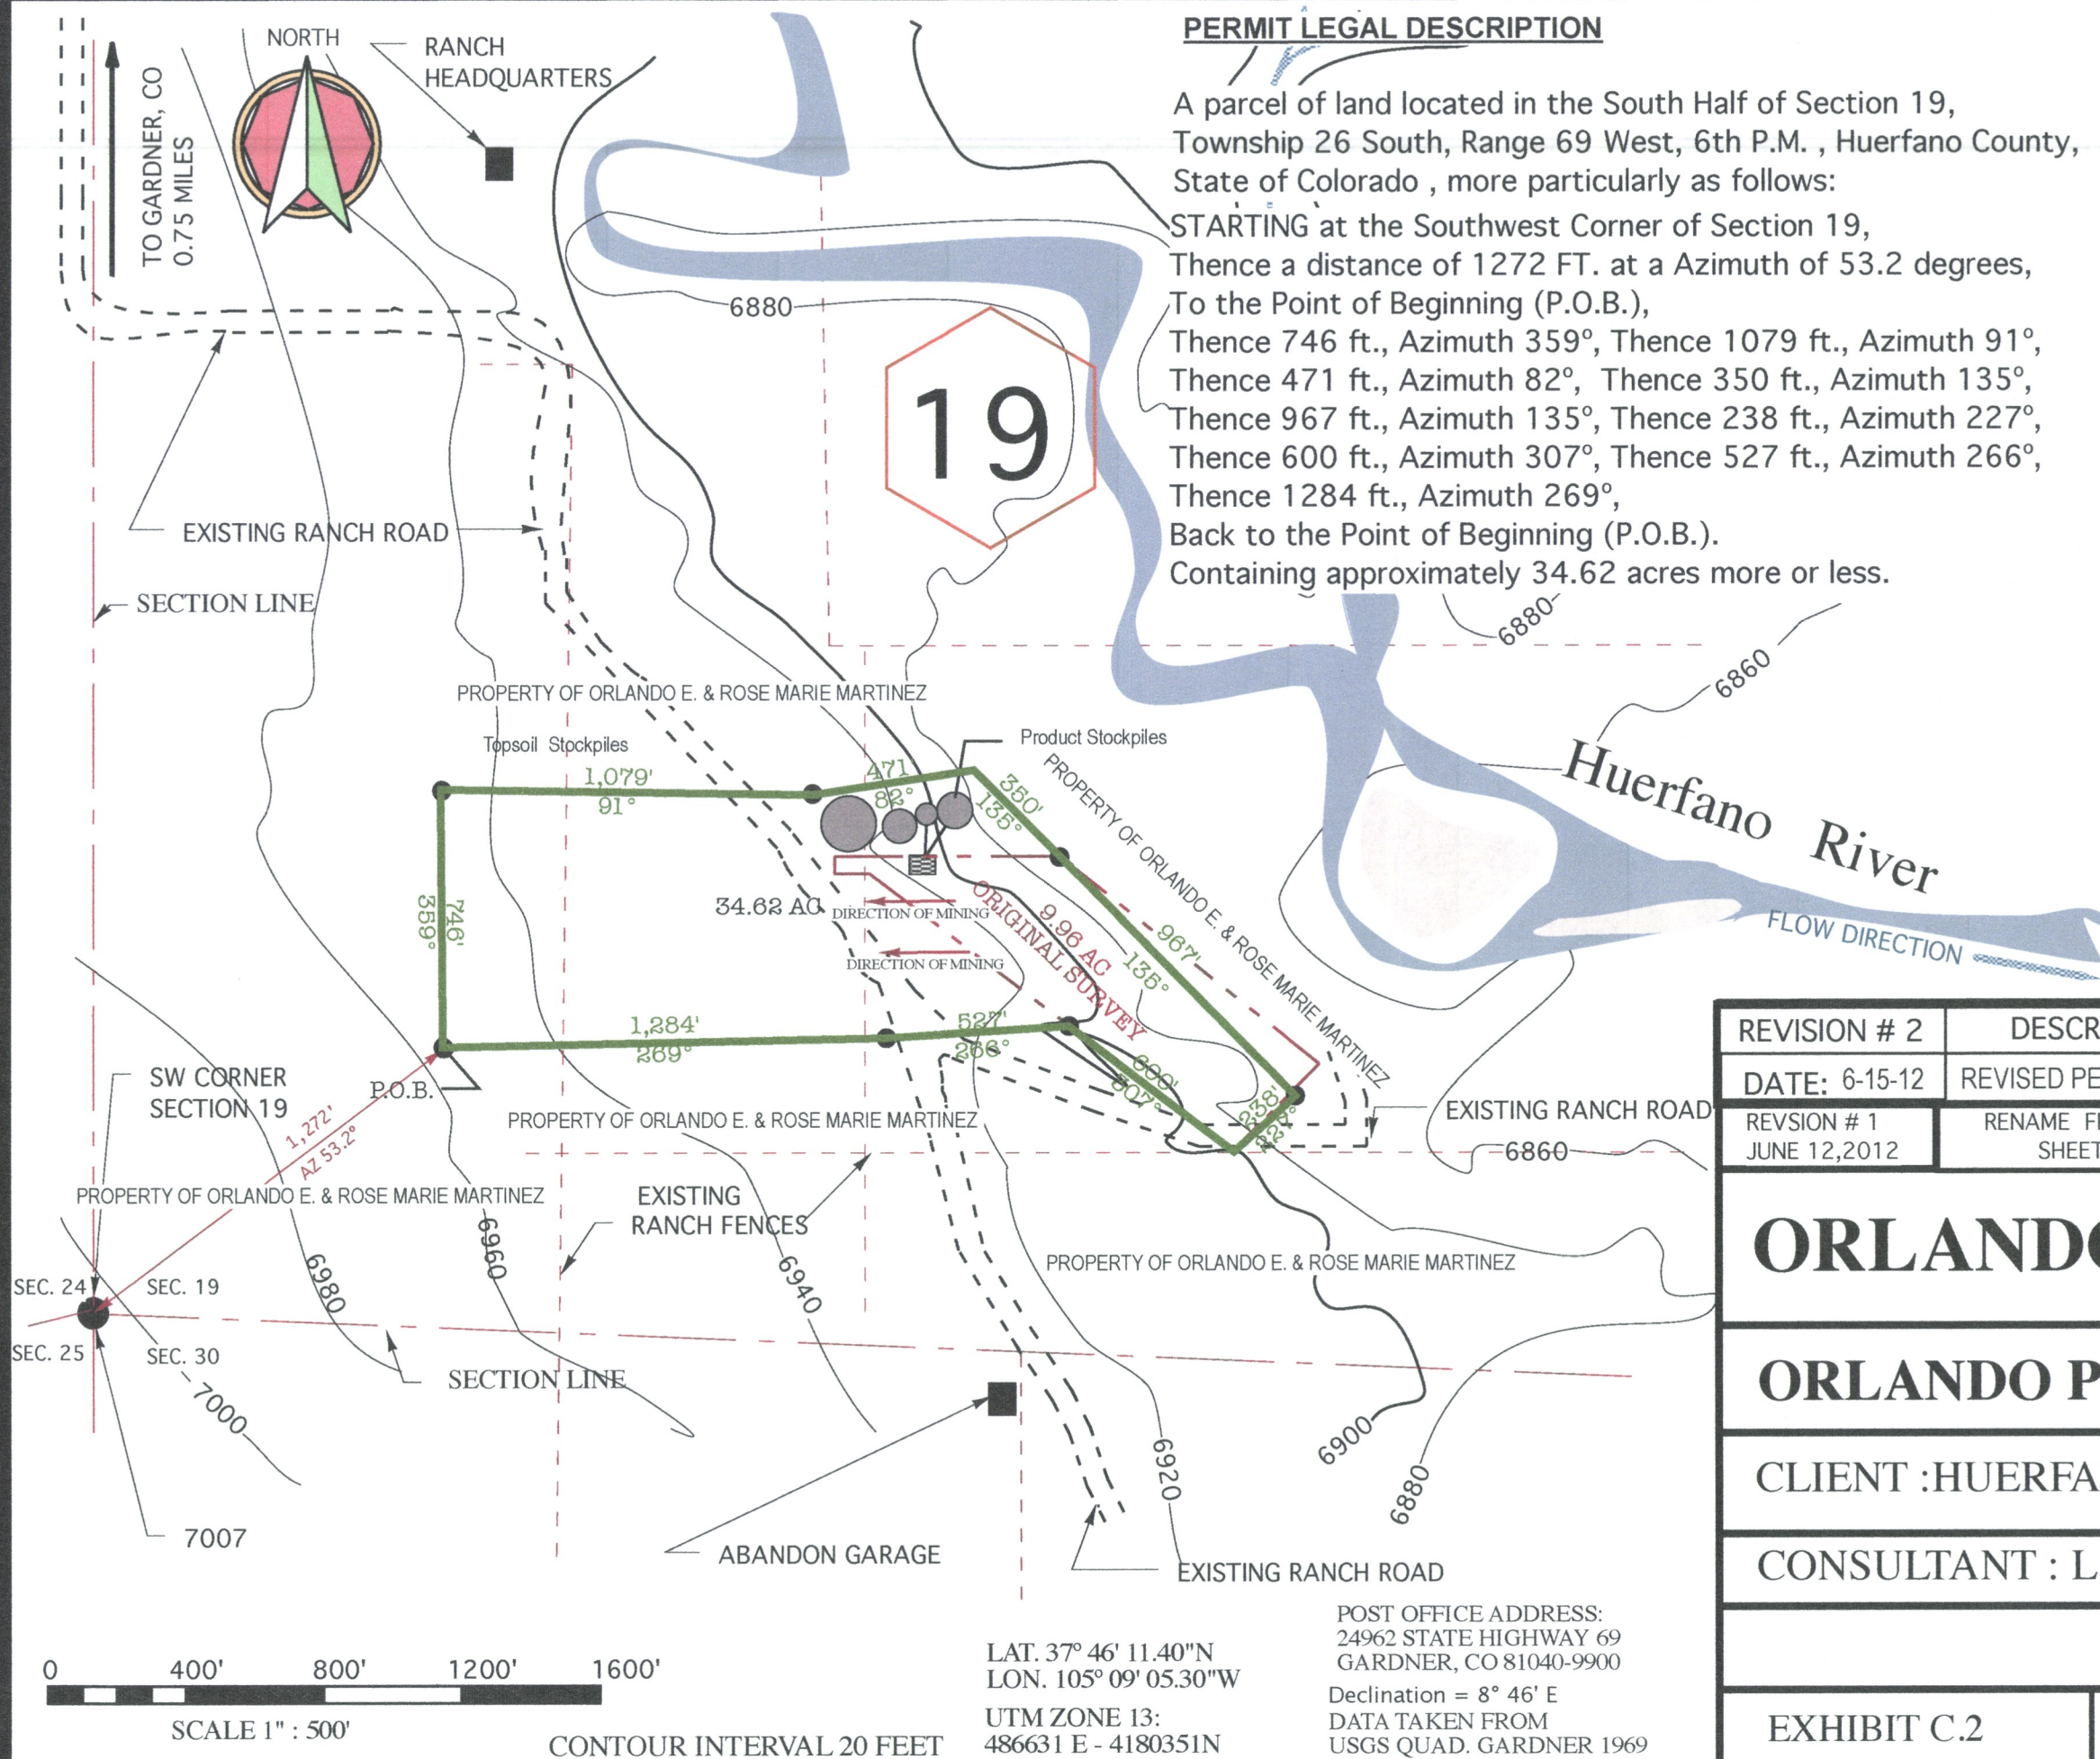
- 2019 Inspection 35.4 acres
- Disturbance Area 9.7 acres
- M-2001-106 Orlando Pit
- OR

PROBLEM: The affected area boundary markers are incorrectly placed. This is a problem for failure to maintain boundary markers around the affected area as required by Section 3.1.12(2) of the rule.

CORRECTIVE ACTIONS: The operator shall conduct a survey and replace the boundary markers in the correct location(s). The operator shall provide proof to the Division that this has been done by the corrective action date.
