Geotechnical Addendum

2019 Annual Report

Aggregate Industries Morrison Quarry
Permit M-1973-021
Jefferson County, Colorado

December 2019
Project 1705051

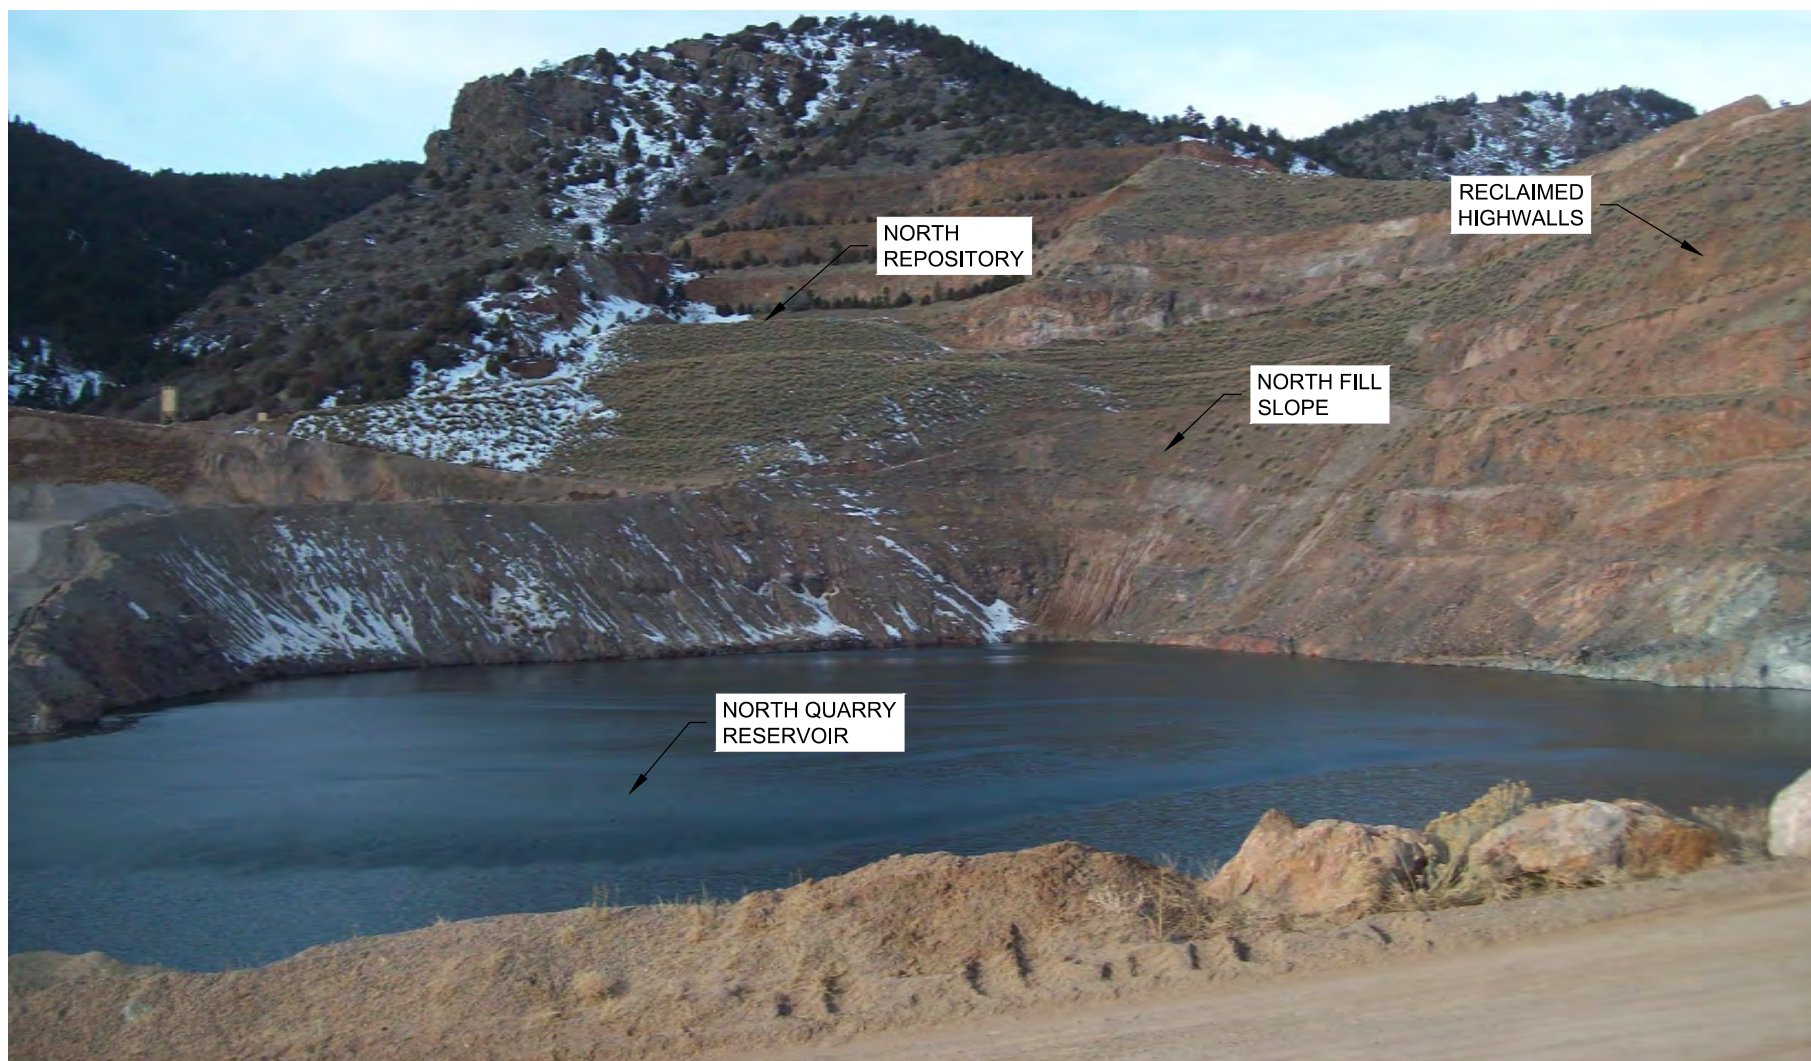
Mining in the North Quarry was completed in 2007 and no mining activity occurred in the North Quarry in 2019. The North Quarry is currently being used as a raw water storage reservoir for the Town of Morrison and for production water storage for use by AI. The water level in the pond is approximately three feet below the ground surface at the southeast corner of the North Quarry pit. Figure 2 shows the current configuration of the North Quarry, including the reservoir and the north repository.

No mining occurred within the North Quarry in 2019 and no major rock disturbances were noted. No new orientation data was obtained during the 2019 review, but the existing highwalls and benches, the repaired North Slope, and the north repository area were observed. Local raveling of rocks and minor instabilities were noted within the main trunk of the North Quarry. These instabilities and raveling events are assumed to be a result of adverse joint conditions, rock alteration, or freeze thaw weathering cycles. Typically, rocks loosened in this manner will be small (usually less than 18 inches) and will likely be contained on the benches. No instability was noted on the North Slope fill or the north repository, and no large-scale seepage was observed within the North Quarry.

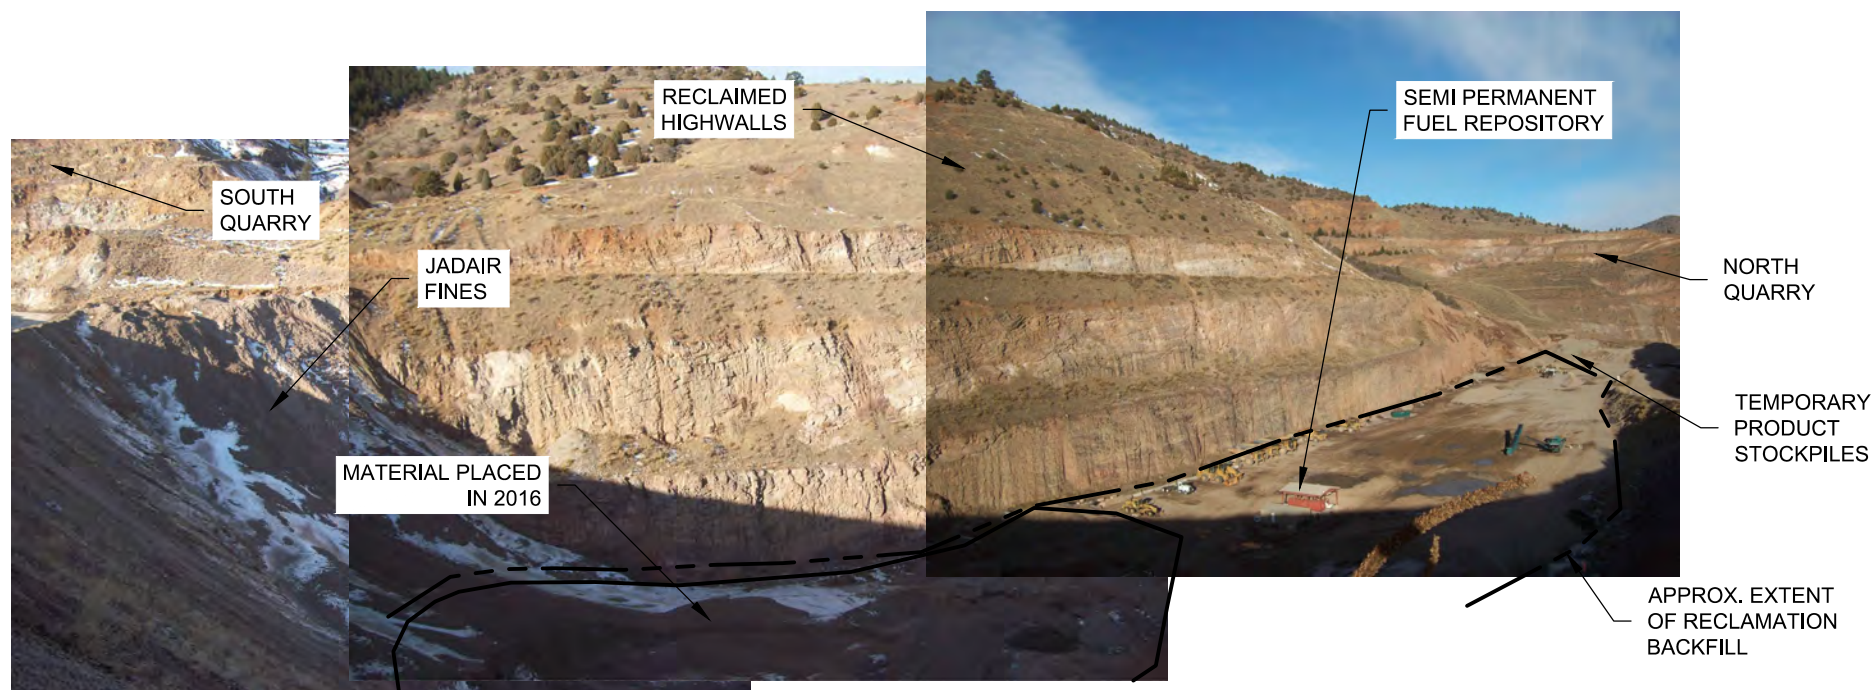
Mining activity was completed in the Central Quarry in 2001. No mining activity occurred in 2019 and the Central Quarry experienced no major rock disturbances. Reclamation is complete to El. 6500 in the Central Quarry and the south side of the quarry is being used to temporarily stockpile stripped materials including overburden, sillimanitic gneiss, and other undesirable material from the South Quarry to be used as future reclamation backfill material. Figure 3 shows an overview of the Central Quarry.

No mining activity in the Central Quarry occurred in 2019 and no new orientation data was collected during the 2019 inspection. Local raveling of rocks and minor instabilities were evident within the Central Quarry but no new slope failures were observed. These instabilities and raveling events are assumed to be a result of adverse joint conditions, rock alteration, or freeze thaw weathering cycles. Typically, rocks loosened in this manner will be small (usually less than 18 inches) and will likely be contained on the benches.

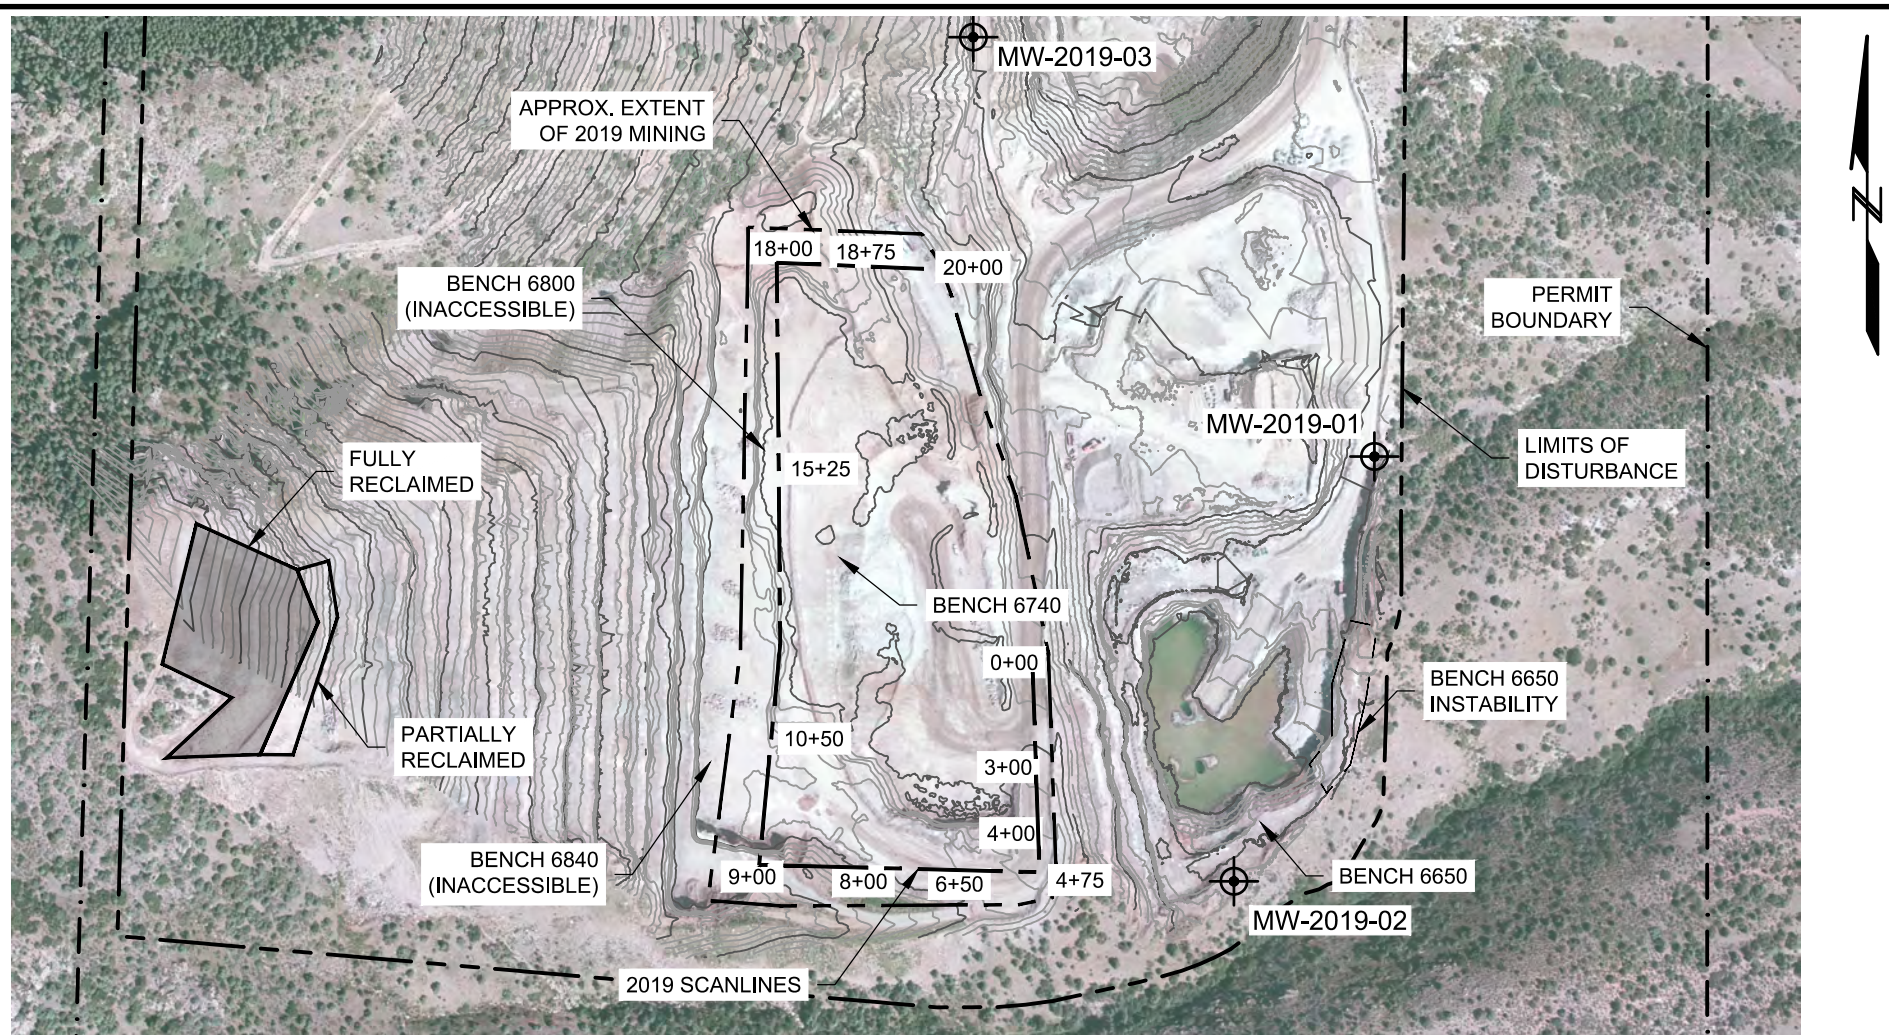
Figure 5

Minor groundwater seepage, visible in the west (east facing) highwall at approximate El. 6600 feet, was noted as a changed condition in the 2013 geotechnical addendum. A year-by-year comparison of the seepage area is shown in Figure 5. The seepage was not observed in 2017, 2018, or 2019.

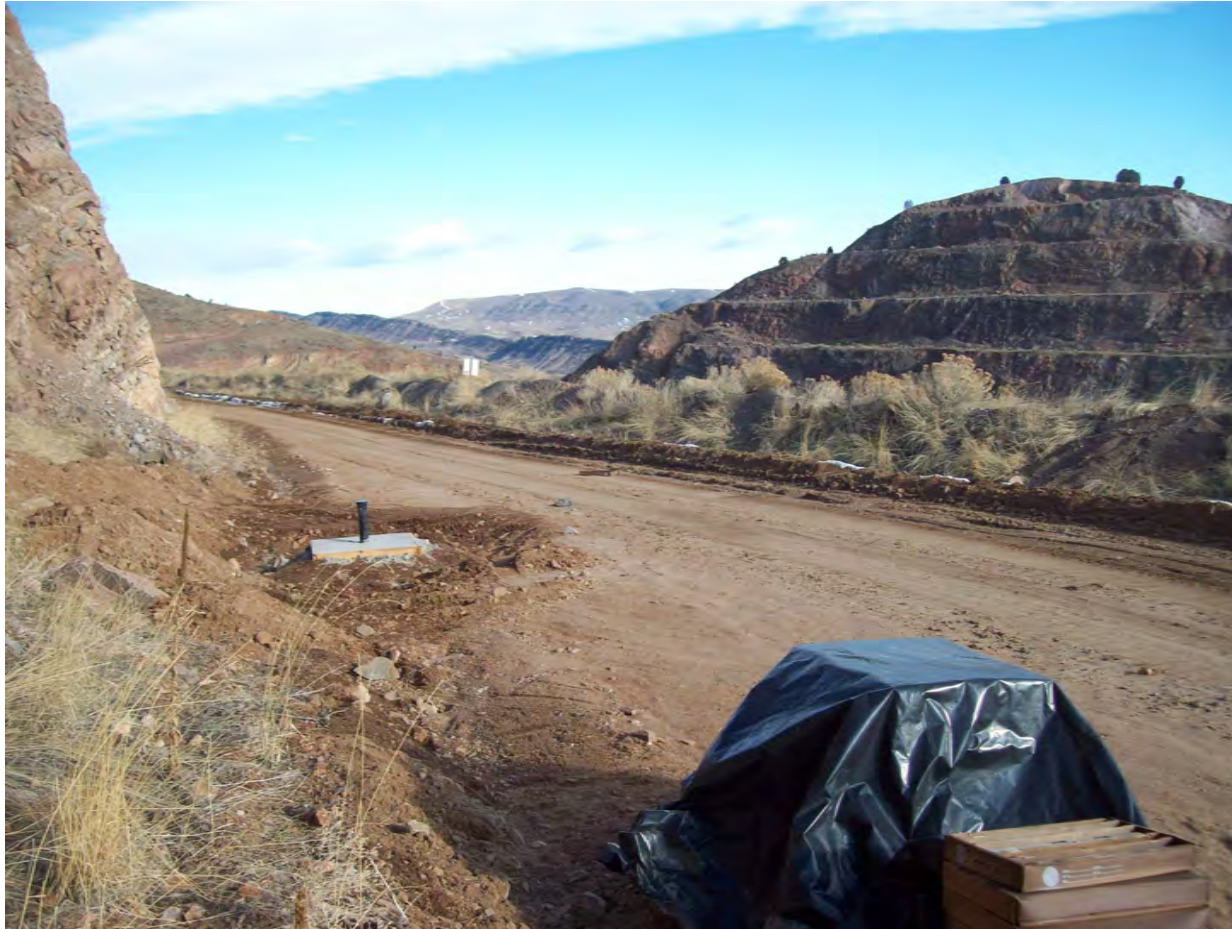
Figure 6

GEI installed a monitoring well near the area of the reclamation slope instability in December 2019 to record groundwater levels in the region. A photograph of the monitoring well is shown in Figure 6.

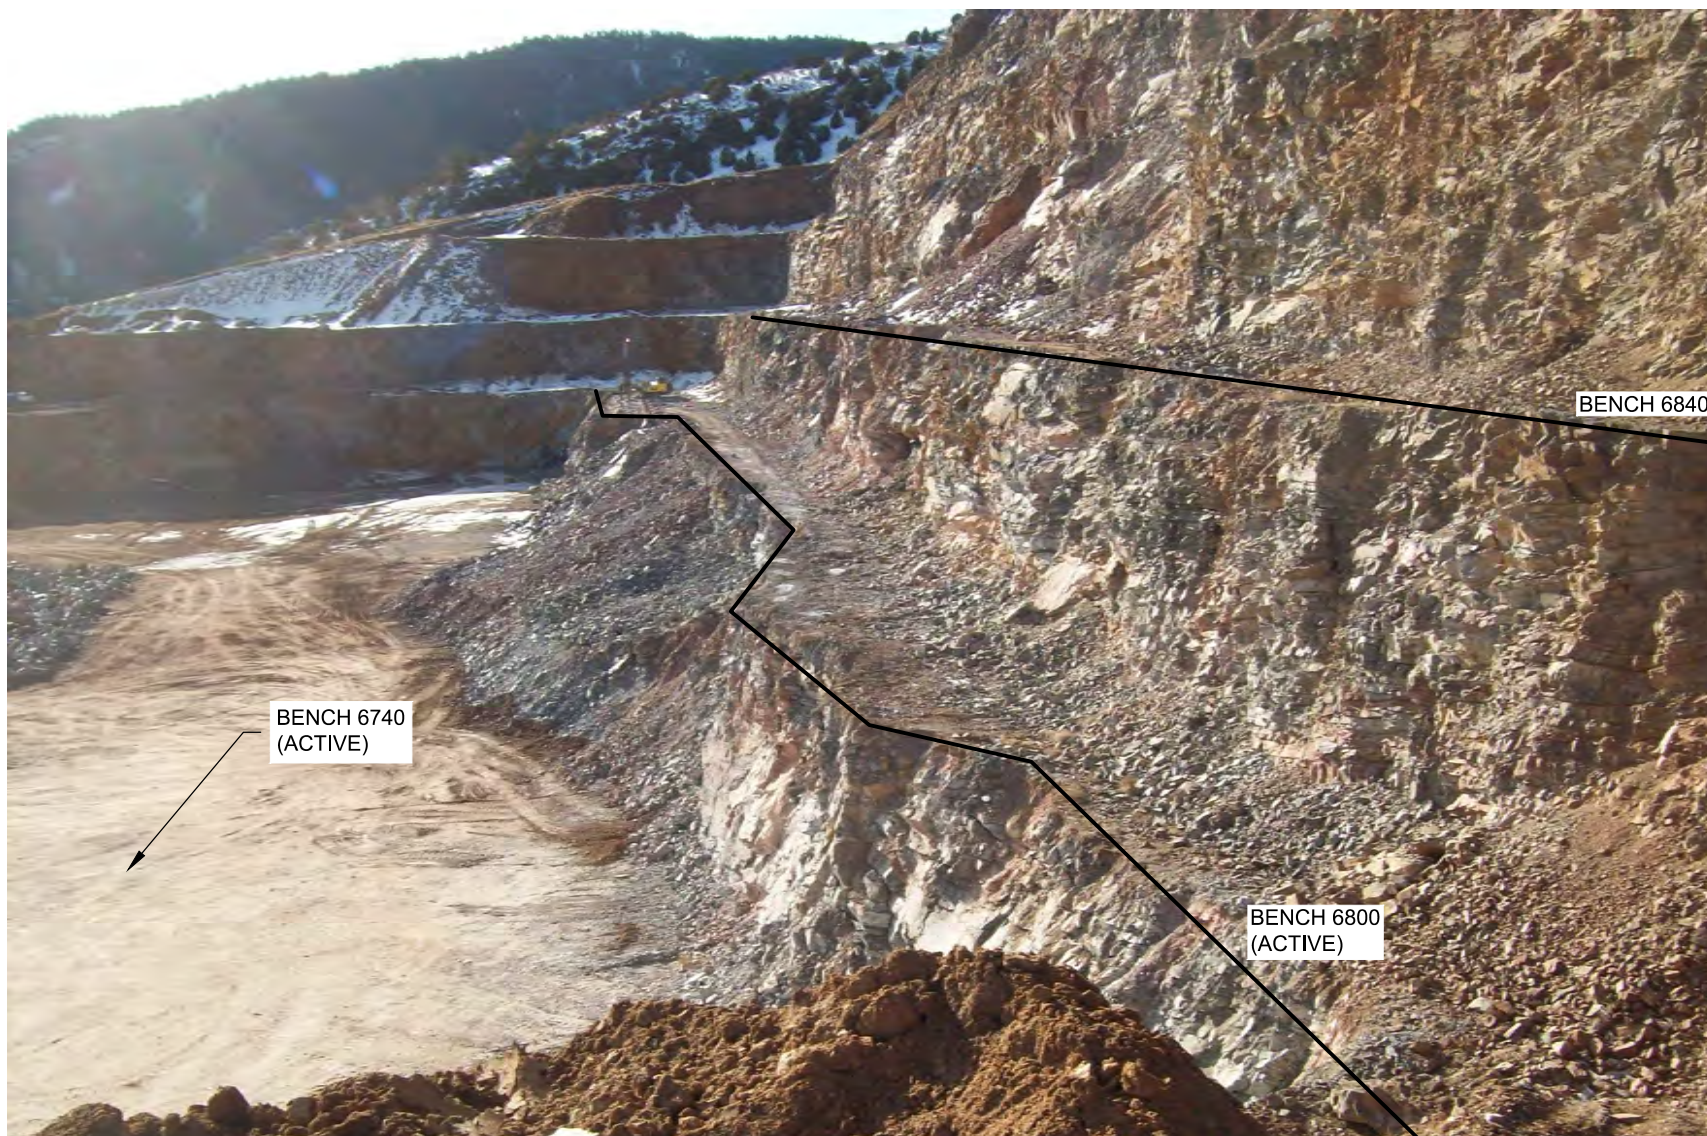
Mining in the South Quarry occurred between approximate El. 6740 and 6800. Mining in the South Quarry was primarily performed on the west and south ends of Bench 6740 to create a highwall and bench configuration similar to Bench 6800. Mining from Bench 6800 down to Bench 6740 was generally performed to the west and is still ongoing. The current width of Bench 6800 was variable at the time of the site inspection due to active mining operations. Figure 7 shows the western highwall configuration at the time of the field investigation.

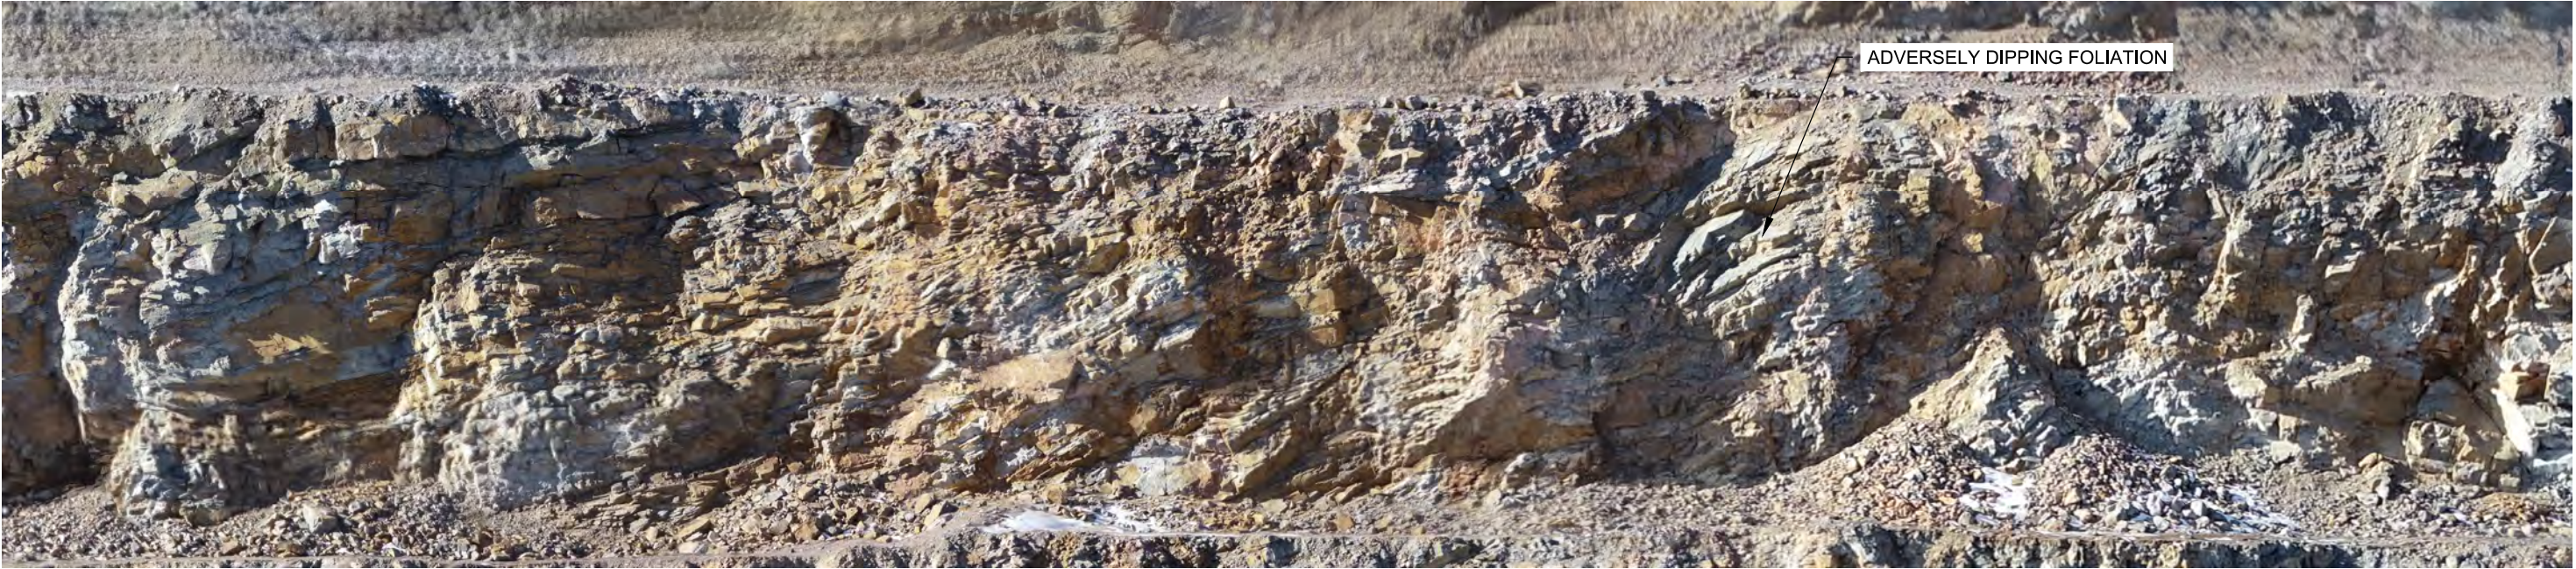
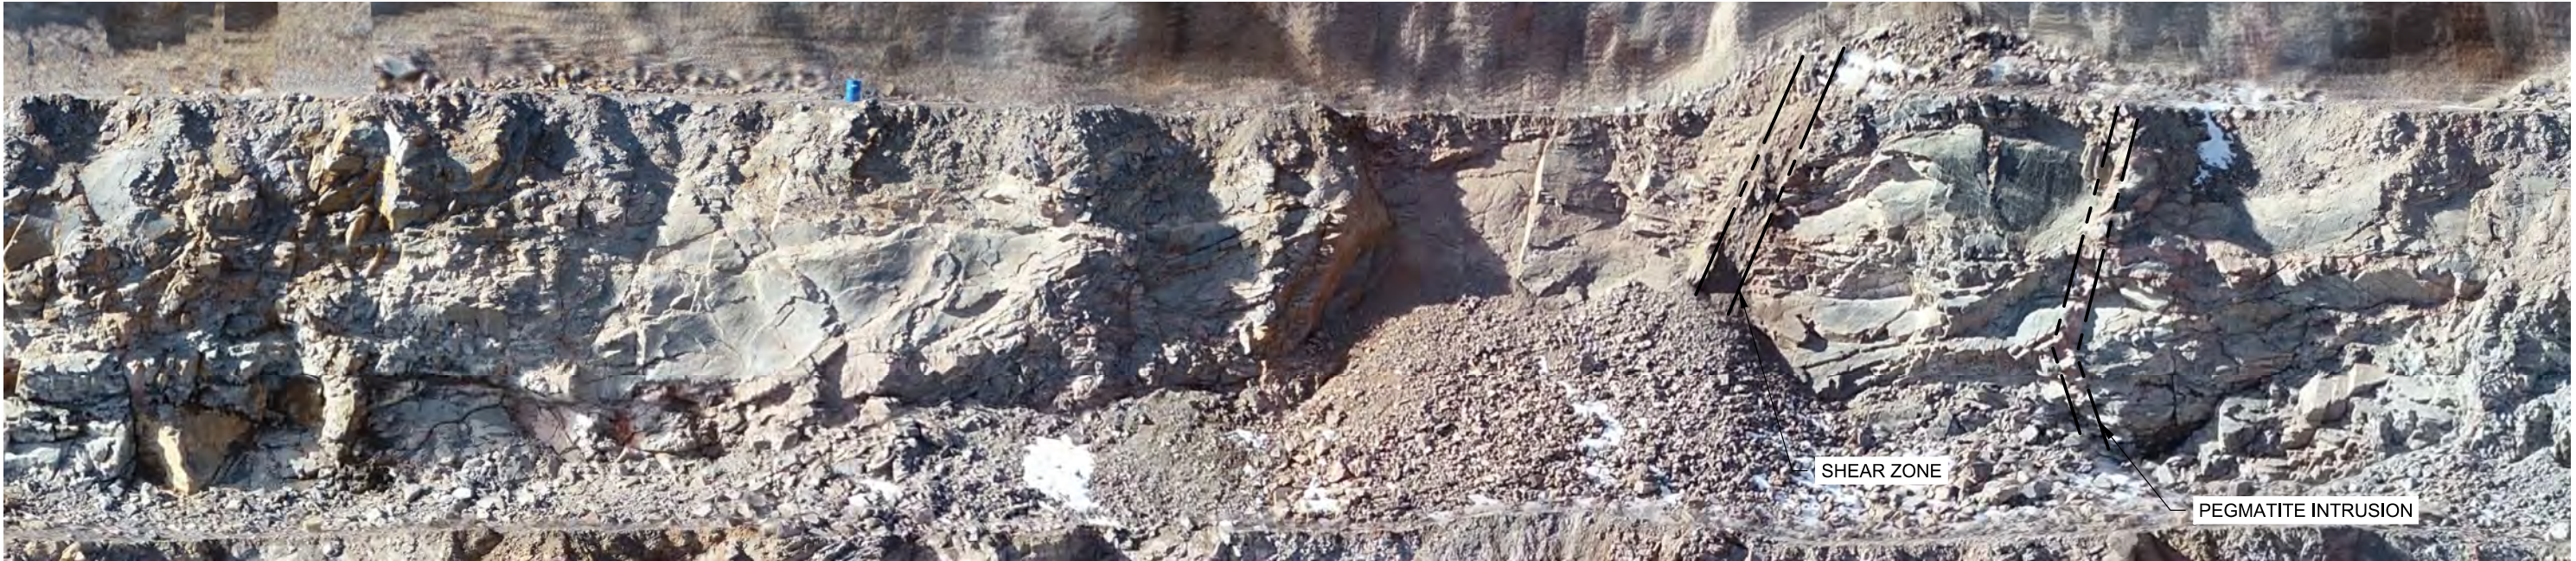
GEI Consultants	BENCH 6840 (2 OF 3)	
Aggregate Industries		Project 1705051	December 2019 Figure 10

Bench 6840 could not safely be accessed by GEI staff due to narrow bench width, the potential for rock fall, and active mining operations. Photos of the highwall above Bench 6840 were taken with a UAS on December 12, 2019. The photos were processed using Pix4D software to create an orthoplane, an orthorectified (uniform scale) image of a vertical object. This highwall orthoplane was then divided to fit on multiple figures, viewed from left to right (Figure 9 through Figure 11). Notable features identified in the image include a mafic dike on the bottom right side of Figure 9, a minor area of adversely dipping foliation in the upper middle of Figure 10, a near-vertical pegmatite intrusion in the bottom right of Figure 10, a shear zone on the lower right side of Figure 10 above a debris pile, and a pegmatite intrusion on the upper left side of Figure 11.

1. BENCH WAS INACCESSIBLE DURING INSPECTION. IMAGERY OBTAINED USING UNMANNED AERIAL SYSTEM ON DECEMBER 12, 2019 AND PROCESSED INTO PHOTOMOSAICS USING PIX4D SOFTWARE.
2. DRAWING NOT TO SCALE. RIGHT END OF HIGHWALL EXCAVATED INTO OVERBURDEN.

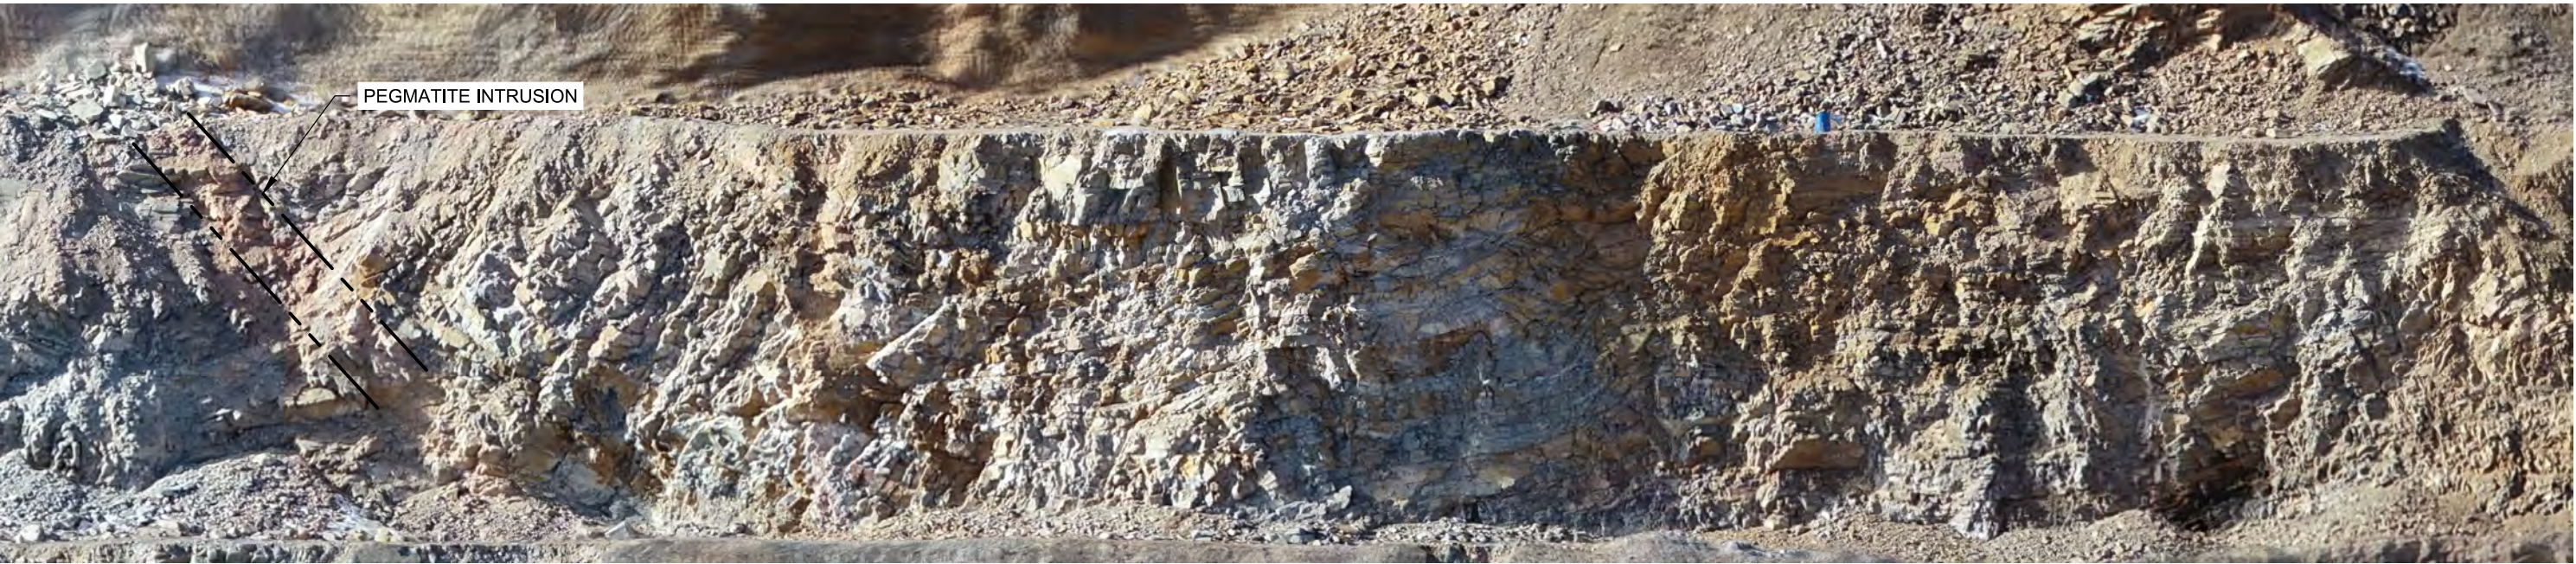
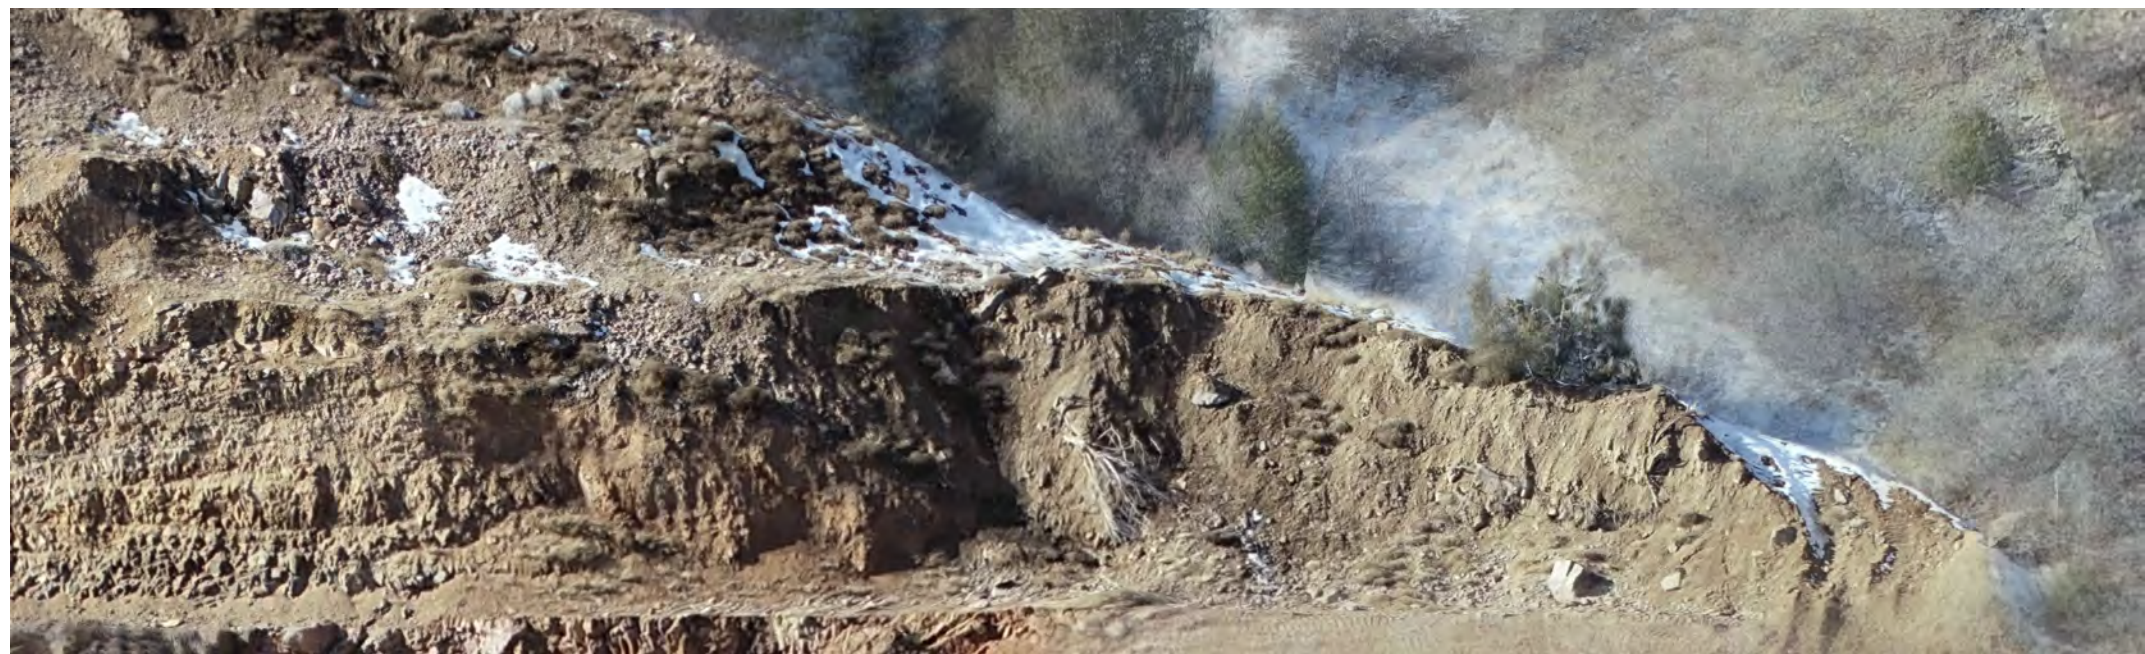
GEI Consultants	BENCH 6840 (3 OF 3)	
Aggregate Industries		Project 1705051	December 2019 Figure 11

1. BENCH WAS INACCESSIBLE DURING INSPECTION. IMAGERY OBTAINED USING UNMANNED AERIAL SYSTEM ON NOVEMBER 29, 2018 AND PROCESSED INTO PHOTOMOSAICS USING PIX4D SOFTWARE.
2. DRAWING NOT TO SCALE. LEFT END OF HIGHWALL OBSCURED BY DEBRIS.

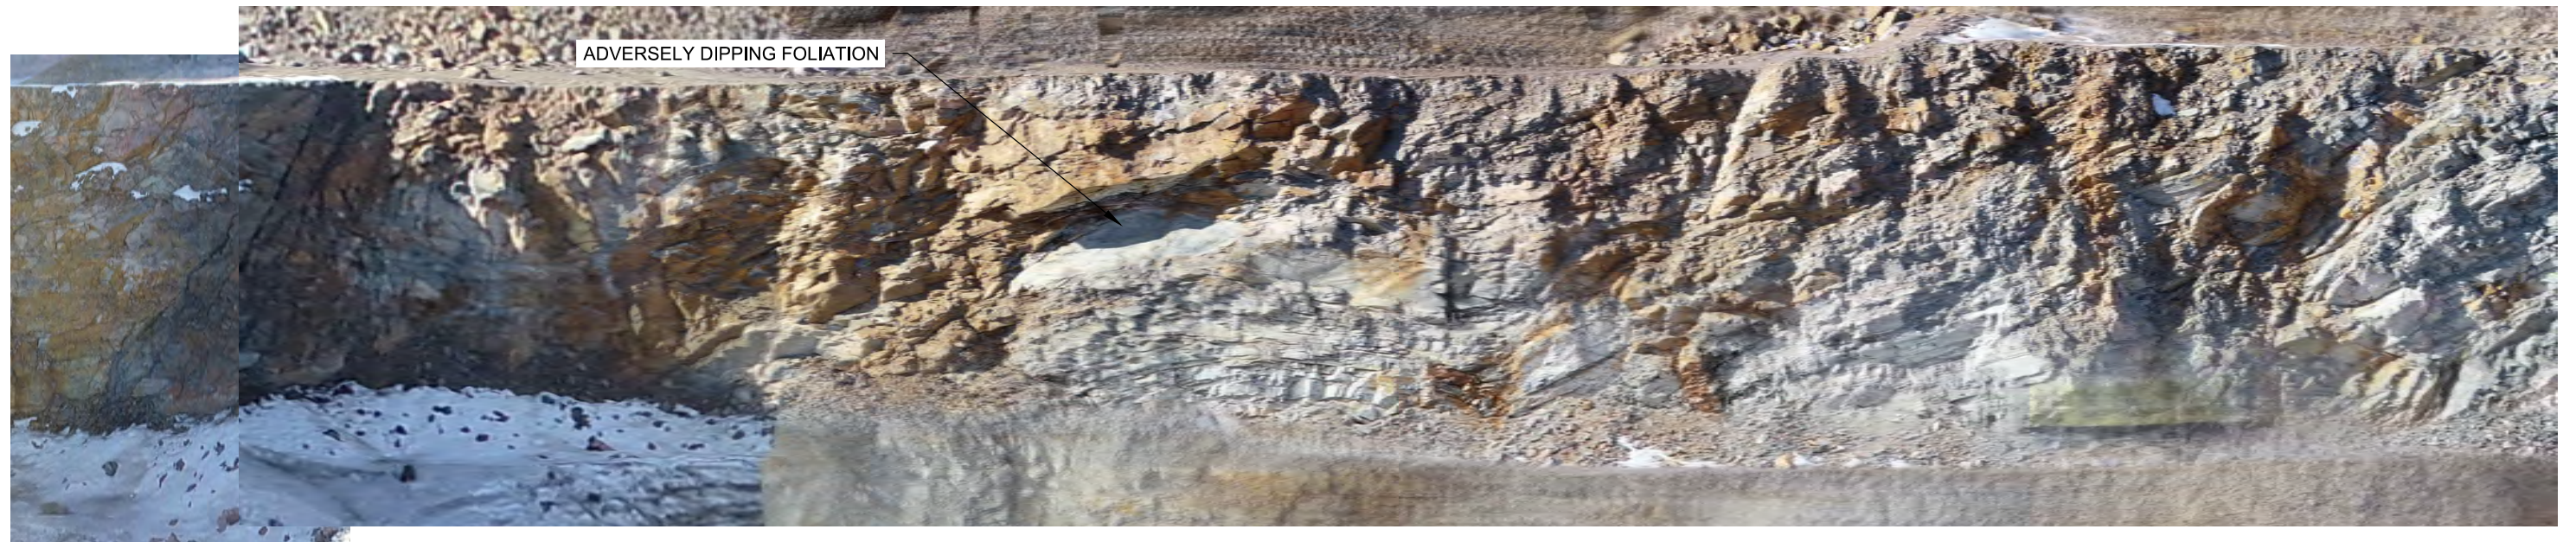
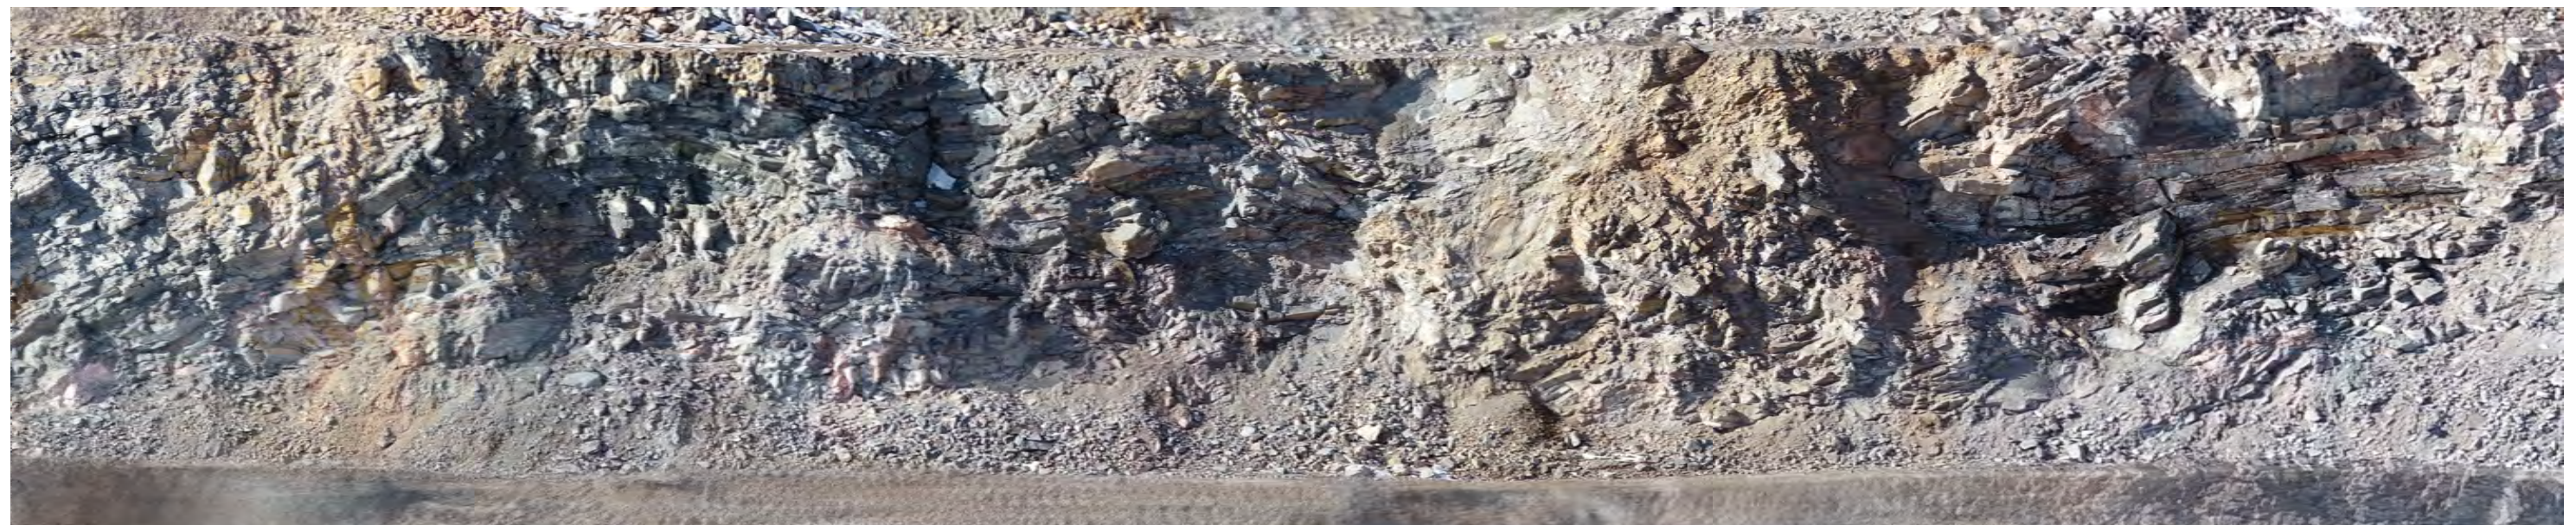
of adversely dipping foliation in the upper left side of Figure 14 and a shear zone on the upper right side of Figure 15.
