MINERALS PROGRAM INSPECTION REPORT
PHONE: (303) 866-3567

MINE NAME: 22 West Pit	MINE/PROSPECTING ID#: M-2017-032	MINERAL: Borrow material for construction, sand and gravel	COUNTY: Otero
INSPECTION TYPE: Monitoring	INSPECTOR(S): Amy Eschberger, DJ Cunningham	INSP. DATE: January 14, 2020	INSP. TIME: 11:30
OPERATOR: Deep Cut LLC	OPERATOR REPRESENTATIVE: Chris Tomky	TYPE OF OPERATION: 112c - Construction Regular Operation

M-2017-032 / 22 West Pit / Deep Cut LLC (112c Operation)

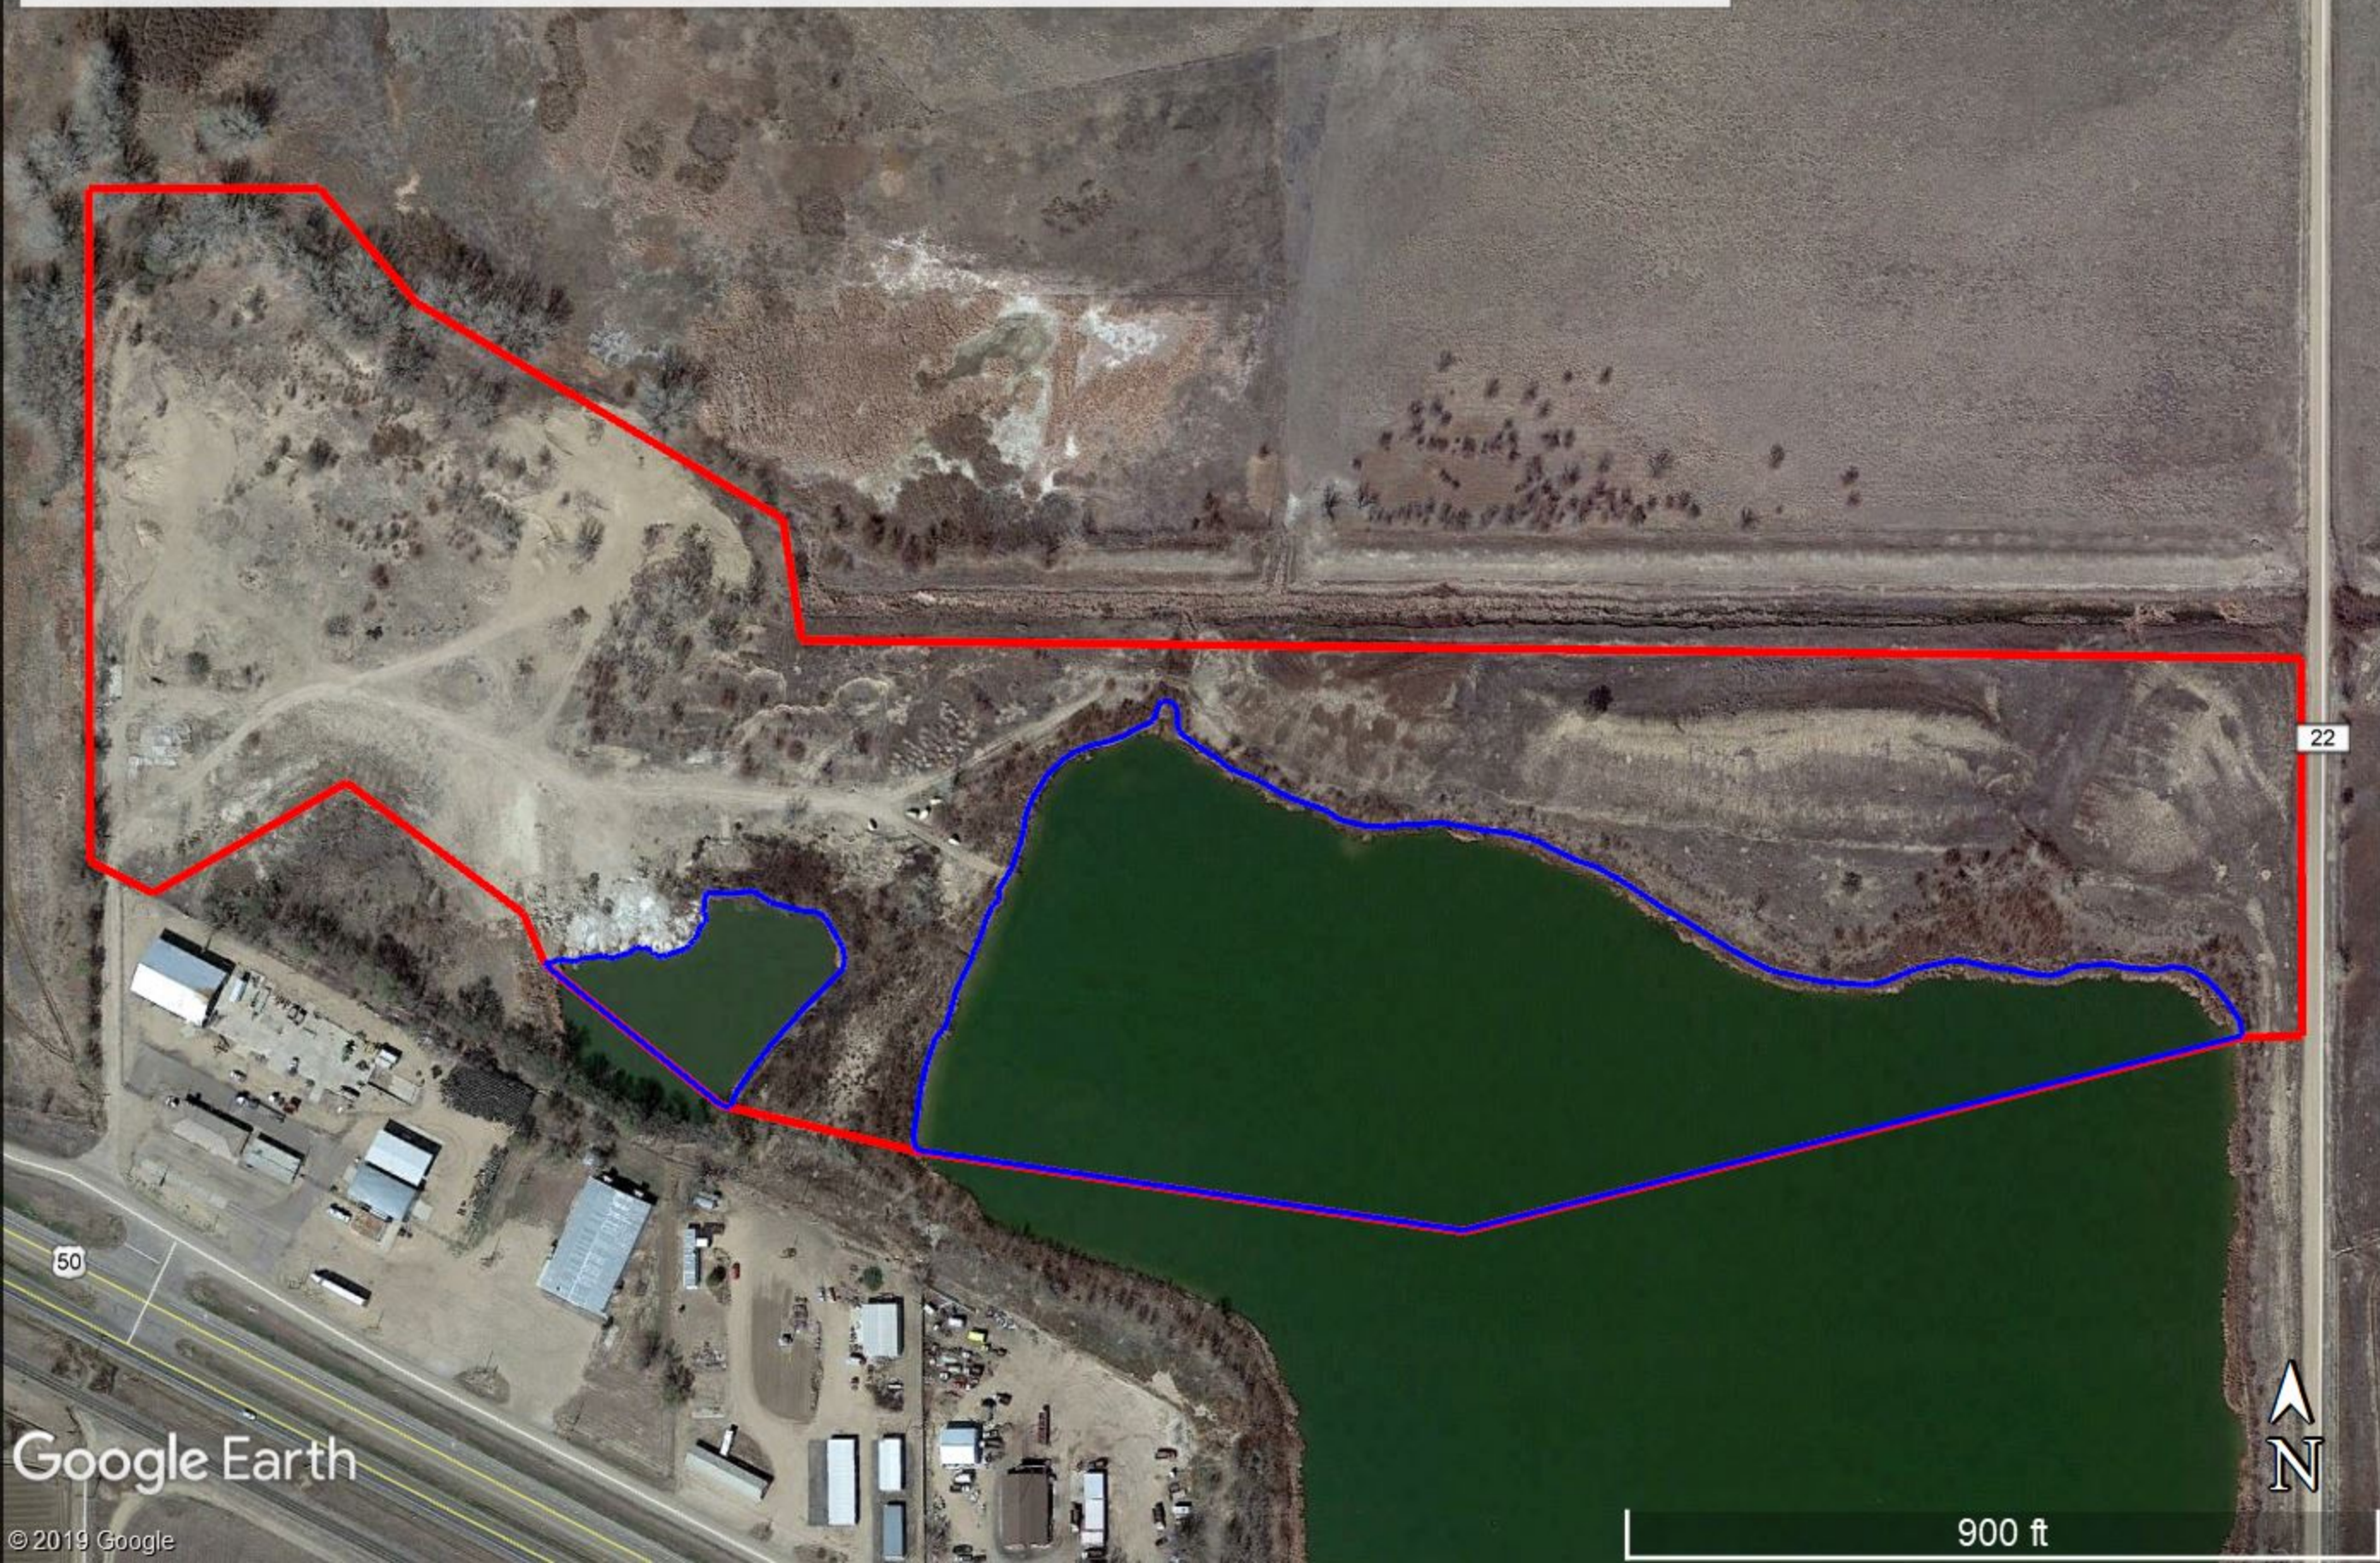
Blue Outline = 12.6 acres = Total Pond Surface Within Permit Area (1 acre small pond + 11.6 acres large pond)

(Image data from 3/19/2016)
