Huddleston-Berry
Engineering & Testing, LLC

January 16, 2020
Project#01349-0001

Subject: Summary of Instrumentation Monitoring
4th Quarter 2019
Bowie Coal Waste Disposal Area No. 2
Paonia, Colorado

SUBJECT: Summary Report, 4th Quarter 2019, Inclinometer and Active Vibrating Wire Piezometer Data October – December 2019, Bowie Mine #2 Coal Waste Disposal Area (CWDA) #2

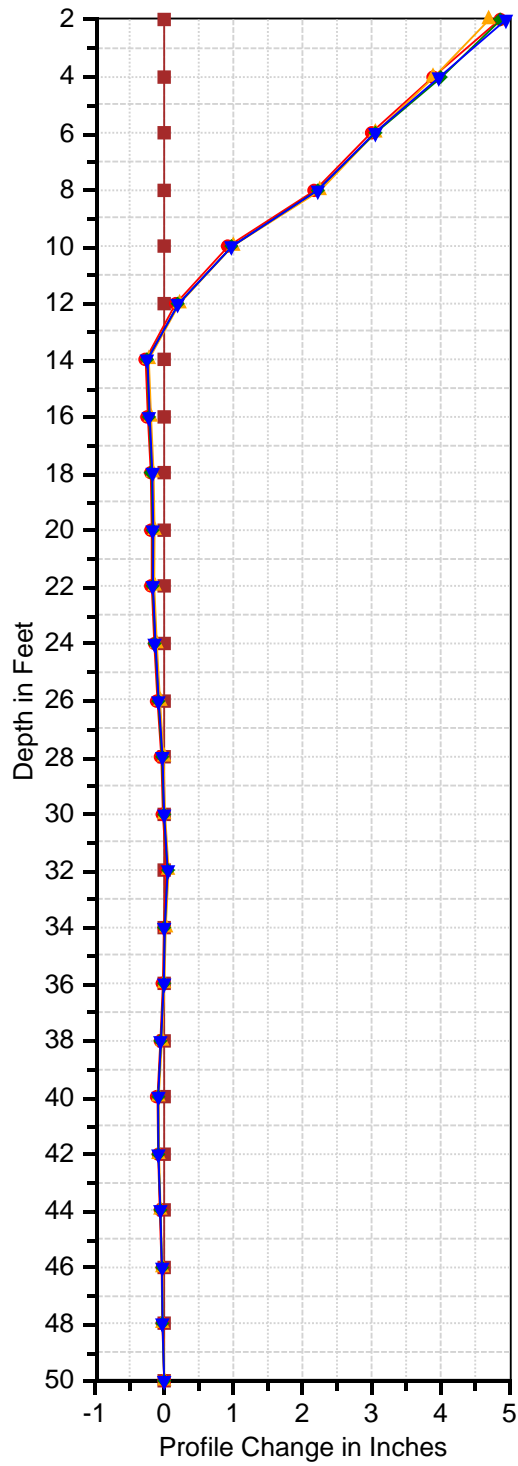
BOWIE BG05_7 A

Three inclinometers, designated BG05-4, BG05-5, and BG05-7, were installed at CWDA #2 in August 2005. The inclinometers were installed through the coal refuse and approximately 20 feet into the native foundation soils. The physical locations of the inclinometers are shown on the attached Instrumentation Site Plan (Map 1). Baseline readings were taken on 8/10/05 and subsequent readings have generally been taken quarterly since that time. Displacement curves for each of the three inclinometers for the current and the prior three readings are presented as attachments to this letter in Figure 3. Axis "A" reflects deformation with depth in the direction of anticipated movement (downslope), while Axis "B" is orthogonal to Axis A.

Figure 3 - Inclinator Displacement Curves
