**Annual Report – 2019**  
**Henderson Mine and Mill Reclamation Activities**  
**Permit No. M-1977-342**

**HENDERSON MINE**  
MLRB Permit No. M-77-342  
Annual Reclamation Report  
March 4, 2019

**HENDERSON MILL**  
MLRB Permit No. M-77-342  
Annual Reclamation Report  
March 4, 2019

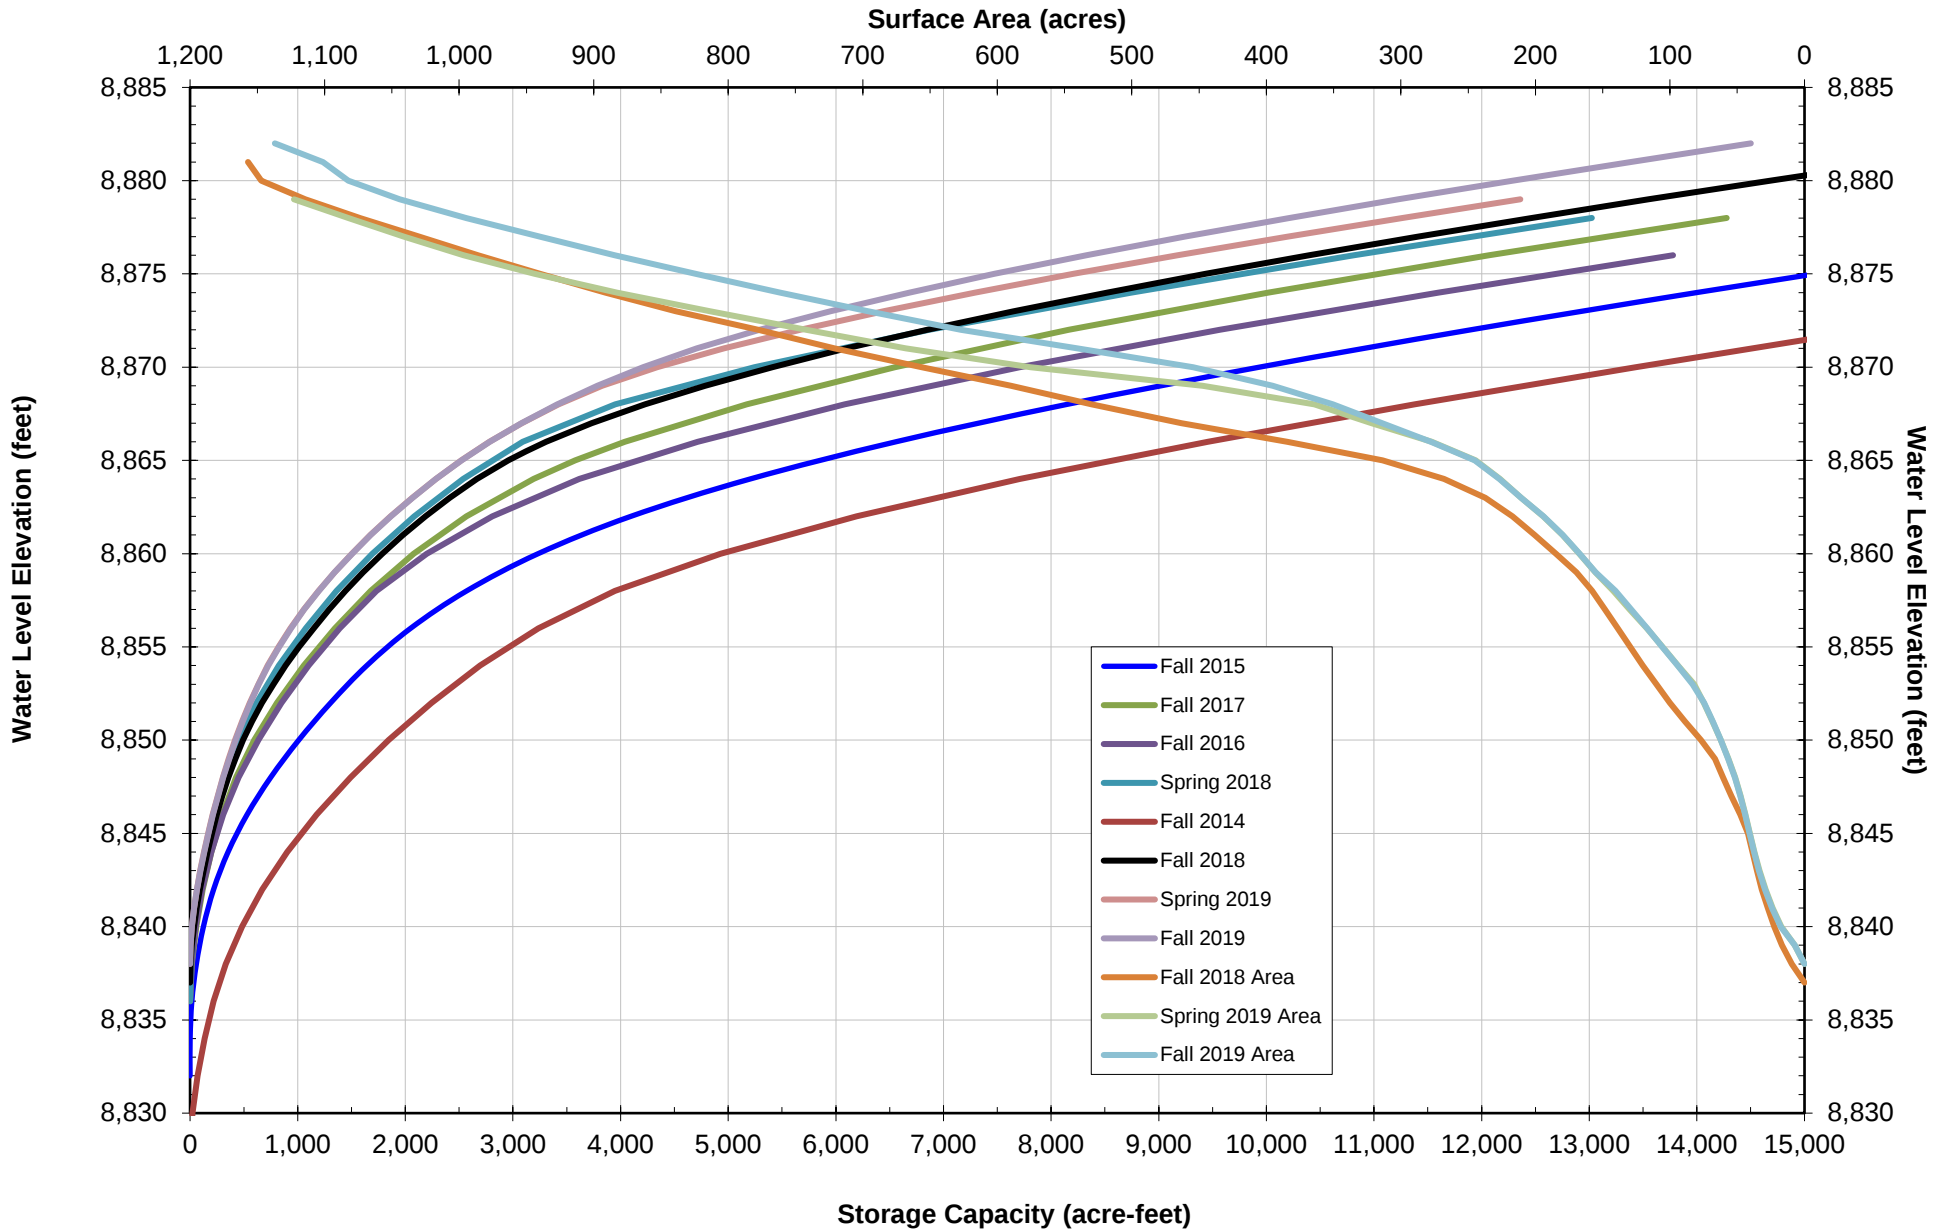
**Figure 2 - Henderson TSF  
Elevation Area Capacity**

One of the primary uses of the survey data is to evaluate the flood storage capacity conditions in the water system. As summarized on Figure 1, at the approximate time of the fall survey there was a total system surcharge storage capacity of about **10,277 acre-feet** in the system. This capacity includes both the TSF and East Branch Reservoir and is based on 0.5 feet of residual freeboard below the minimum dam crest elevation of 8,881.4' and a October 31<sup>st</sup> water level of 8,868.7 feet. The flood storage requirement for the system is **3,582 acre-feet**. This requirement is based on hydrologic modeling of the probable maximum precipitation (PMP) event. The available flood storage capacity in the system at

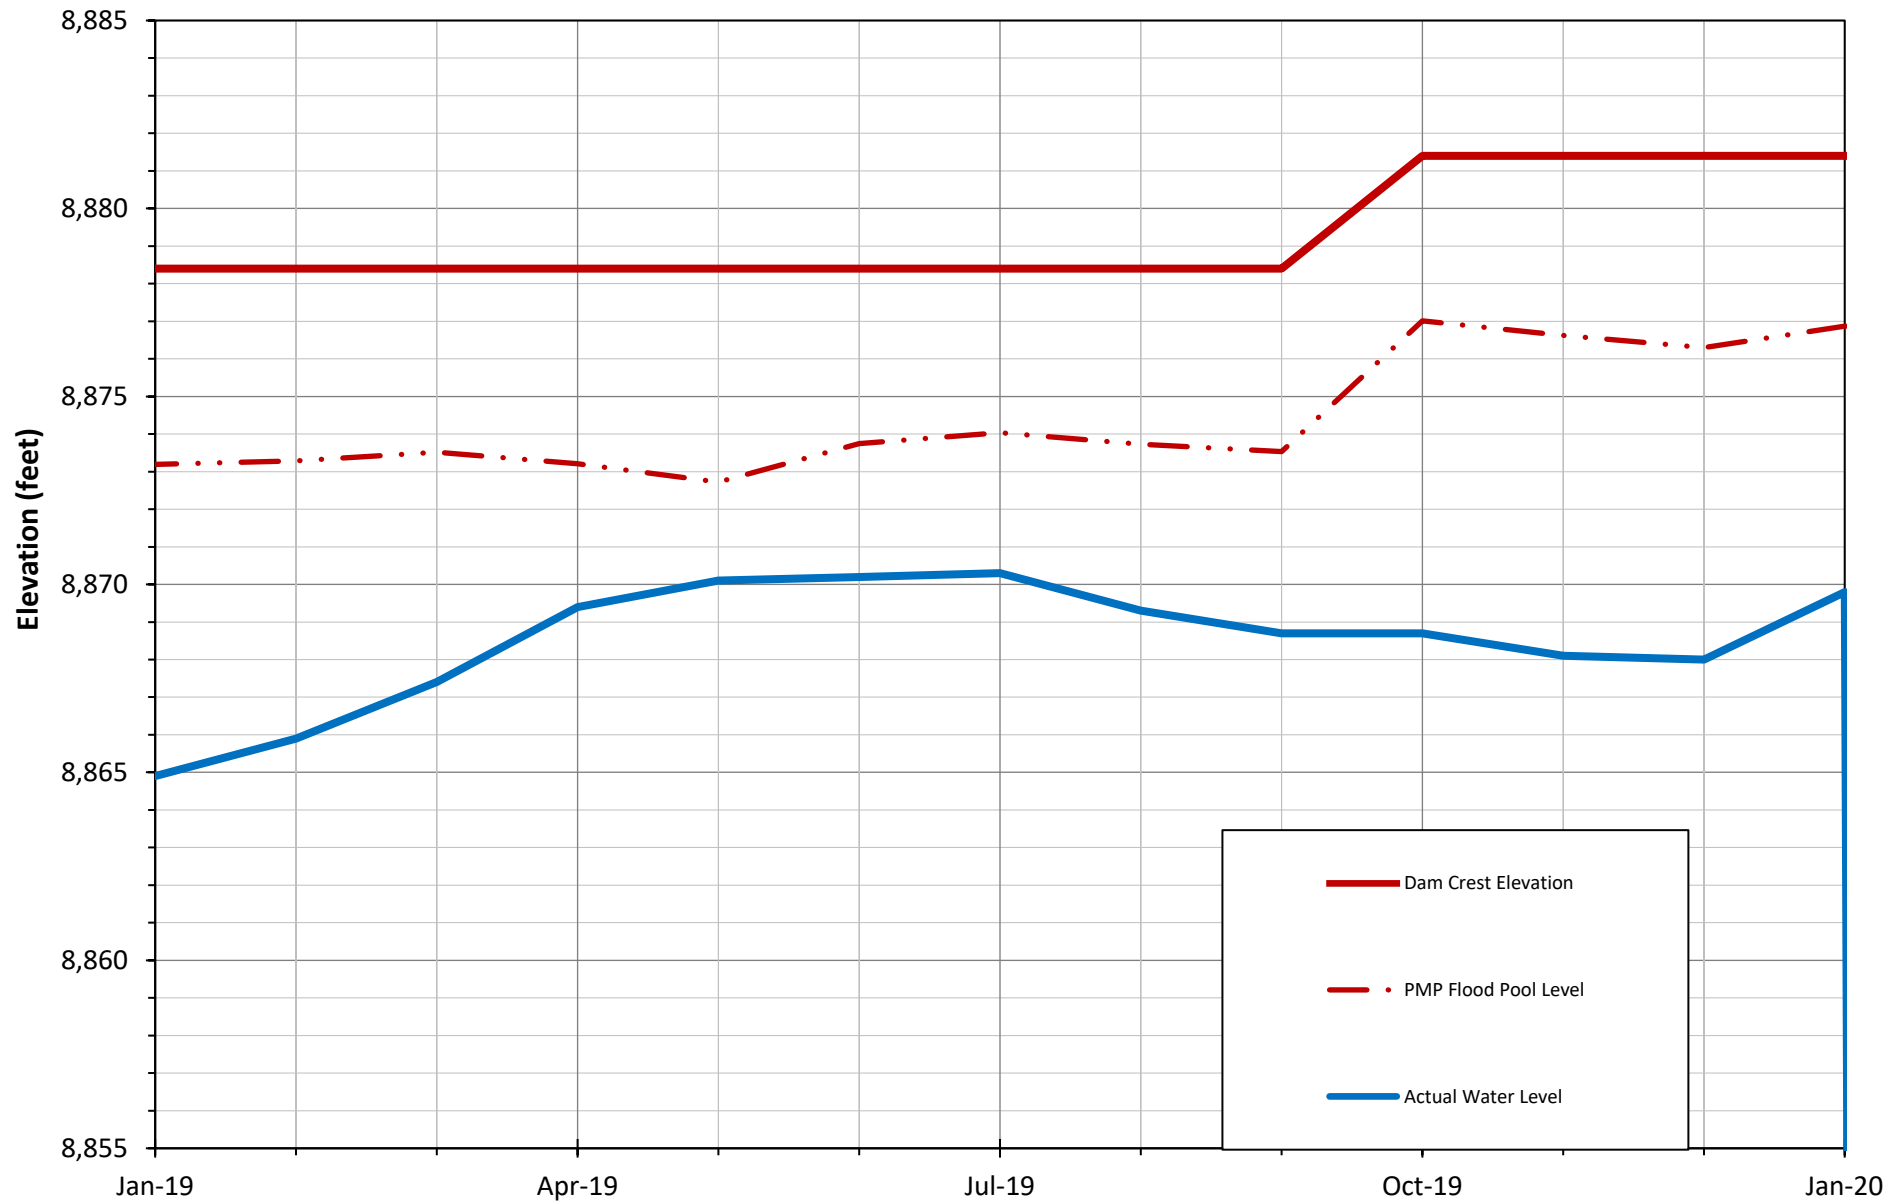
**Figure 3 Henderson TSF  
Water Pool Level Tracking**

A relatively accurate determination of the flood storage capacity in the impoundment can be made at the time of the pond surveys. An operations model has been developed to track water levels and estimate the flood storage availability in the system between surveys. This model is updated by Henderson personnel or Wheeler on a monthly basis. One of the reports generated by this model is the attached TSF Water Level Report (Figure 3). This graph shows the actual water level in the TSF as compared to the flood pool level in the pond, which is defined as the level corresponding to 3,582 acre-feet of available capacity. Note that the actual water level did not exceed the flood pool level at any time in 2019. This shows that the required flood storage space was maintained in the system throughout the 2019 calendar year.
