**MINERALS PROGRAM INSPECTION REPORT**  
**PHONE: (303) 866-3567**

<b>MINE NAME:</b> Bennett Pit	<b>MINE/PROSPECTING ID#:</b> M-2016-085	<b>MINERAL:</b> Sand and gravel	<b>COUNTY:</b> Weld
<b>INSPECTION TYPE:</b> Multi Person Inspection	<b>INSPECTOR(S):</b> Peter Hays	<b>INSP. DATE:</b> May 21, 2020	<b>INSP. TIME:</b> 10:00
<b>OPERATOR:</b> Northern Colorado Constructors	<b>OPERATOR REPRESENTATIVE:</b> Chris Zadel, J.C. York	<b>TYPE OF OPERATION:</b> 112c - Construction Regular Operation

CT-1 Inspection Report  
May 21, 2020  
Overall Map

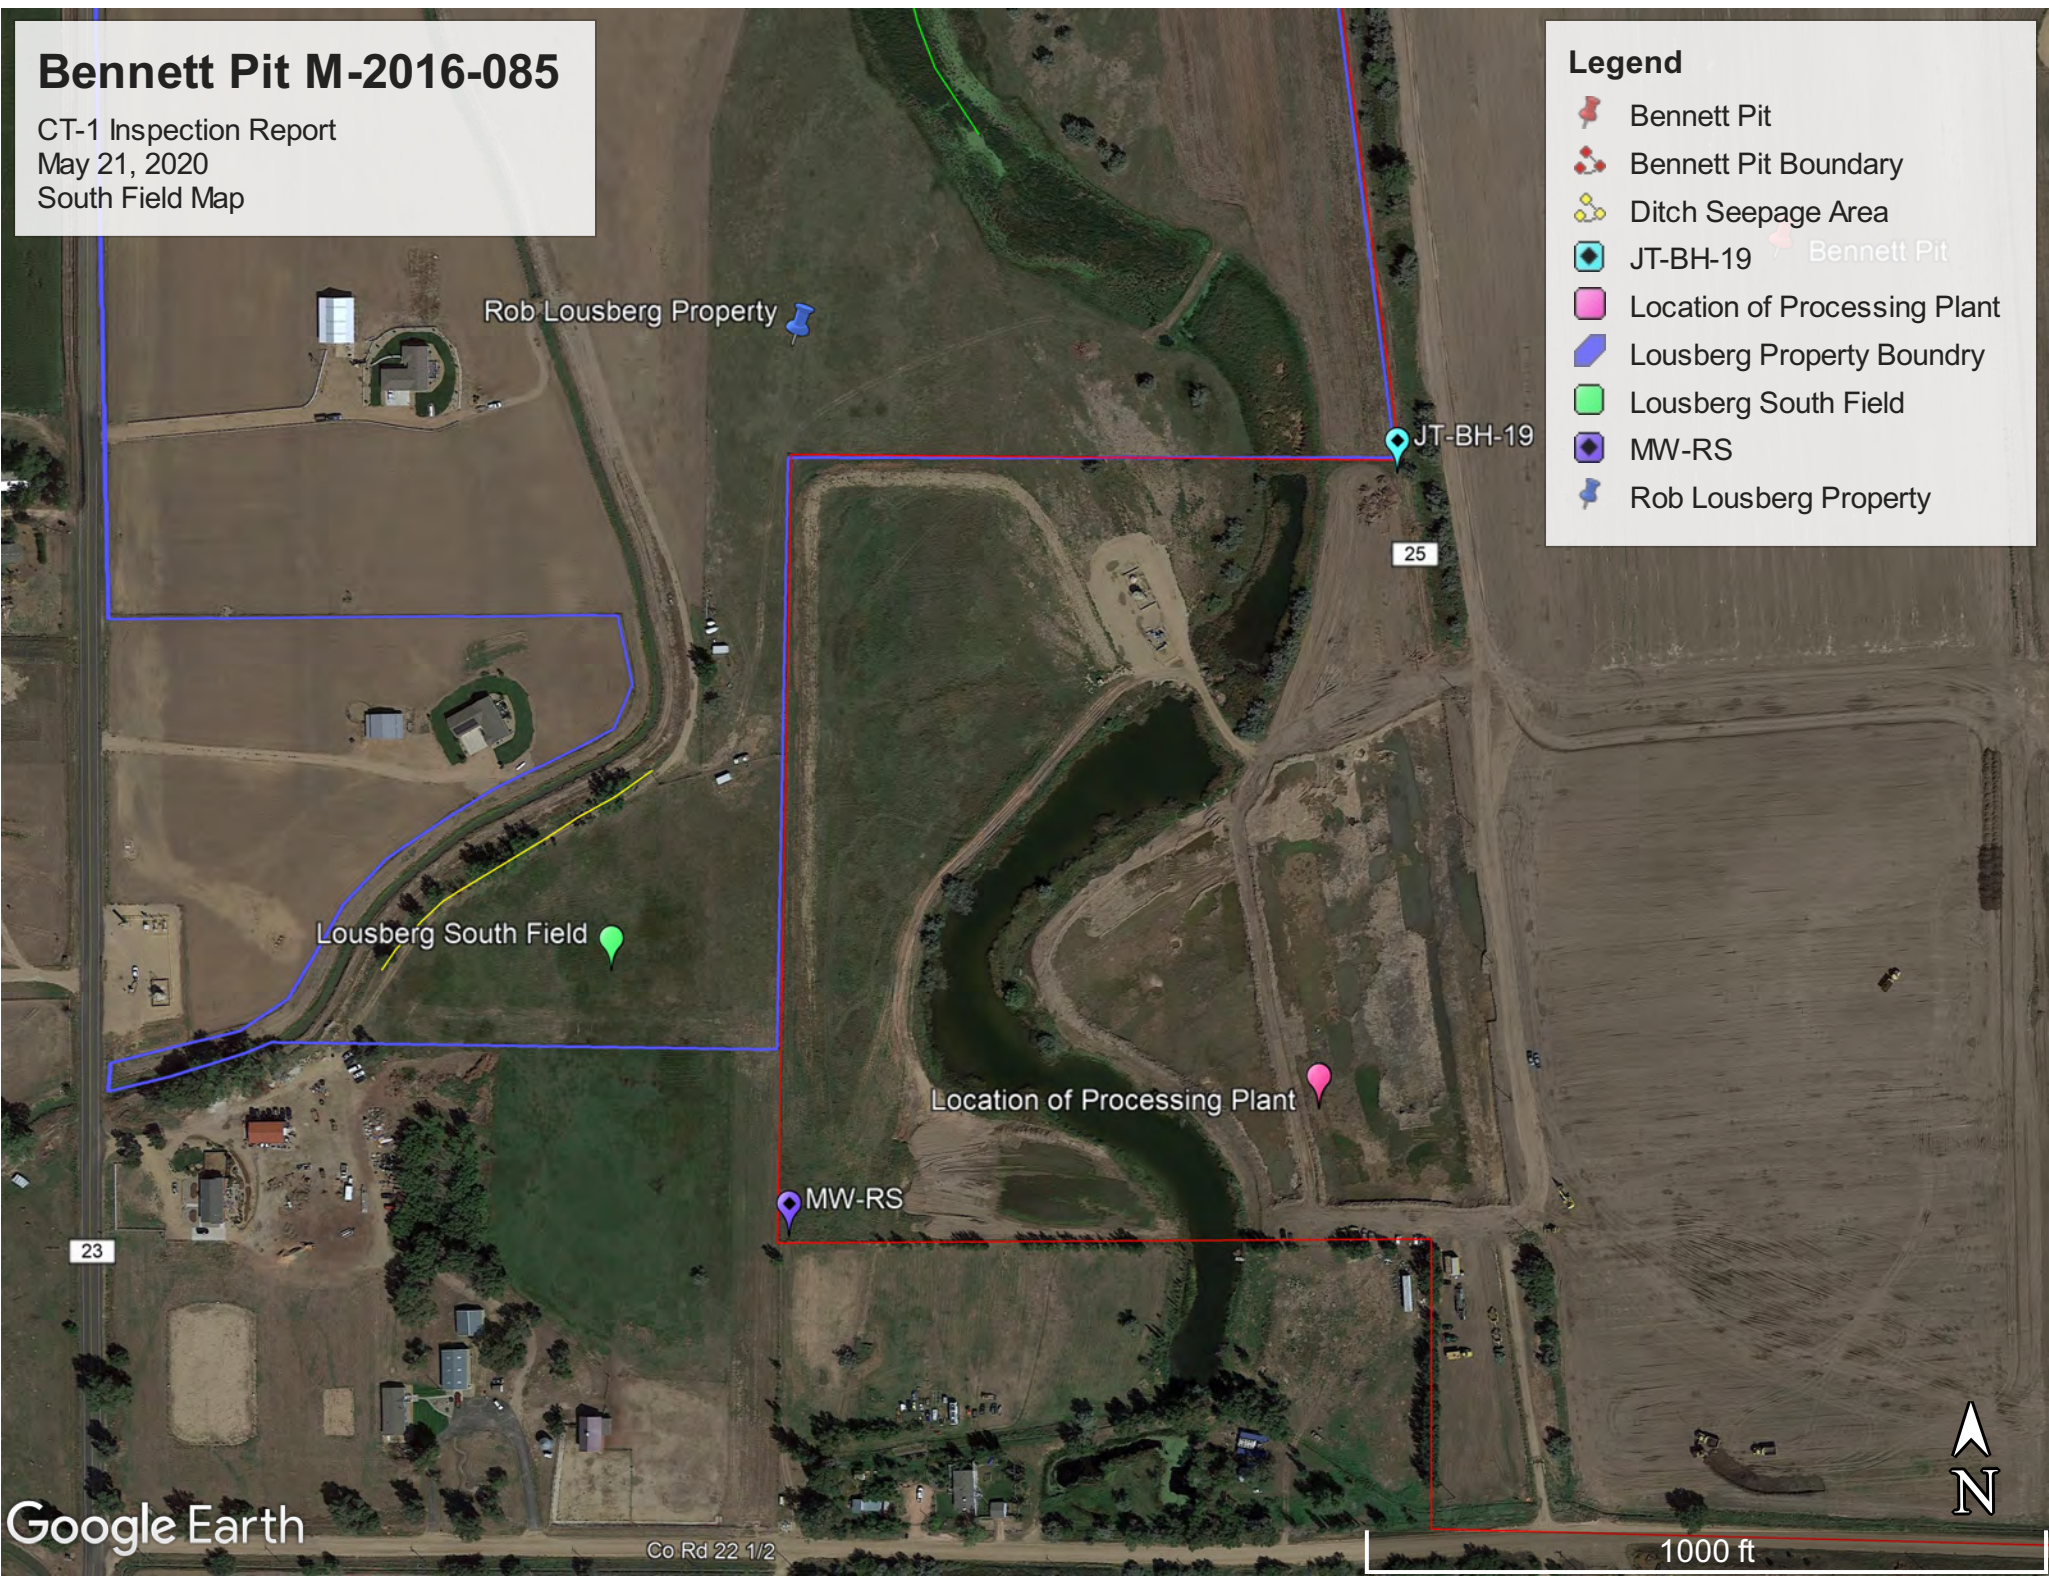
CT-1 Inspection Report  
May 21, 2020  
Access Road Map

The culverts associated with the access road were observed during the inspection. One (1) thirty-six (36) inch diameter culvert was observed at approximately the middle of the slough under the access road. The culvert appeared to be functioning properly. The Operator has installed a ditch from the east side of the slough to the west end of the access road to allow water to flow to the west from the slough. Two (2) twenty (20) inch diameter HDPE pipes were observed at the end of the access road. Ponded water was observed on both sides of the culverts inlets and outlets. The culverts were estimated to be seventy-five (75) percent full and appeared to be undersized for the amount of water required to be conveyed under the west end of the access road.

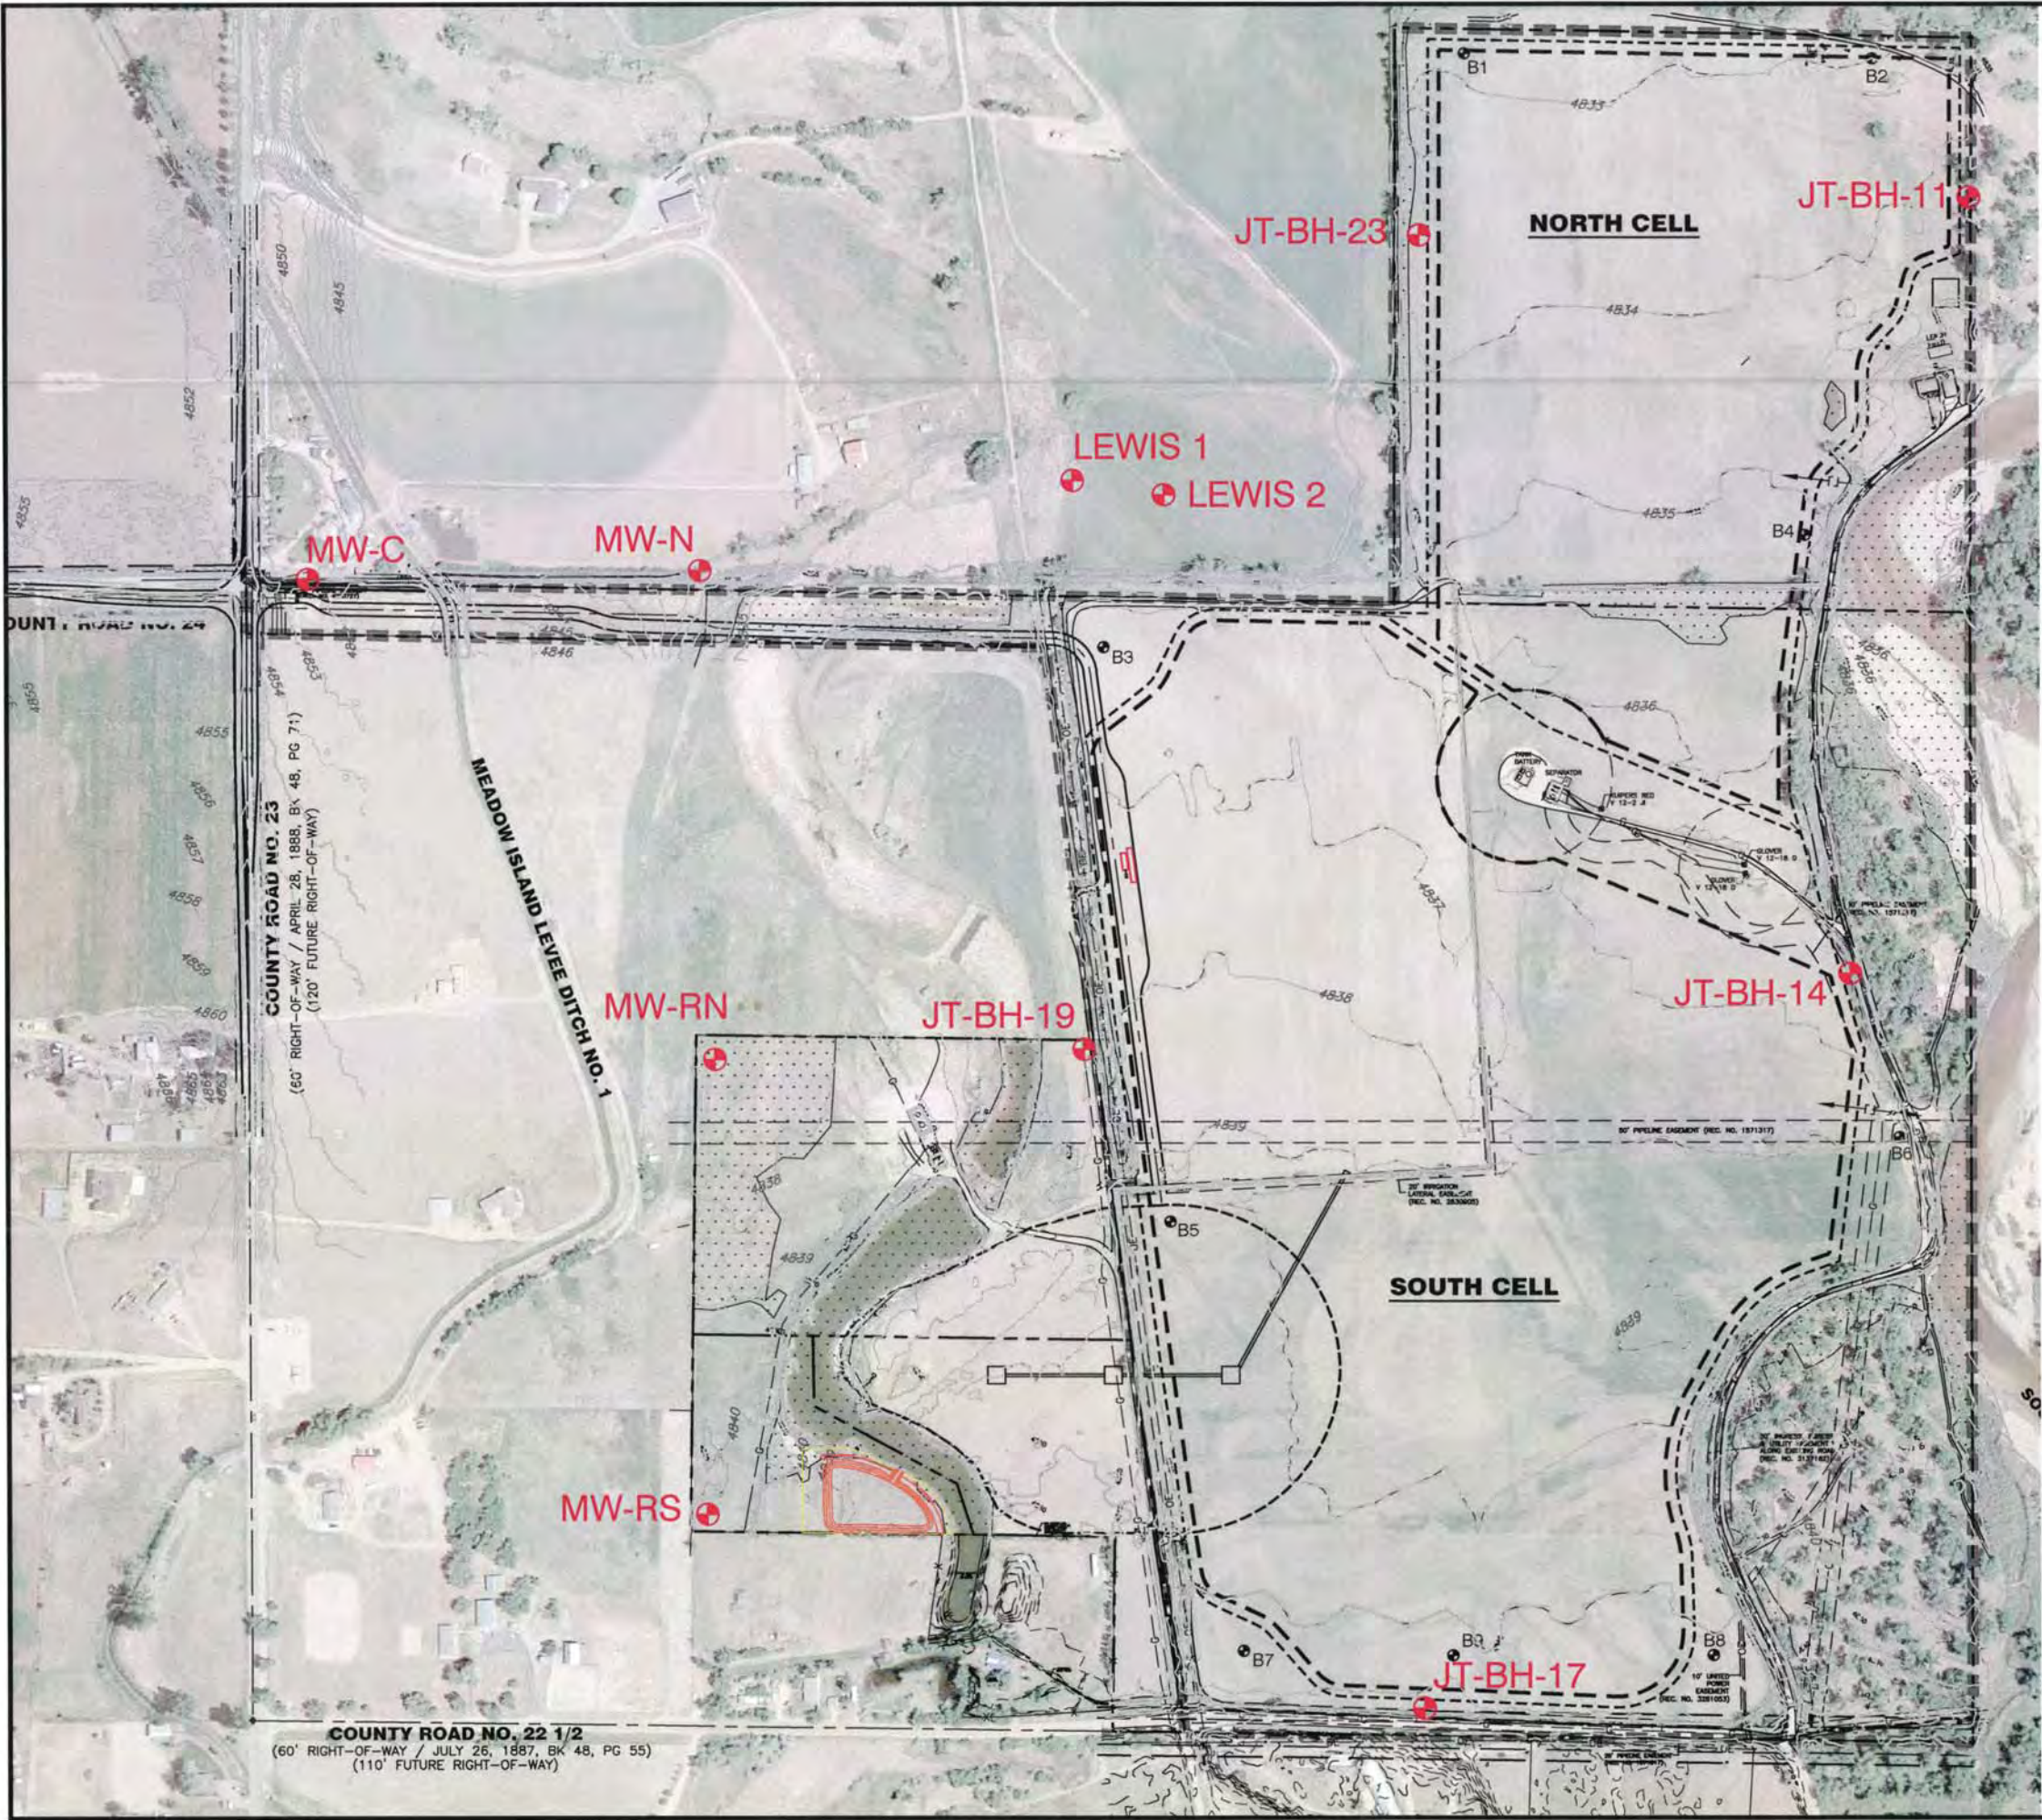
JT-BH-14 MONITORING WELL LOCATION

The groundwater data indicates a similar increase in the groundwater elevation for all of the monitored wells, including the Lewis wells which were predicted to be in the shadow area (reduced groundwater elevation) in the Slurry Wall Assessment report. The fact that all of the monitored wells are indicating similar increases in the groundwater elevation indicates the increases are season fluctuation and not caused by the slurry wall. Copies of the groundwater data and the monitoring well location map are attached for reference.

The Division will continue to require the Operator to collect and report the groundwater elevation data to the Division with the annual report. During the inspection, the Operator stated a survey crew would be on-site in a few weeks to survey the slurry wall. The Division recommends the elevation of the Lousberg south field be surveyed to allow the groundwater data collected at MW-RS to be correlated with the field elevation.
