MINERALS PROGRAM INSPECTION REPORT
PHONE: (303) 866-3567

MINE NAME: Revenue Mine	MINE/PROSPECTING ID#: M-2012-032	MINERAL: Lead, silver and gold	COUNTY: Ouray
INSPECTION TYPE: Multi Person Inspection	INSPECTOR(S): Lucas West	INSP. DATE: June 23, 2020	INSP. TIME: 11:28
OPERATOR: Ouray Silver Mines Inc.	OPERATOR REPRESENTATIVE: Brian Briggs, Kyle Erdmann	TYPE OF OPERATION: 112d-1 - Designated Mining Operation	
REASON FOR INSPECTION: Normal I&E Program	BOND CALCULATION TYPE: None	BOND AMOUNT: \$476,269.41	
DATE OF COMPLAINT: NA	POST INSP. CONTACTS: None	JOINT INSP. AGENCY: None	
WEATHER: Clear	INSPECTOR'S SIGNATURE:

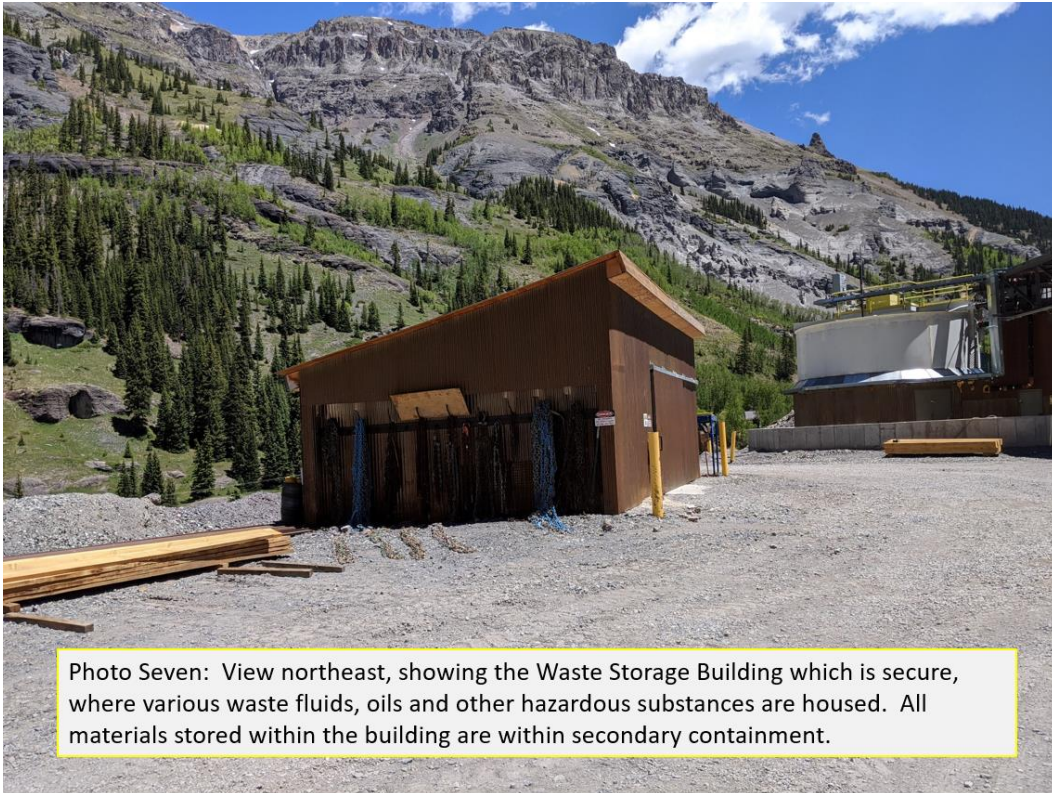
The mine water conveyance and settling system was observed and appears to be functioning as designed and approved. Pond #1 can be seen in Photo Five and Pond #2 in Photo Six. Some of the monitoring well locations were observed and all covers and caps were secured at the time of the inspection. Other surface facilities that were inspected included the fuel and waste storage building, Tailings Thickener Tank, various propane storage sheds and the Materials Storage Connex. The fuel and waste storage building contained various oils, lubricants and fuels all stored in proper secondary containment and in good condition. Photo Seven shows the Waste Storage Building. Also inspected was the materials storage area adjacent to the storage connex. All items stored in that area were in good condition and stored in a neat and orderly fashion. The area can be seen in Photo Eight. Discussions with the Operator indicate that the Materials Storage Connex may be replaced with a more suitable storage structure. Any significant changes to this or other surface facilities would need to be addressed through the Division's Technical Revision or Amendment Process.

Photo Six: View east, showing Pond #2, formerly the passive treatment pond, which is the second stage in conveying mine water from the portal to the discharge point.
