January 28, 2020

Asphalt Paving Co., Ralston Quarry M-1974-086
Technical Revision – Modifications to Slide Repair Designs and Plans

**Limited Geotechnical Evaluation
Slope Stability and Remediation Approach
Ralston Quarry
Jefferson County, Colorado
Revised6**

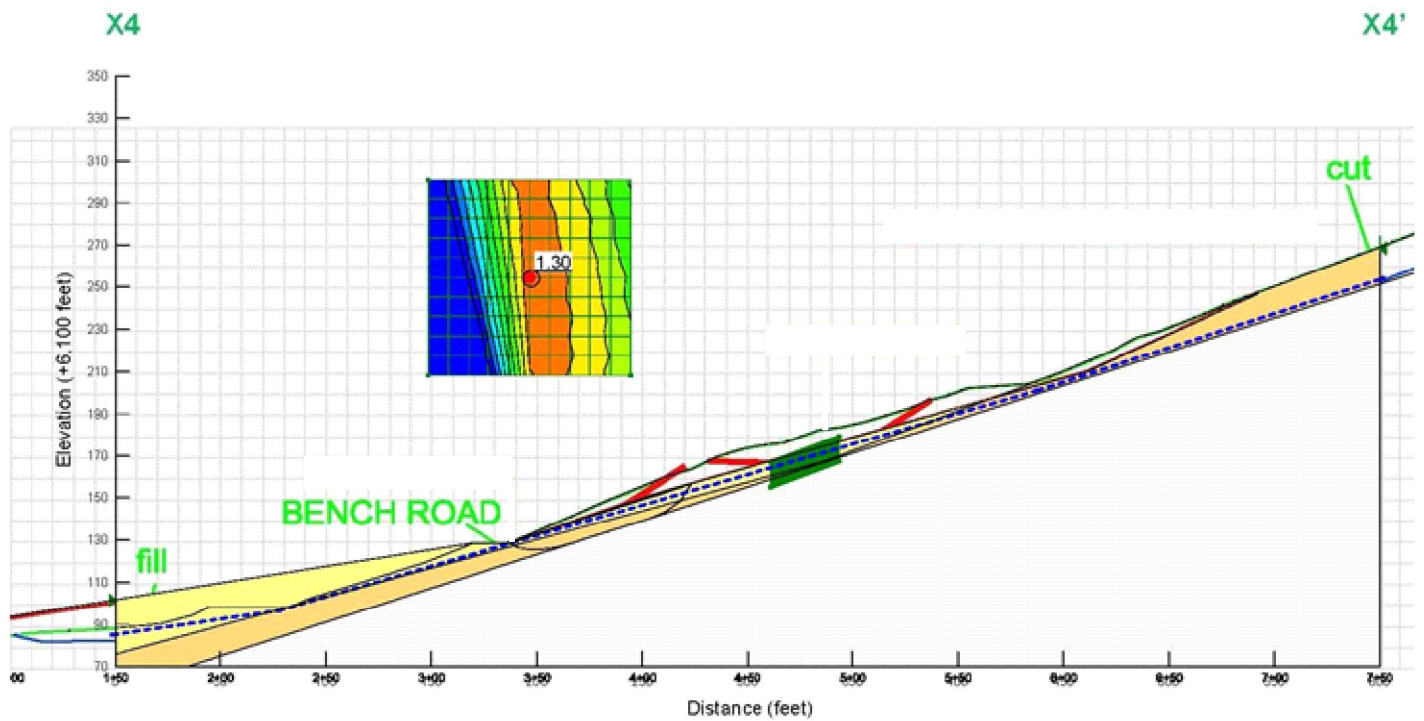
FIGURE: 23A

Zone 3a – The South-Central Slope The extent of this zone is shown on a September 12, 2019, Google Earth[®] image in Figure 23. Tailings also were placed on this portion of the original, west-facing slope over the same general time frame as the portions of the slope farther north. This zone has a smaller volume of fill on the lower slope to act as a buttress and previously a retention pond was present at the toe of the slope in this zone. A small slope failure developed in the central portion of this zone in 2005. Additional movement of the failed area took place in 2007. In 2010, that area was re-graded and the retention pond removed. No subsequent failures have developed in Zone 3a.

Slope stability analyses of this zone of the slope in the proposed (re-graded) condition (Sections X3 – X3' and X4 – X4') indicated a Morgenstern-Price factor of safety against failure of about **1.3** for both sections, as shown on the SlopeW[®] output on Figure 23, even with the water at the contact between the tailings and the underlying, native soils.

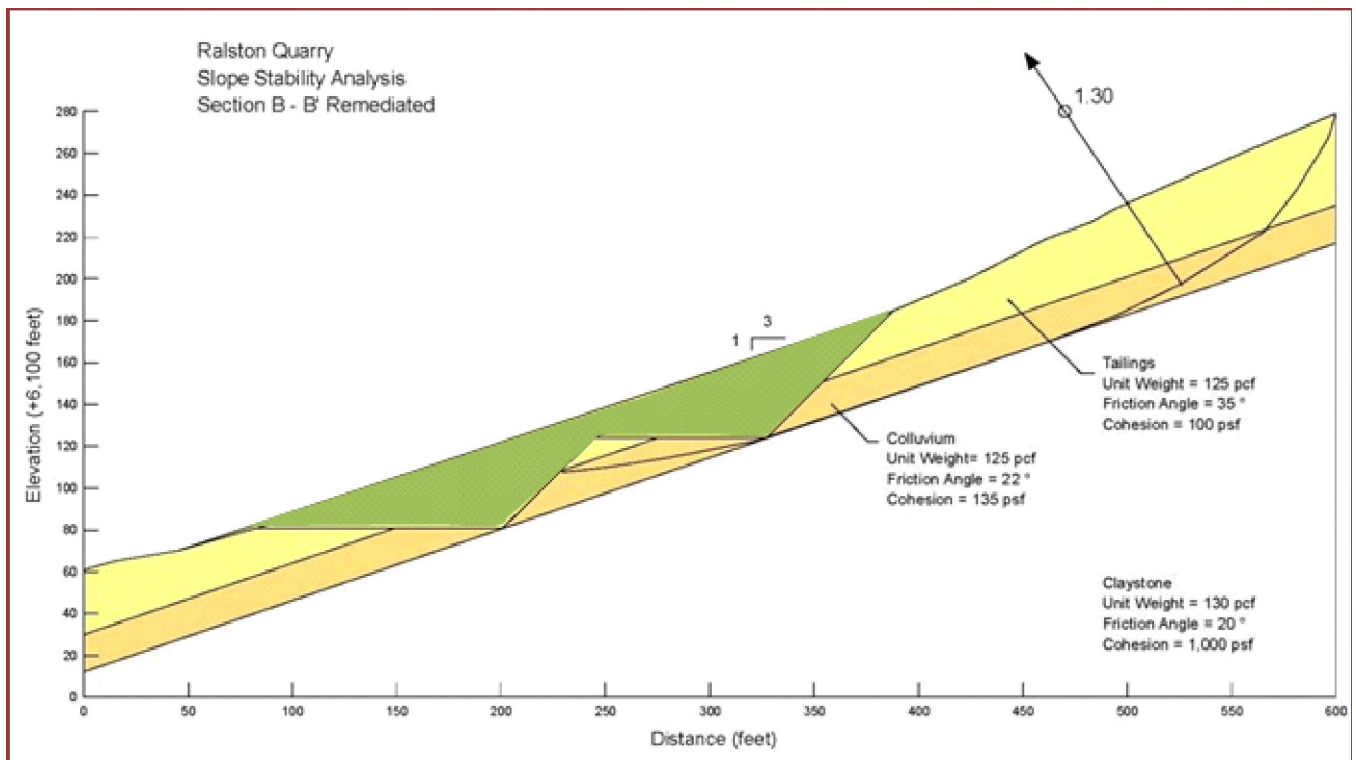
FIGURE: 24A

Zone 3b – The Central Slope Slope In Zone 3b (shown on a September 12, 2019, Google Earth[®] image in Figure 24a) tailings extended the farthest down slope, but exhibited no slope failures prior to construction of the retention ponds which appear to have been constructed in 2002. The slope failures in Zone 3b appear to have been moderate to low velocity failures.

Remedial Measures In GROUND's opinion, in order to increase the factor of safety against failure in Zone 3b, two stability embankments should be constructed along the slope across the full north to south width of the zone. The excavations to construct the embankments should be extended through the colluvium and into in-place shale (into firm weathered shale is sufficient) to interrupt the low-strength layer of colluvium underlying the tailings. This geometry is shown on the SlopeW[®] output in Figure 24a. The stability embankments are shown in green. Stability analyses of this geometry indicated a calculated Morgenstern-Price factor of safety against failure of about **1.3**. With seismic loading, the calculated minimum factor of safety was about **1.1** as shown on Figure 24b.

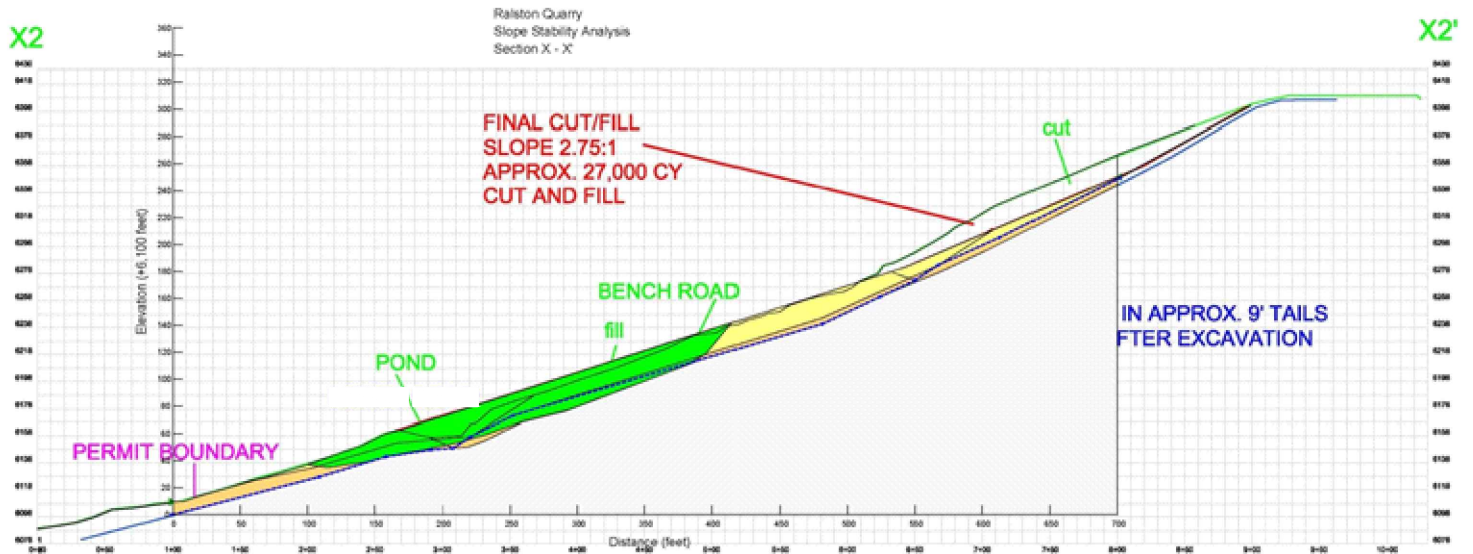
FIGURE: 27B

Zone 4 – The Earliest Failure The boundaries of Zone 4 shown on a September 12, 2019, Google Earth® image in Figure 27a. The outline of a previous slope failure is visible within the zone, indicated by the red arrow. This slope failure in Zone 4 also appears to have been a moderate to low velocity failure. In 2010, the area was re-graded by Asphalt Paving Company to construct a buttress and directing surface water away from the toe area of the failure. There has been little or no further movement in the area of that slope failure area, and the vegetation has re-grown extensively since that time.

Slope stability analyses of Zone 4 of the slope were made of the proposed (re-graded) condition with drains installed to keep water from accumulating in the tailings. The sections analyzed for slope stability for this study are indicated approximately in Figure 27a (X1 – X1' and X2 – X2'). Analyses indicated a Morgenstern-Price factor of safety against failure of about **1.23** for X1 – X1' and **1.40** for X2 – X2' as shown on the SlopeW® output on Figure 27a and b, respectively, for this condition.

Remedial Measures Based on the factor of safety obtained for Zone 4 by slope stability modeling, the proposed re-grading should be implemented in this zone, and two transverse (roughly north – south) slope drains should be installed to keep water from accumulating in the tailings section. The slope drains should be installed at mid-slope and relatively low on the slope. A typical slope drain section is provided in Figure 28. Minor raveling or surficial sloughing should be anticipated on the slopes until vegetation is well re-established. The slope should be observed periodically for indications of instability or excessive erosion, particularly after heavy precipitation events.

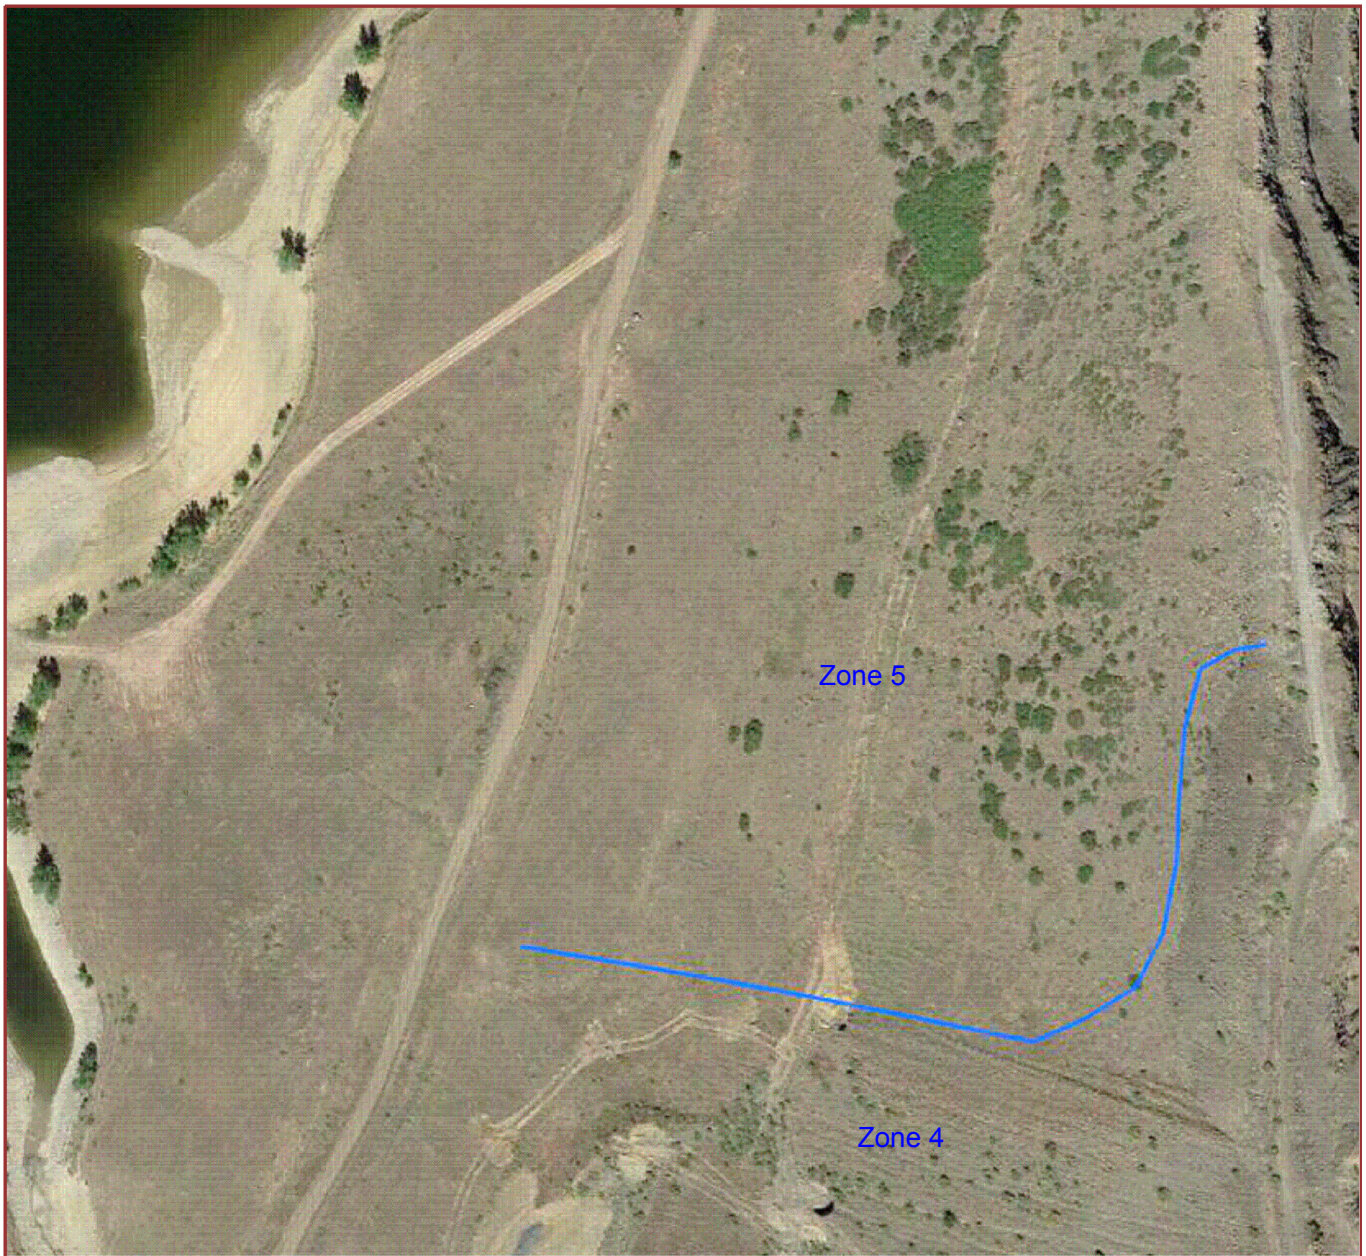
FIGURE: 29

Zone 5 – The Northern Slope The extent of this reach is shown on a September 12, 2019, Google Earth® image in Figure 29. The blue zone boundary line also indicates the approximate limit of the tailings adjacent to this reach.
