MINERALS PROGRAM INSPECTION REPORT
PHONE: (303) 866-3567

MINE NAME: Three Bells Pit	MINE/PROSPECTING ID#: M-1979-191	MINERAL: Sand and gravel	COUNTY: Larimer
INSPECTION TYPE: Surety Release Inspection	INSPECTOR(S): Amy Eschberger	INSP. DATE: July 16, 2020	INSP. TIME: 10:00
OPERATOR: Martin Marietta Materials, Inc.	OPERATOR REPRESENTATIVE: Julie Mikulas	TYPE OF OPERATION: 112c - Construction Regular Operation	
REASON FOR INSPECTION: Surety Release Requested	BOND CALCULATION TYPE: Complete Bond	BOND AMOUNT: \$3,294,000.00	
DATE OF COMPLAINT: NA	POST INSP. CONTACTS: None	JOINT INSP. AGENCY: None	
WEATHER: Clear	INSPECTOR'S SIGNATURE:

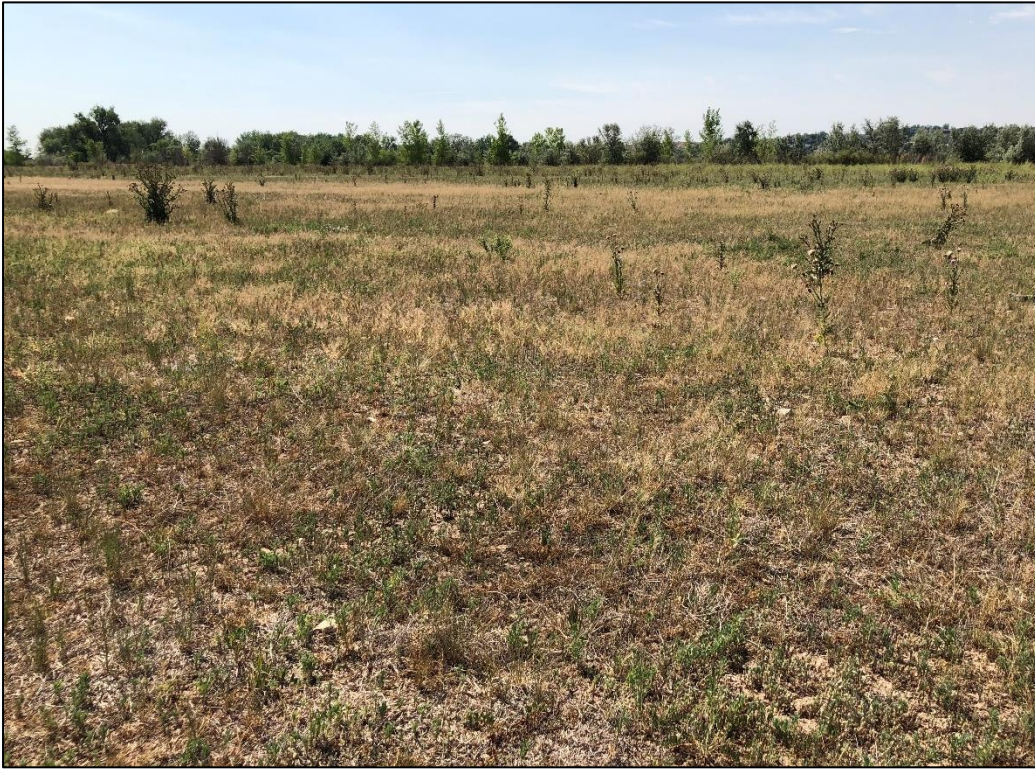
Photo 1. View looking south across DiTullio phase 4 backfill area, showing vegetative cover consisting of grasses and weeds. Note Canada thistle present in this area (in background). Additional weed management and interseeding is required in this area.

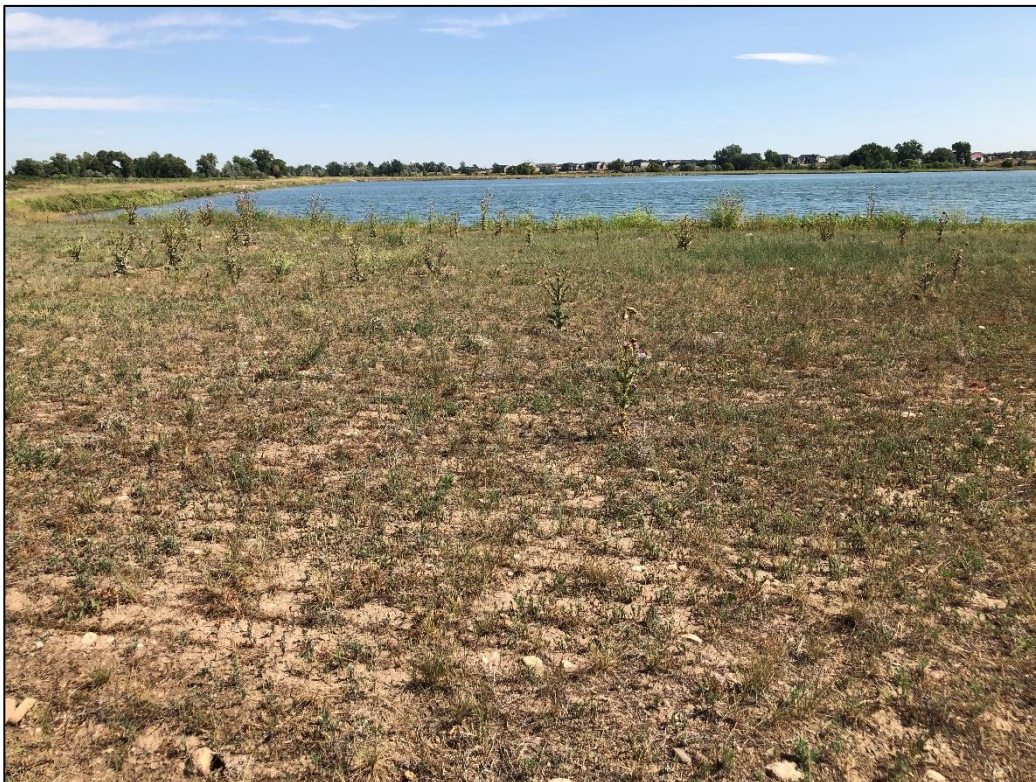
Photo 2. View looking northwest across DiTullio phase 4 backfill area, showing vegetative cover consisting of grasses and weeds. Note Canada thistle present in this area (in background near reservoir). Additional weed management and interseeding is required in this area.

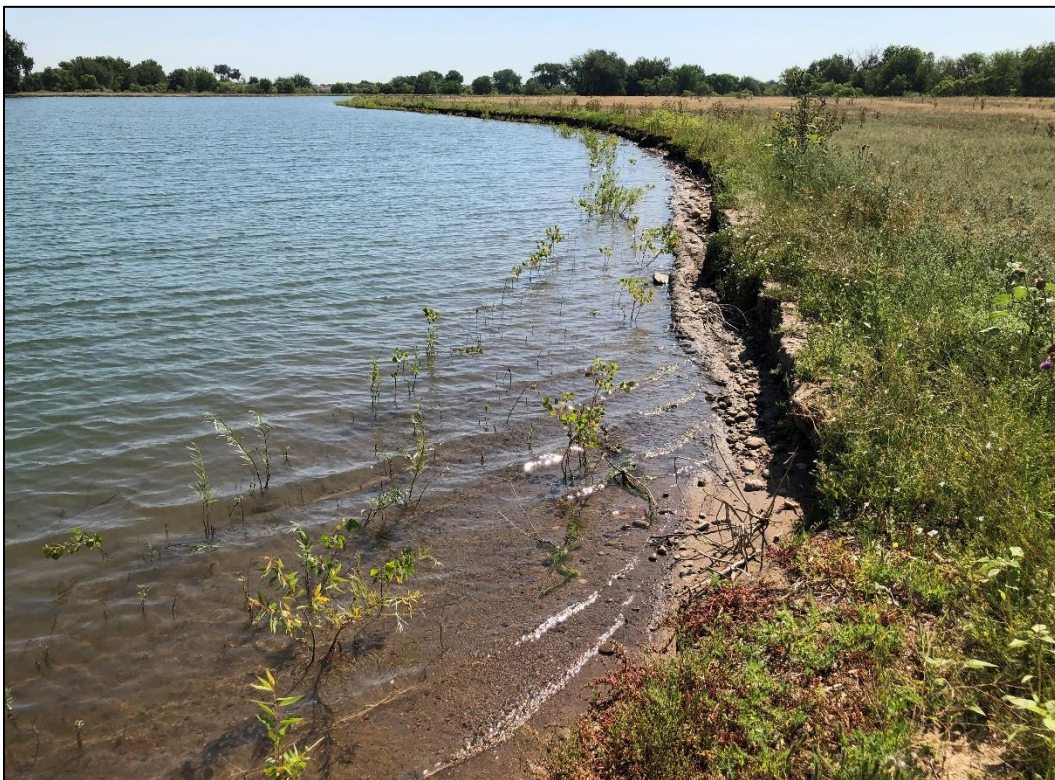
Photo 10. View looking east across southern shoreline of DiTullio phase 4 reservoir, showing slopes at a stable configuration with a natural terrace created along the shoreline. Note volunteer trees growing along shoreline which must be removed. Additional weed management is required, particularly for field bindweed and Canada thistle.

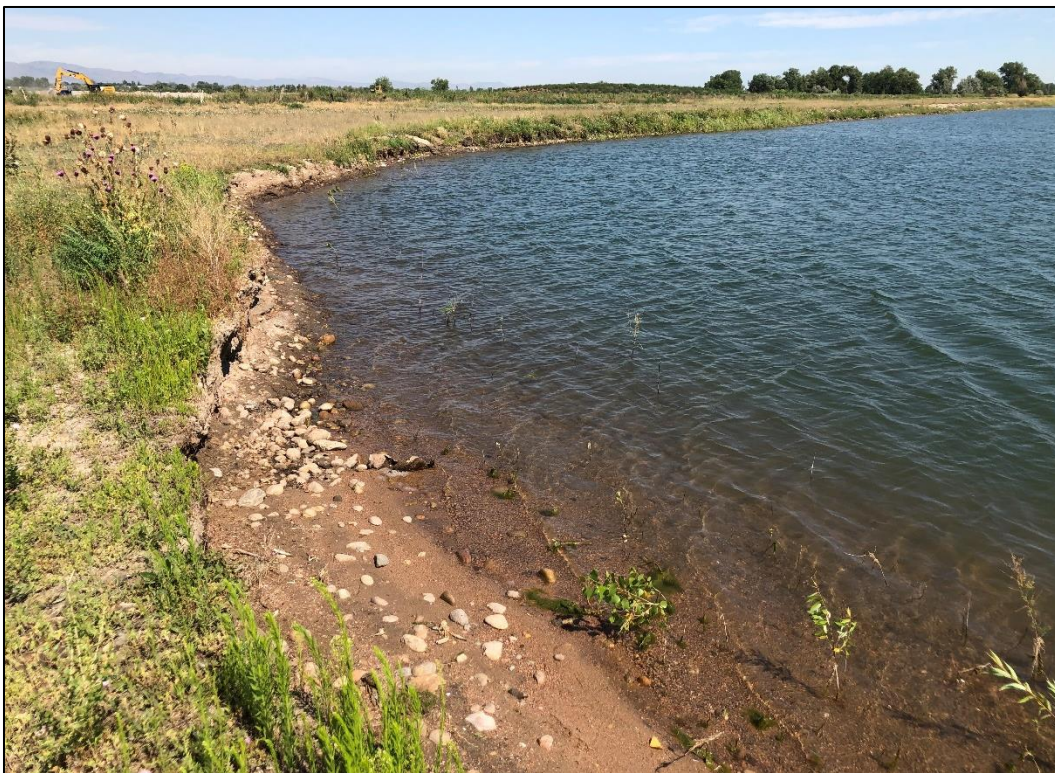
Photo 12. View looking west across southwestern shoreline of DiTullio phase 4 reservoir, showing slopes at a stable configuration with a natural terrace created along the shoreline. Note volunteer trees growing along shoreline which must be removed. Additional weed management is required, particularly for field bindweed and Canada thistle.

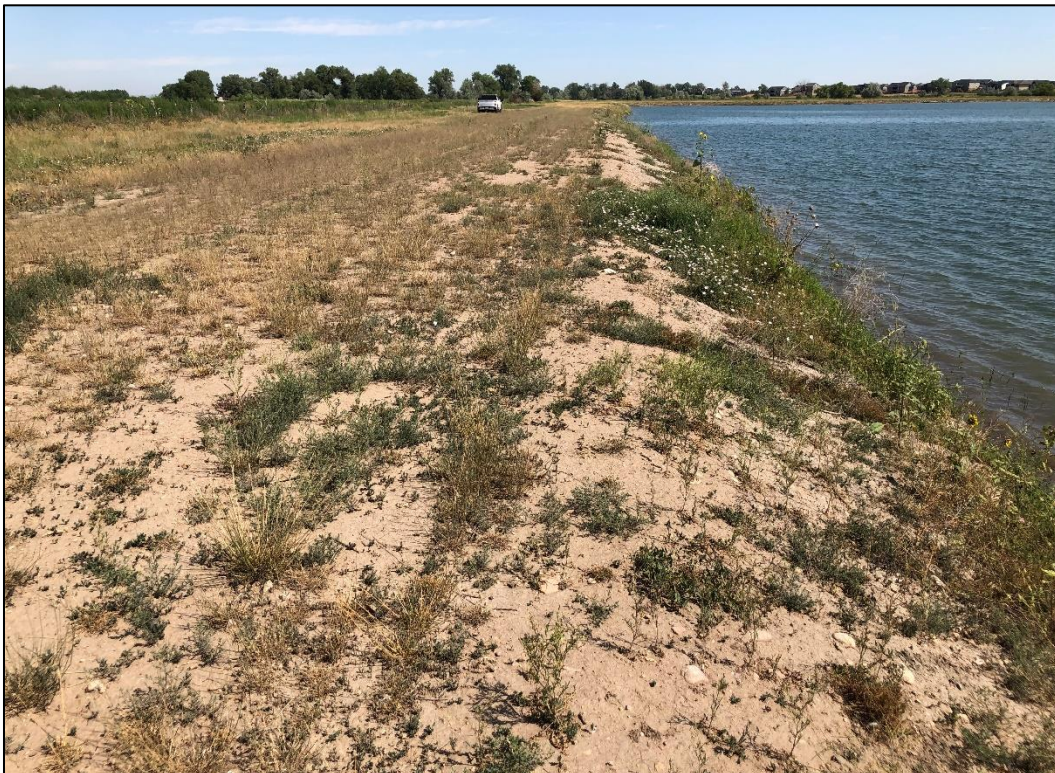
Photo 14. View looking north across western shoreline of DiTullio phase 4 reservoir, showing slopes graded to stable configuration. However, vegetative cover along slopes is fairly sparse consisting primarily of weeds. Additional weed management and interseeding is required in this area.

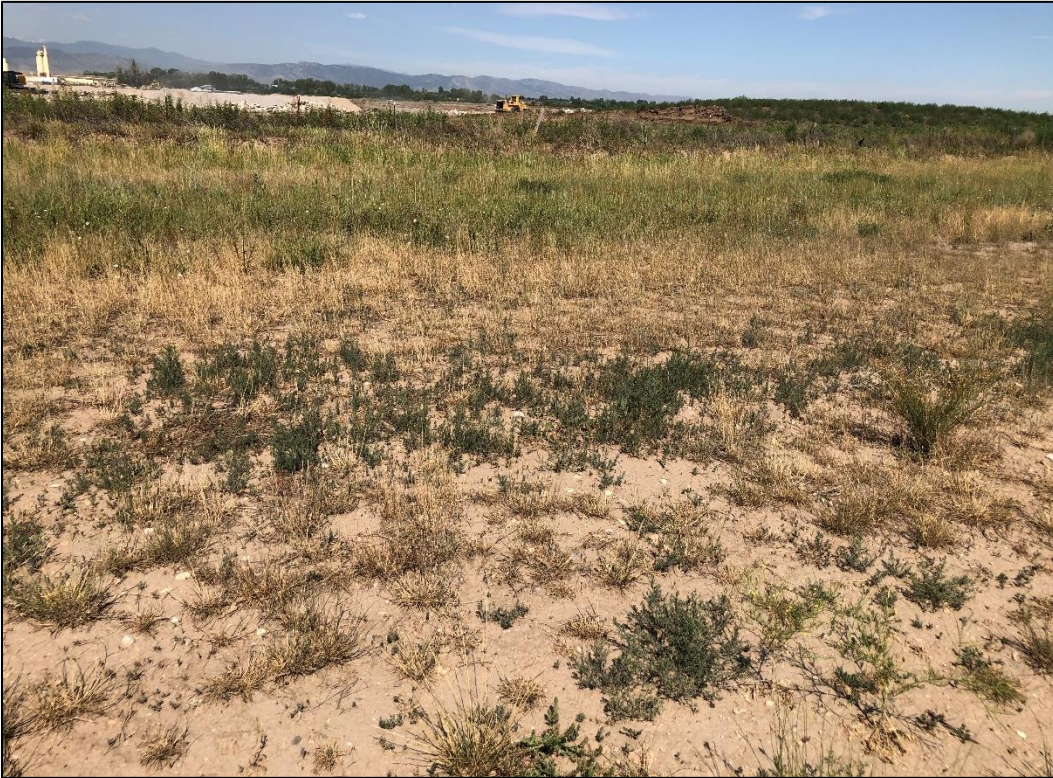
Photo 15. View looking west across area west of DiTullio phase 4 reservoir, showing established grasses in background (approx. 35 feet from edge of reservoir) and fairly sparse vegetative cover consisting primarily of weeds in foreground. Additional weed management and interseeding is required in this area.

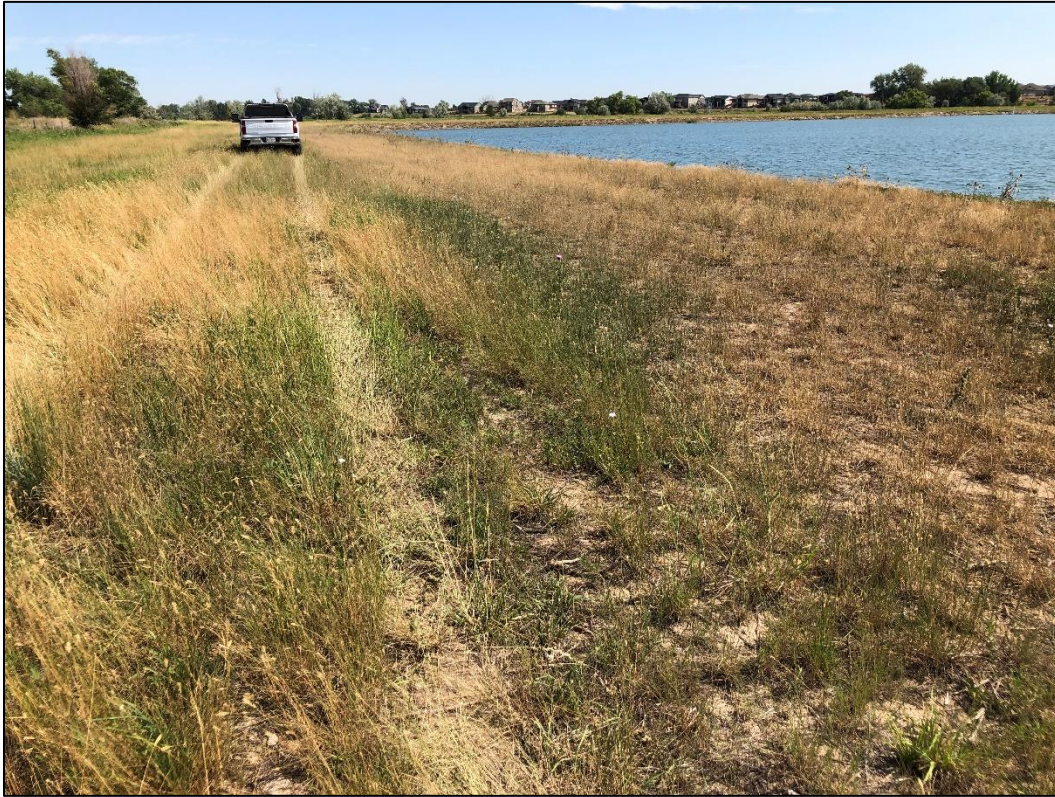
Photo 19. View looking north across area west of DiTullio phase 4 reservoir, showing established grass cover (at left) approx. 35 feet out from edge of reservoir.

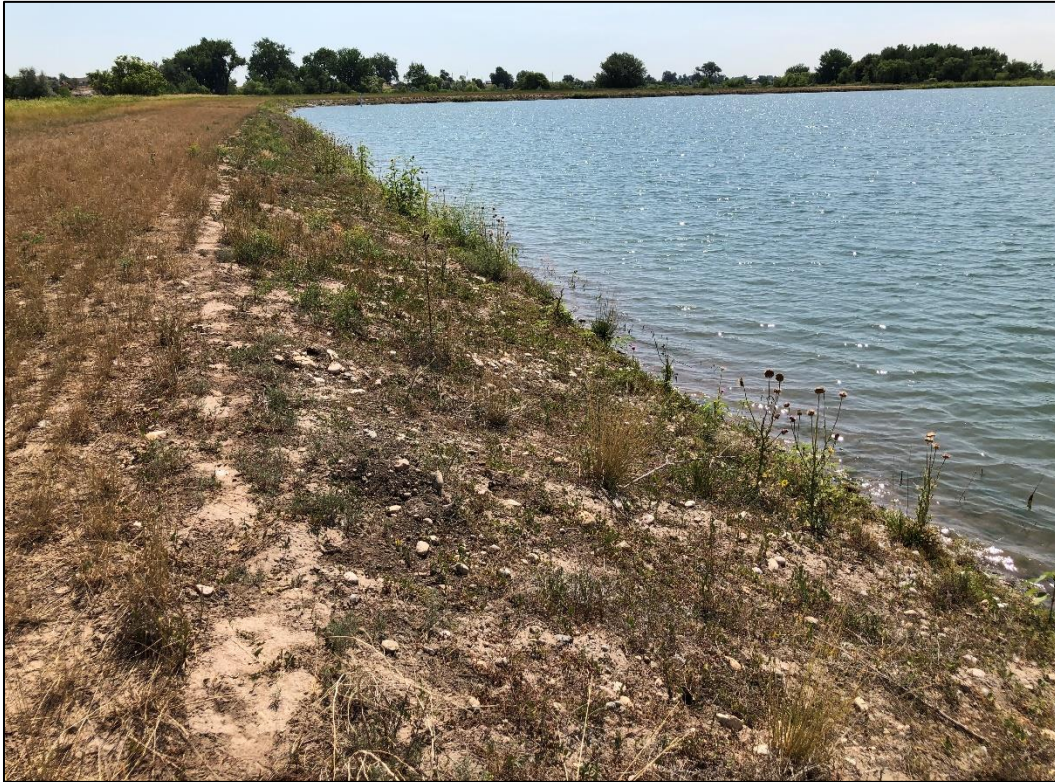
Photo 23. View looking east across northern shoreline of DiTullio phase 4 reservoir, showing slopes graded to stable configuration. Vegetative cover along slopes consists of grasses and weeds. Additional weed management is required, particularly for Canada thistle and field bindweed. Additional interseeding may also be necessary.

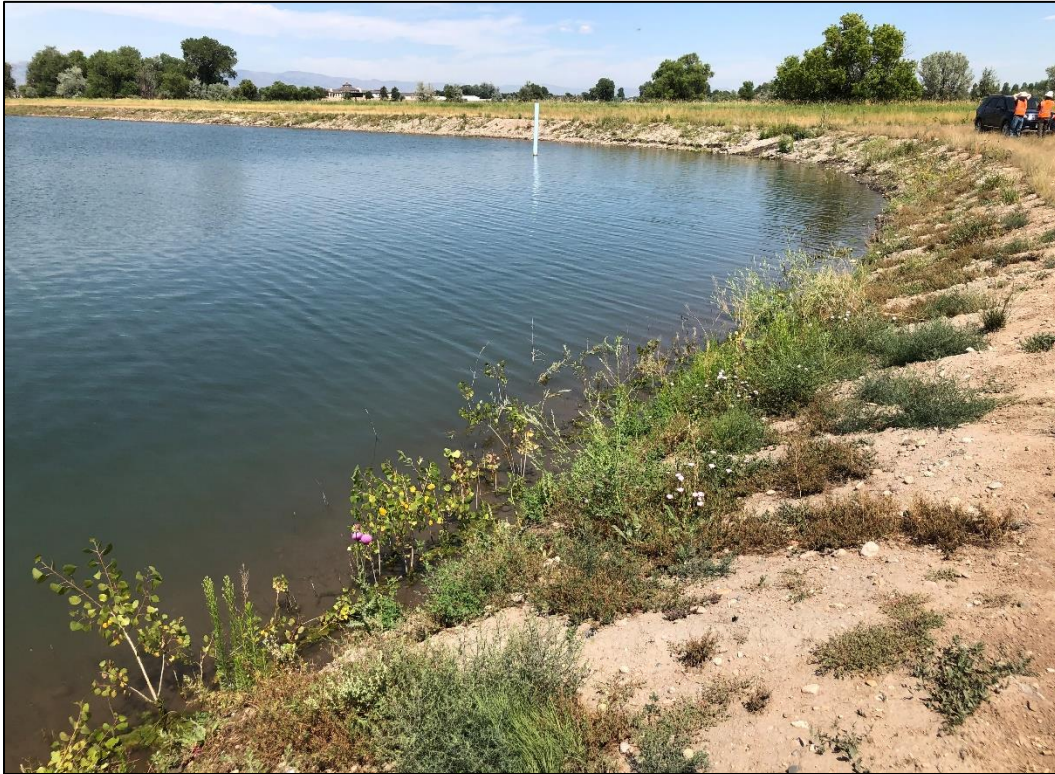
Photo 25. View looking north across northeastern shoreline of DiTullio phase 4 reservoir, showing slopes graded to stable configuration. However, vegetative cover along slopes is sparse consisting primarily of weeds. Additional weed management and interseeding is required in this area. Also note volunteer trees growing along shoreline which must be removed.

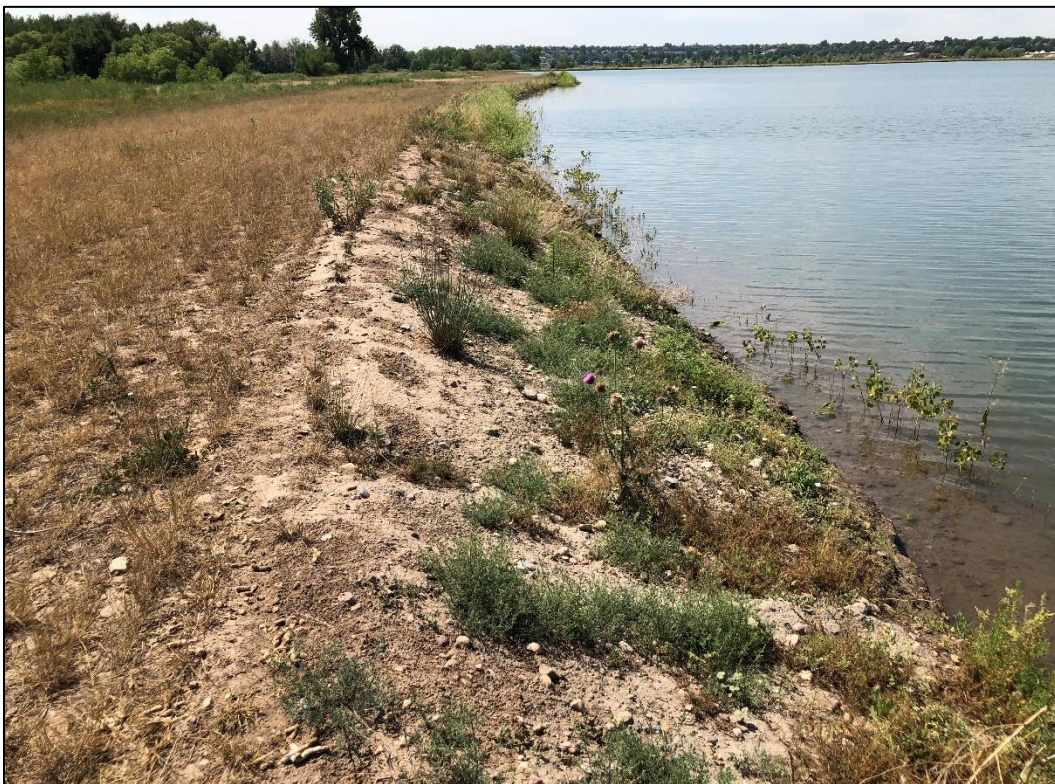
Photo 26. View looking south across northeastern shoreline of DiTullio phase 4 reservoir, showing slopes graded to stable configuration. However, vegetative cover along slopes is sparse consisting primarily of weeds. Additional weed management and interseeding is required in this area. Also note volunteer trees growing along shoreline which must be removed.

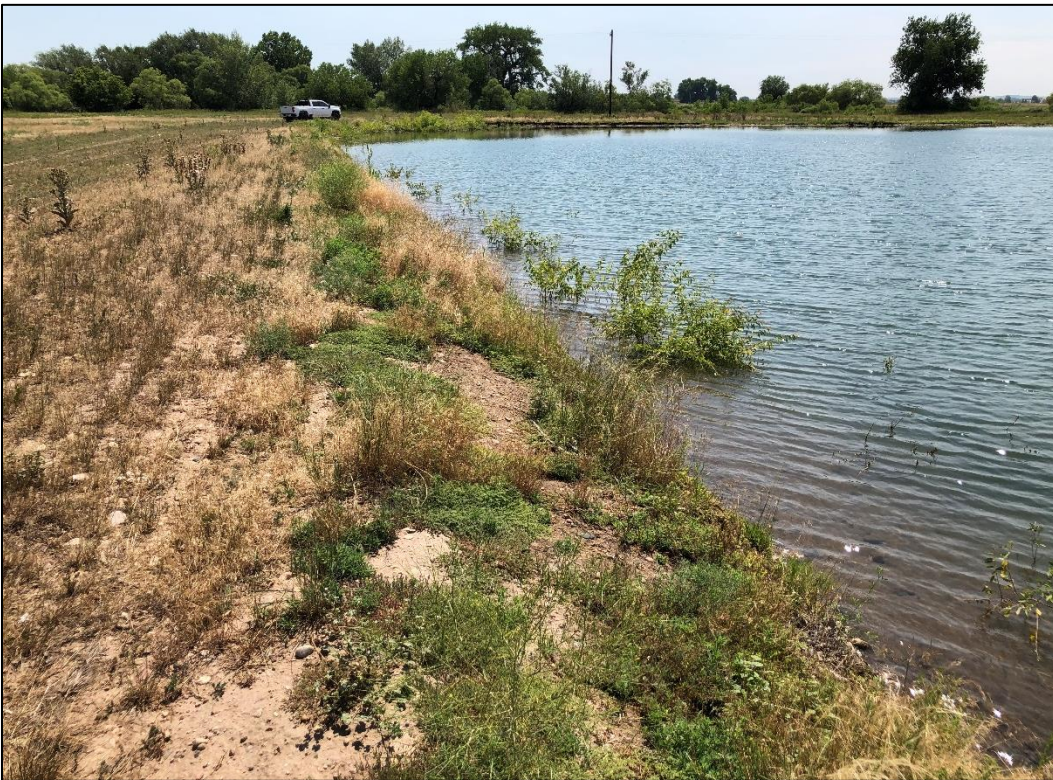
Photo 32. View looking south across eastern shoreline of DiTullio phase 4 reservoir, showing slopes graded to stable configuration. However, vegetative cover along slopes consists primarily of weeds. Additional weed management and interseeding is required in this area. Also note volunteer trees growing along shoreline which must be removed.

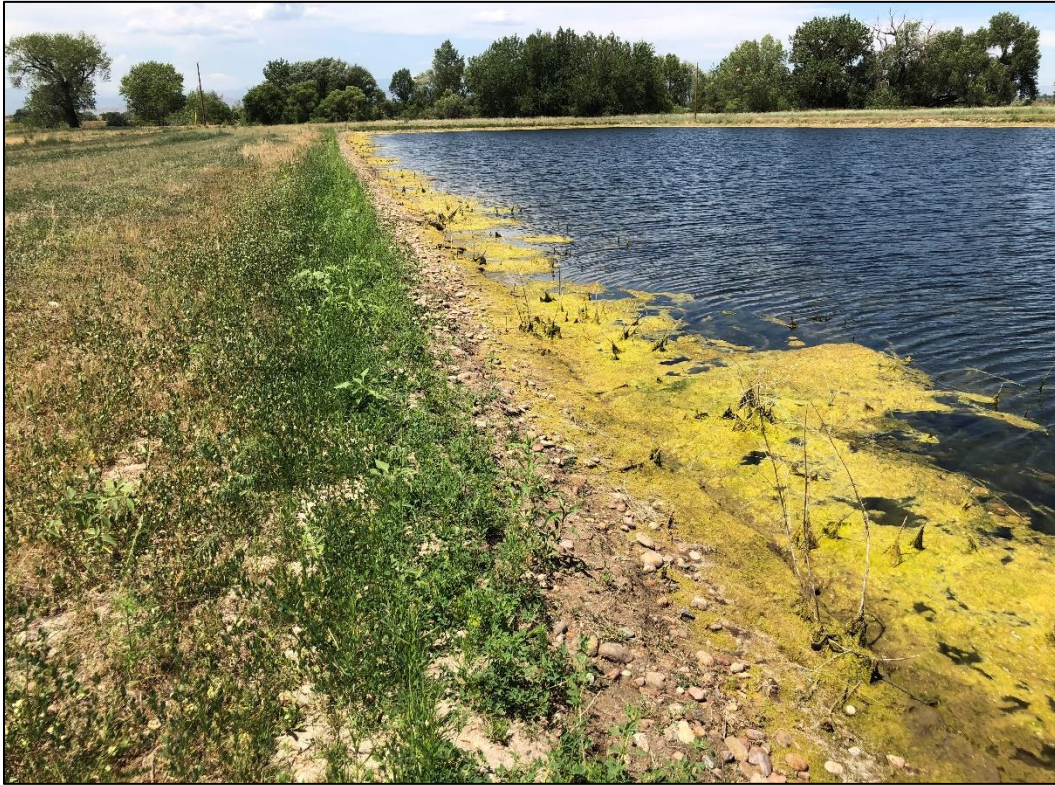
Photo 41. View looking west across southern shoreline of DiTullio phase 1 reservoir, showing slopes graded to stable configuration. Vegetative cover along slopes consists of grasses and weeds (Canada thistle, field bindweed, kochia). Additional weed management is required.

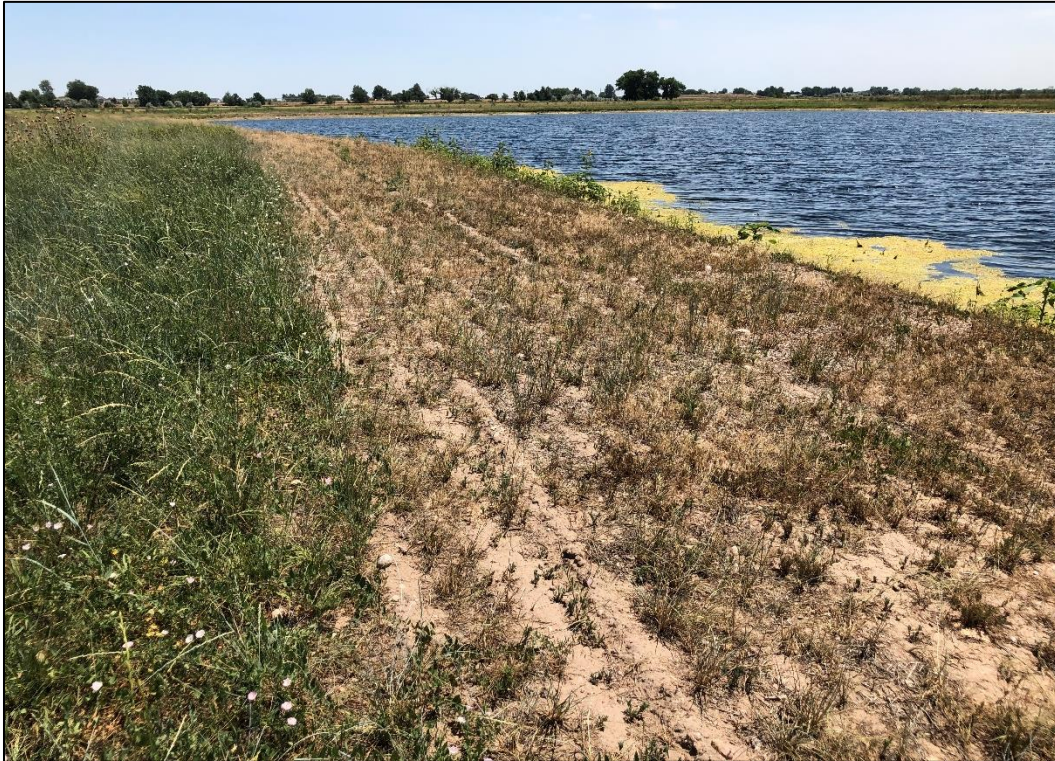
Photo 45. View looking northeast across area north of DiTullio phase 1 reservoir, showing fairly sparse vegetative cover in area adjacent to reservoir (at right) and established grasses in area approx. 20-25 feet out from reservoir (at left). Additional weed management is required, particularly for Canada thistle, field bindweed, and downy brome. Additional interseeding may also be necessary.

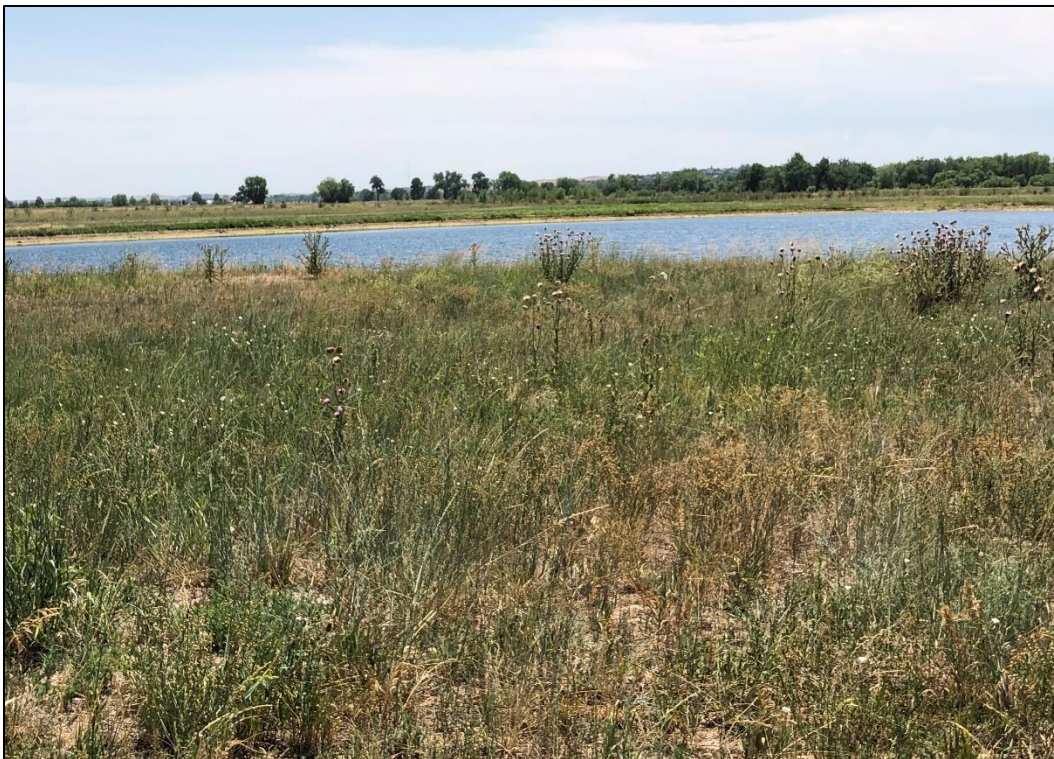
Photo 48. View looking south across area north of DiTullio phase 1 reservoir, showing area with good grass establishment. Additional weed management is required, particularly for leafy spurge, Canada thistle, field bindweed, and downy brome.

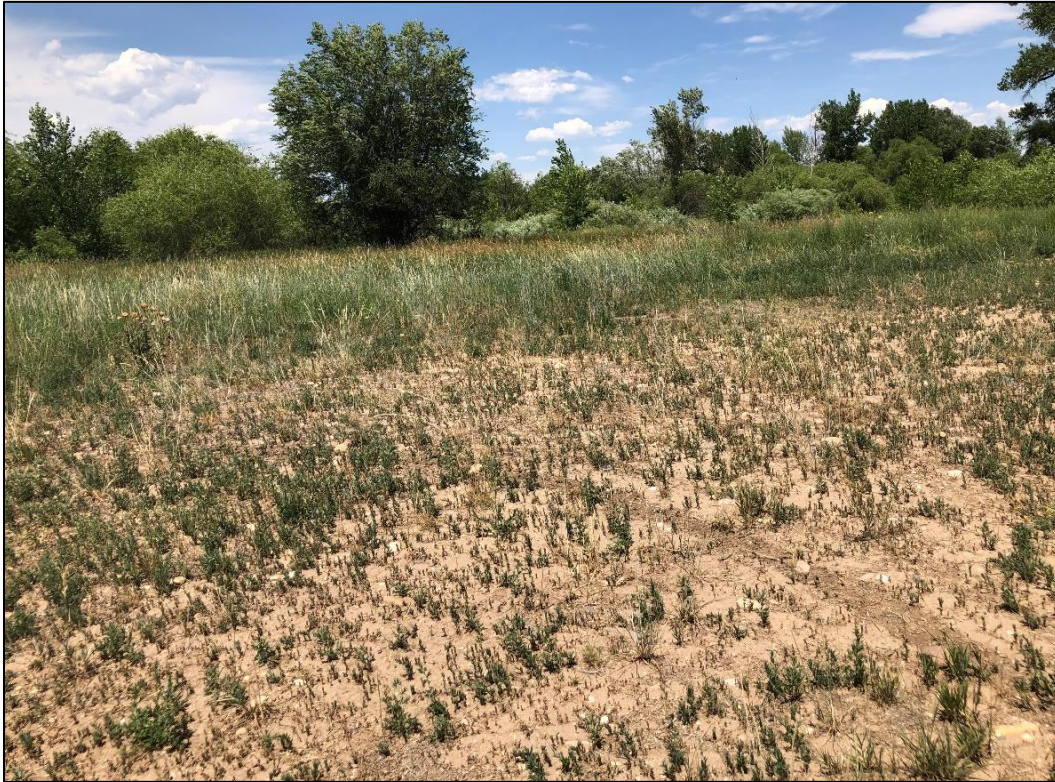
Photo 51. View looking north across area northeast of DiTullio phase 1 reservoir, showing vegetative cover fairly sparse in some areas (in foreground) consisting primarily of weeds. Additional weed management is required in this area. Additional interseeding may also be necessary.

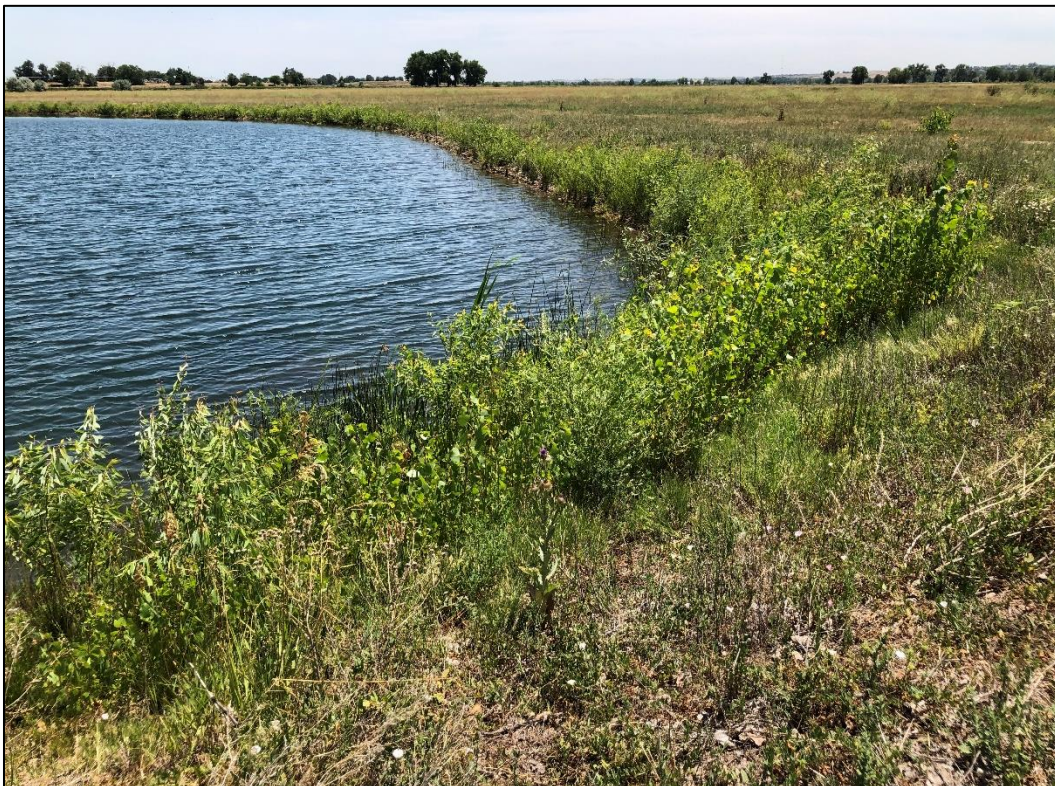
stable with good grass cover. The Division observed volunteer trees (mainly cottonwoods and willows) growing along the shorelines of the phase 3 reservoir. As mentioned above, the roots of these trees could compromise the integrity of the clay liner, and therefore, the trees will need to be removed from the shorelines of the reservoir. Vegetative cover in areas around the reservoir consists of grasses and weeds, including kochia, wild sunflowers, and the noxious weed species Canada thistle, field bindweed, and downy brome. The Division also recalls observing some patches of the noxious weed species leafy spurge growing in the area south of the reservoir. Additional weed management is required in these areas, especially for state-listed noxious weed species. There were some areas observed around the reservoir, particularly north and south of the reservoir, with sparser vegetative growth consisting primarily of weeds. The Division recommends the operator continue to monitor revegetation success in areas around the phase 3 reservoir, and reseed as necessary.

Photo 52. View looking northeast across eastern shoreline of DiTullio phase 3 reservoir, showing slopes graded to stable configuration and well-vegetated. Volunteer trees (e.g., cottonwoods, willows) must be removed from the shoreline. Additional weed management is required in this area.

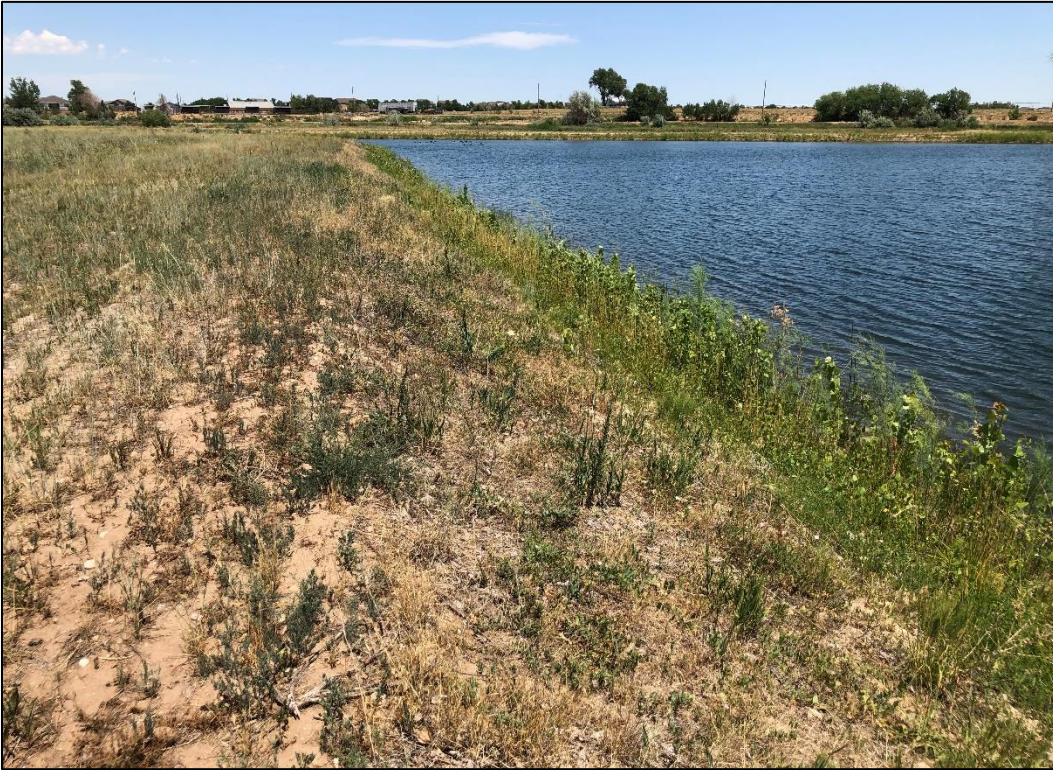
Photo 53. View looking northwest across western shoreline of DiTullio phase 3 reservoir, showing slopes graded to stable configuration and vegetated with grasses and weeds. Volunteer trees must be removed from the shoreline. Additional weed management is required in this area. Additional interseeding may also be necessary.

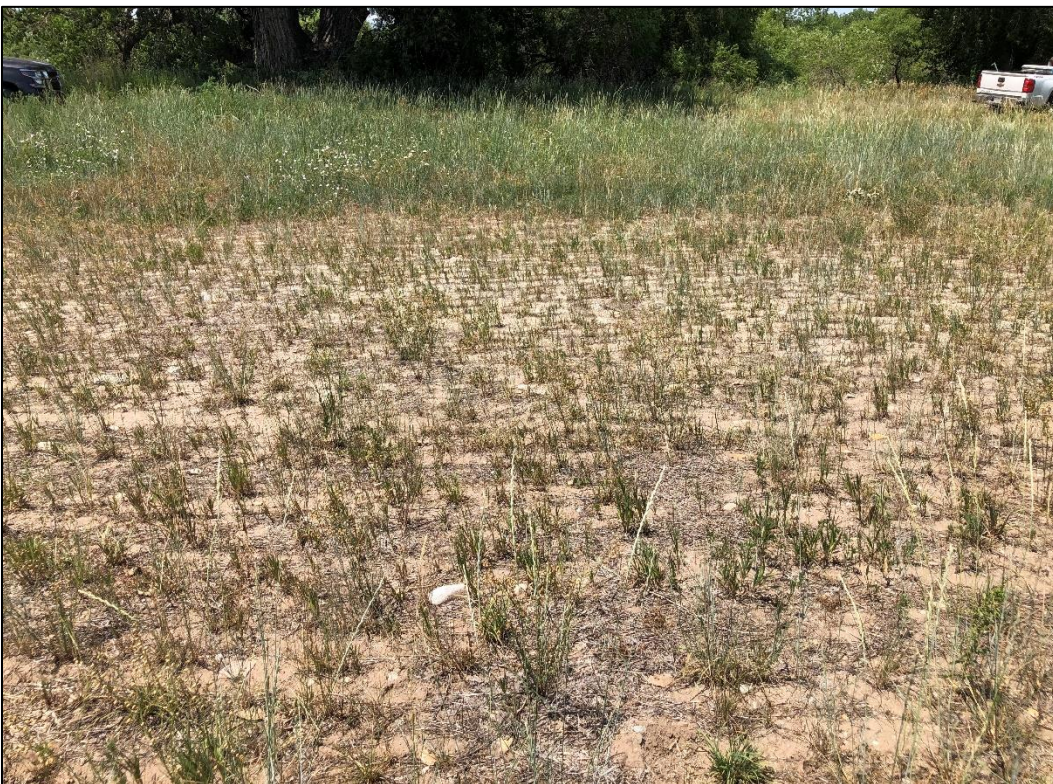
Photo 54. View looking west across area southwest of DiTullio phase 3 reservoir, showing area where grass cover is less dense. Additional weed management is required in this area. Additional interseeding may also be necessary.

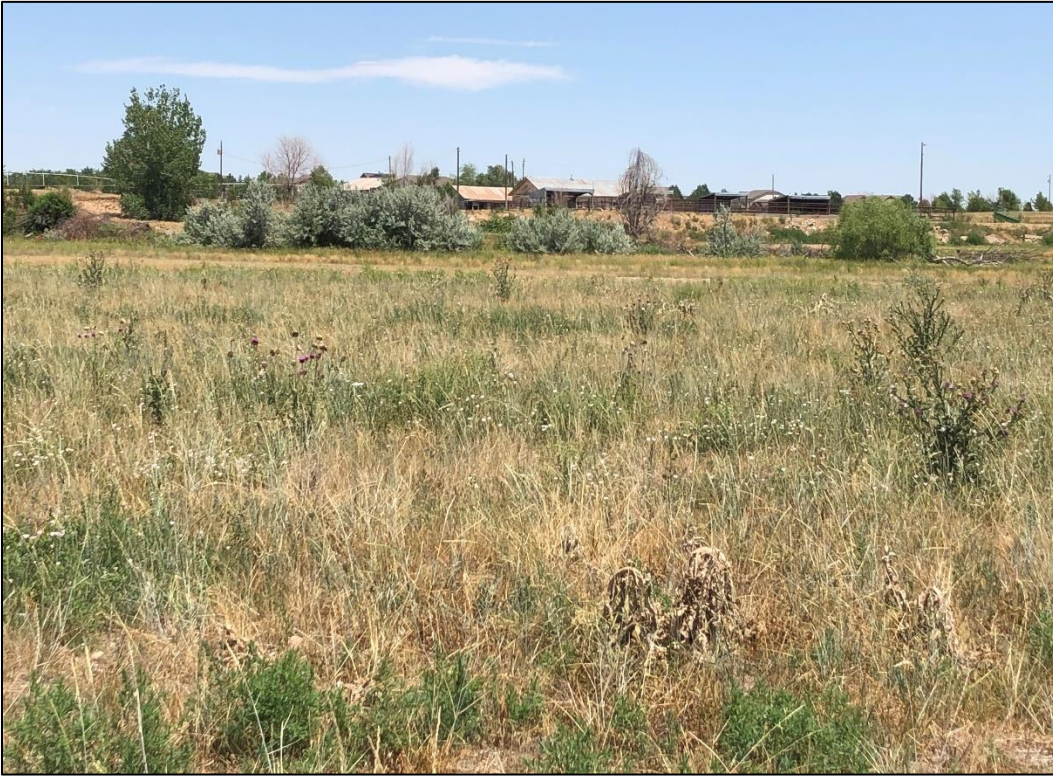
Photo 57. View looking east across area west of DiTullio phase 3 reservoir, showing area with good grass establishment but abundant weeds. Additional weed management is required, particularly for leafy spurge, Canada thistle, field bindweed, and downy brome.

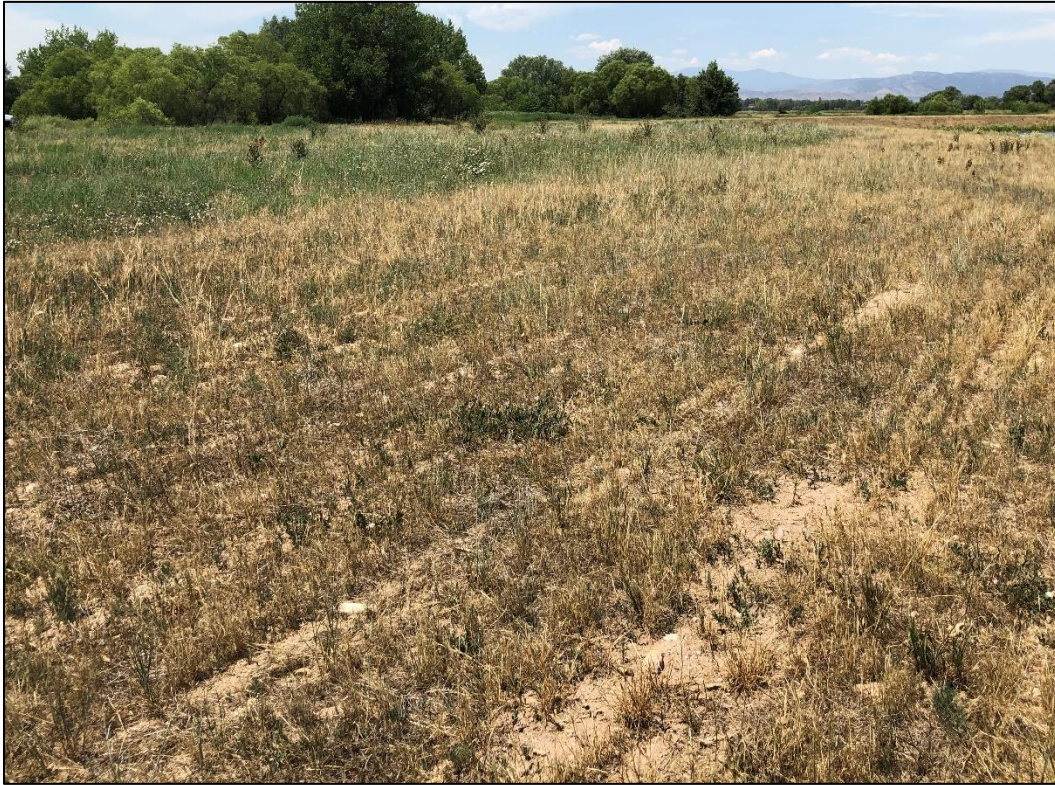
Photo 59. View looking northwest across area west of DiTullio phase 3 reservoir, showing area with good grass establishment but abundant weeds. Additional weed management is required, particularly for Canada thistle and field bindweed.

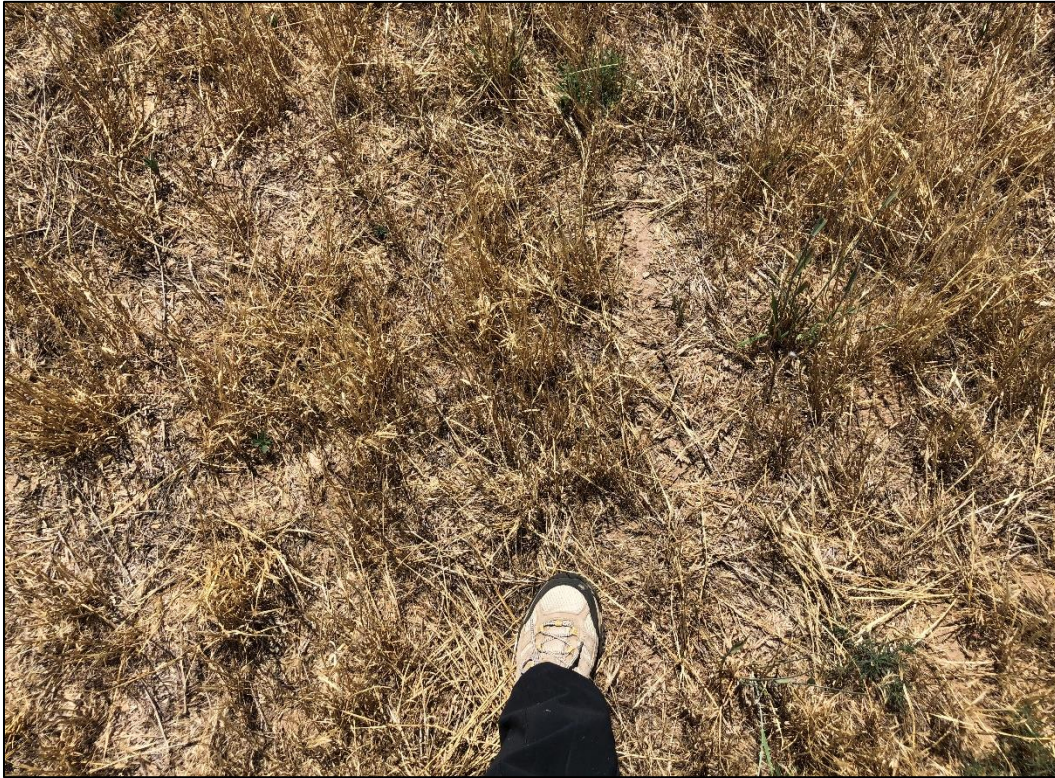
Photo 61. Closer view of ground in area west of DiTullio phase 3 reservoir, showing good grass establishment in this area. Additional weed management is required, particularly for Canada thistle and field bindweed.

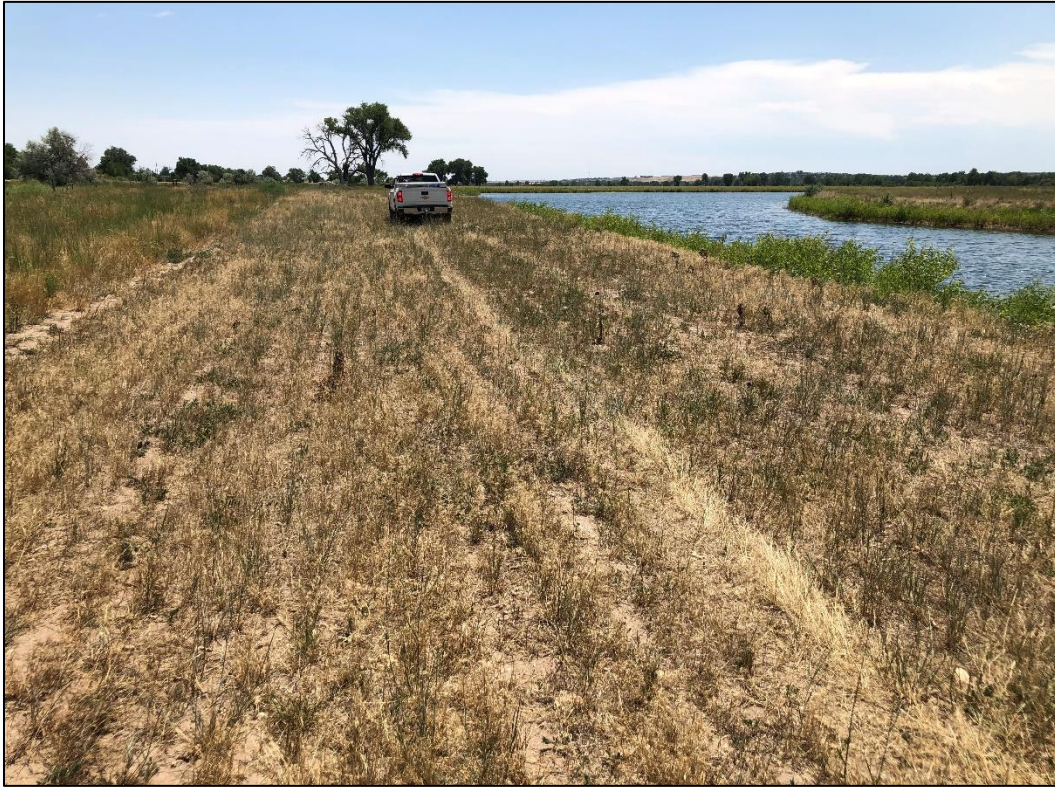
Photo 63. View looking southeast across area north of DiTullio phase 3 reservoir, showing vegetative cover consisting of grasses and some weeds. Additional weed management is required in this area, particularly for Canada thistle and field bindweed.

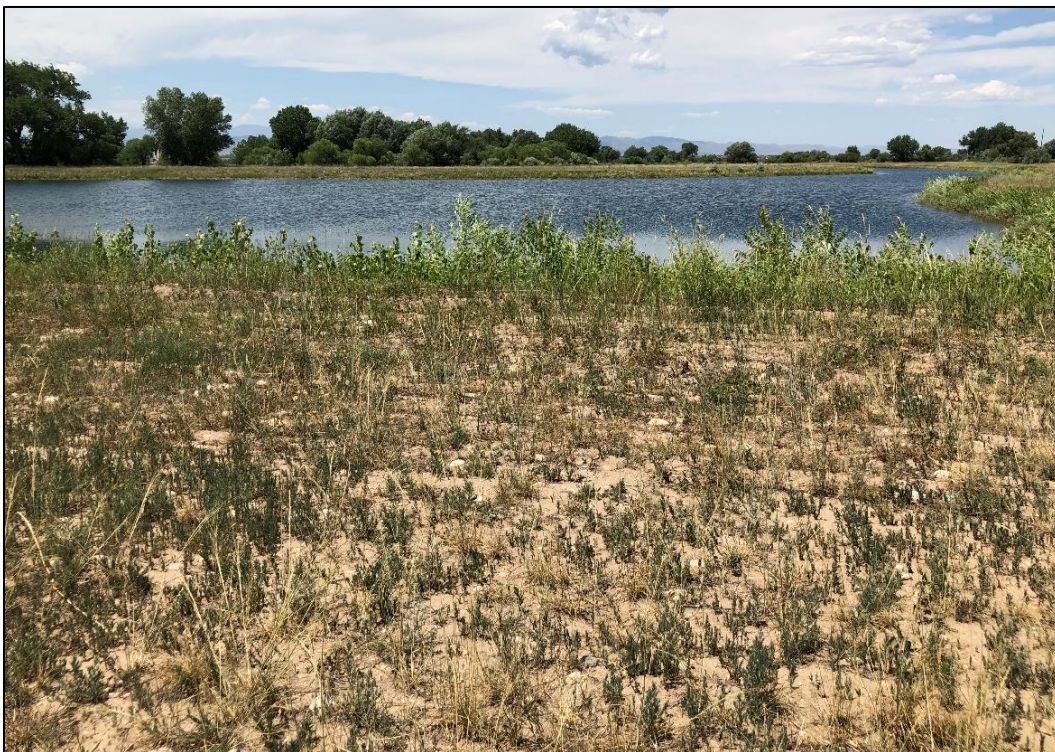
Photo 66. View looking northwest across area southeast of DiTullio phase 3 reservoir, showing area with fairly sparse vegetative cover consisting of grasses and abundant weeds. Additional weed management is required in this area. Additional interseeding may also be necessary.

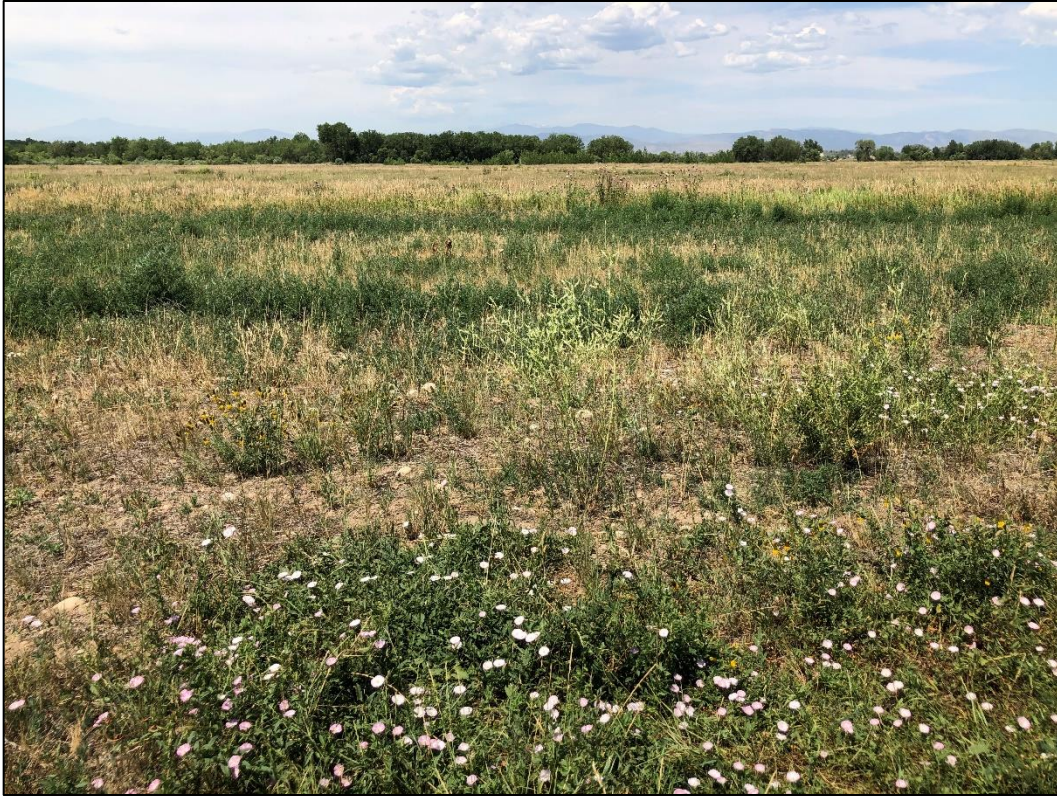
Photo 75. View looking northwest across area northwest of Veldman reservoir, showing area with good establishment of grasses but abundant weeds. Additional weed management is required in this area, particularly for field bindweed and downy brome.

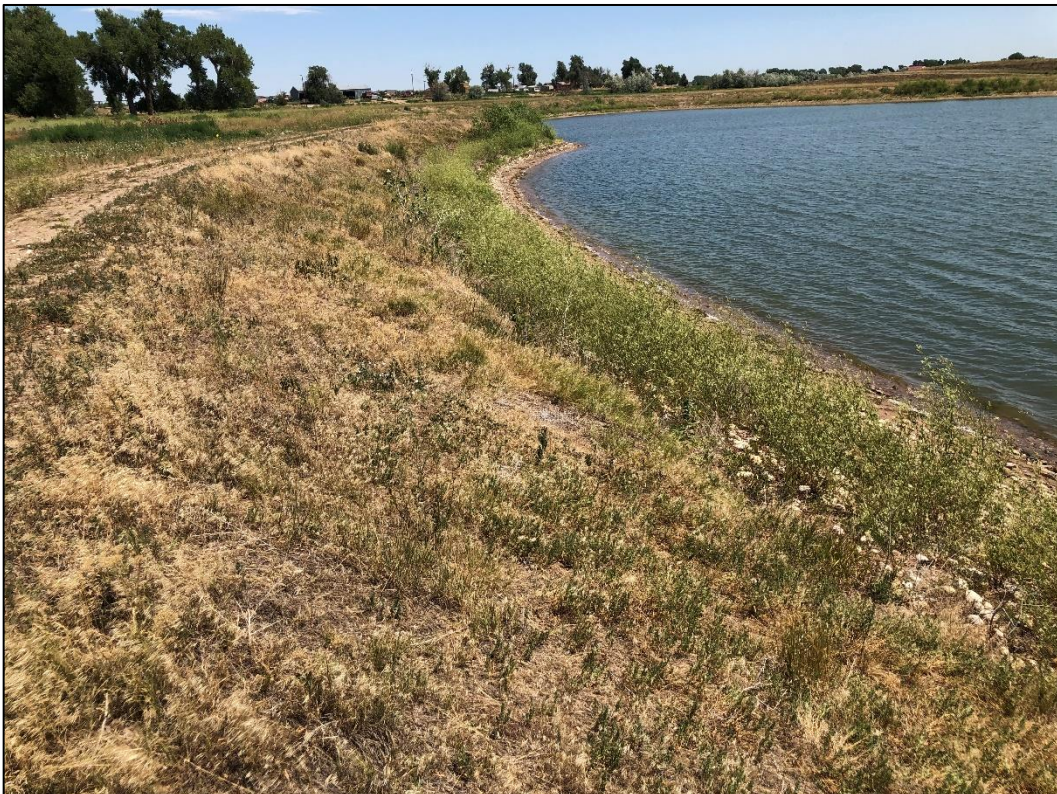
Photo 76. View looking north across western shoreline of Veldman reservoir, showing slopes at a stable configuration with good grass cover. Additional weed management is required in this area.
