MINERALS PROGRAM INSPECTION REPORT
PHONE: (303) 866-3567

MINE NAME: Three Bells Pit	MINE/PROSPECTING ID#: M-1979-191	MINERAL: Sand and gravel	COUNTY: Larimer
INSPECTION TYPE: Surety Release Inspection	INSPECTOR(S): Amy Eschberger	INSP. DATE: July 16, 2020	INSP. TIME: 10:00
OPERATOR: Martin Marietta Materials, Inc.	OPERATOR REPRESENTATIVE: Julie Mikulas	TYPE OF OPERATION: 112c - Construction Regular Operation	
REASON FOR INSPECTION: Surety Release Requested	BOND CALCULATION TYPE: Complete Bond	BOND AMOUNT: \$3,294,000.00	
DATE OF COMPLAINT: NA	POST INSP. CONTACTS: None	JOINT INSP. AGENCY: None	
WEATHER: Clear	INSPECTOR'S SIGNATURE:

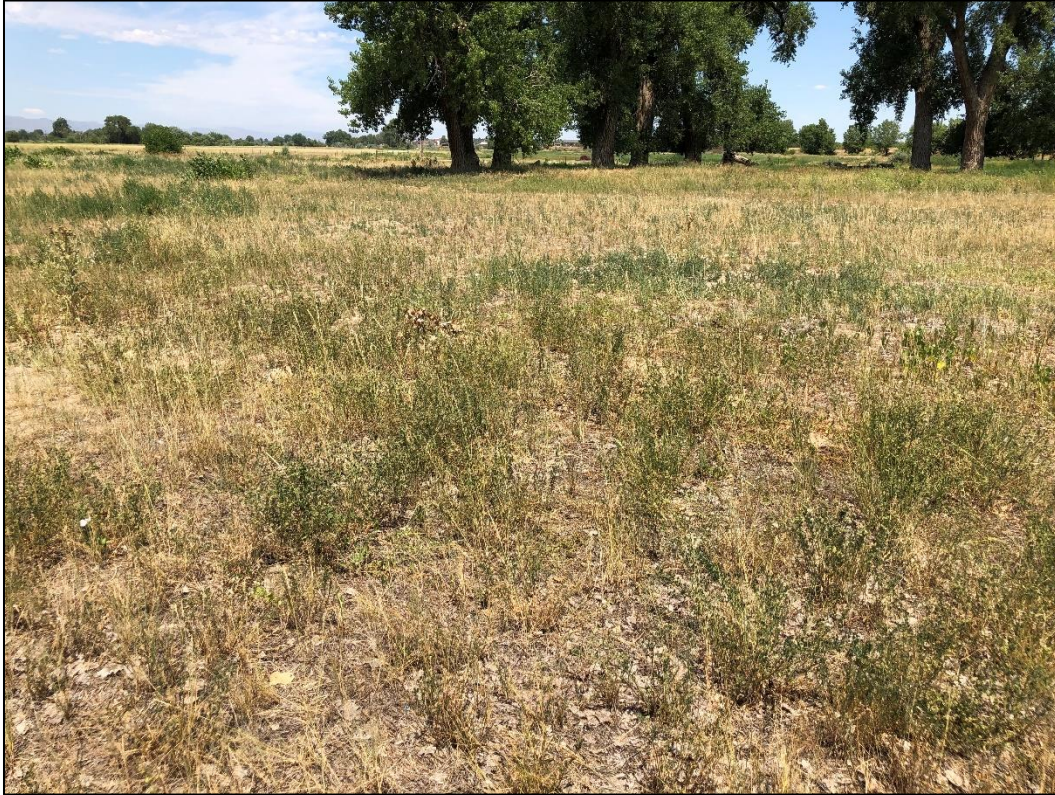
Photo 77. View looking north across area northwest of Veldman reservoir, showing good grass establishment in this area. However, additional weed management is required, particularly for Canada thistle, field bindweed, and downy brome.

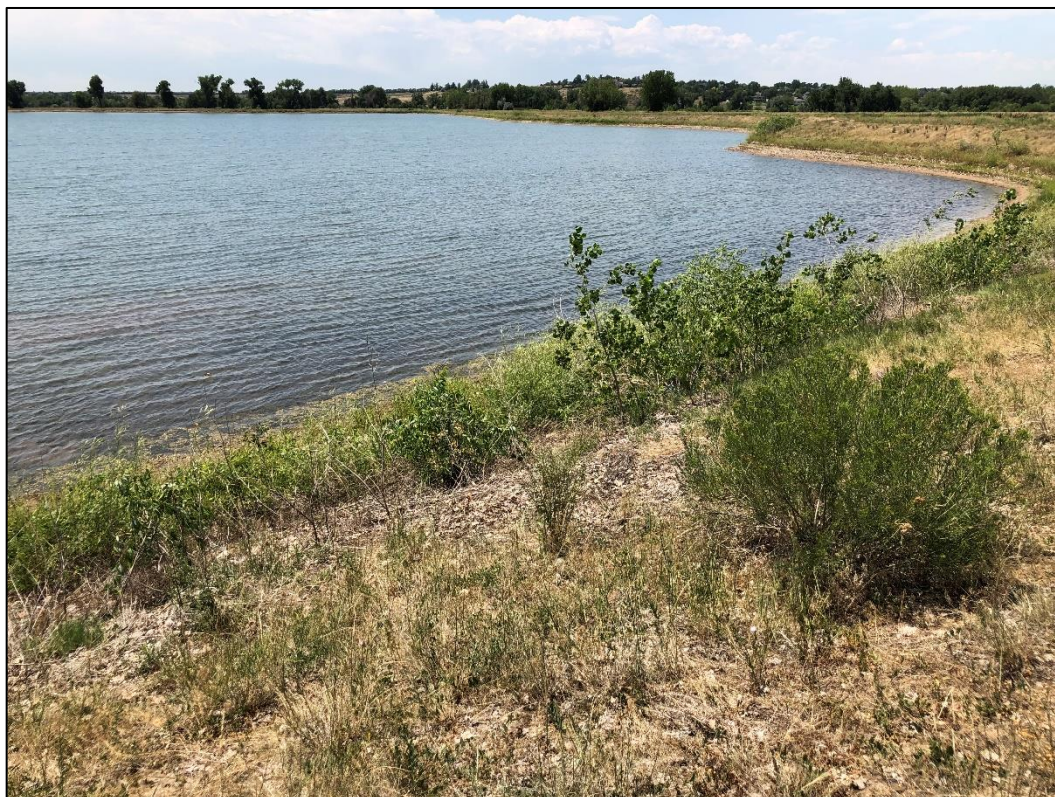
Photo 78. View looking southwest across northwestern shoreline of Veldman reservoir, showing slopes at a stable configuration with good grass cover. Volunteer trees must be removed from the shoreline. Additional weed management is required.

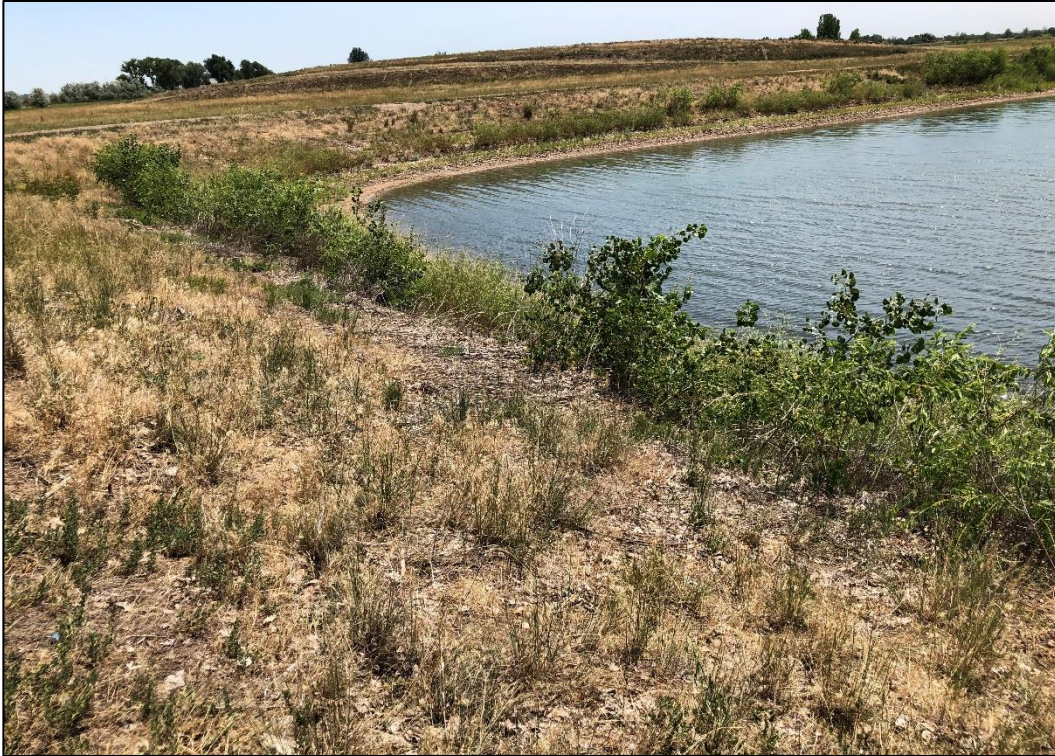
Photo 79. View looking northeast across northwestern shoreline of Veldman reservoir, showing slopes at a stable configuration with good grass cover. Volunteer trees must be removed from the shoreline. Additional weed management is required.

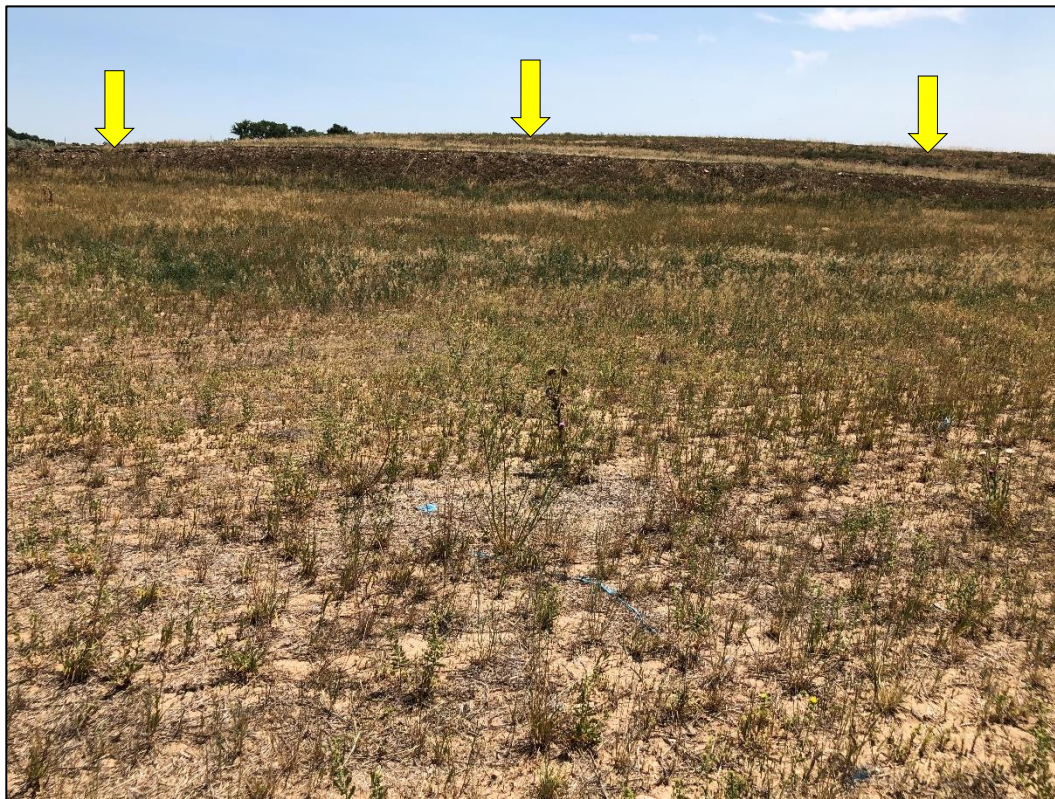
Photo 80. View looking east toward large overburden stockpile (indicated) left in area north of Veldman reservoir, graded to a stable configuration and well vegetated. Additional weed management is required in this area, particularly for Canada thistle, field bindweed, and downy brome. Additional interseeding may also be necessary.

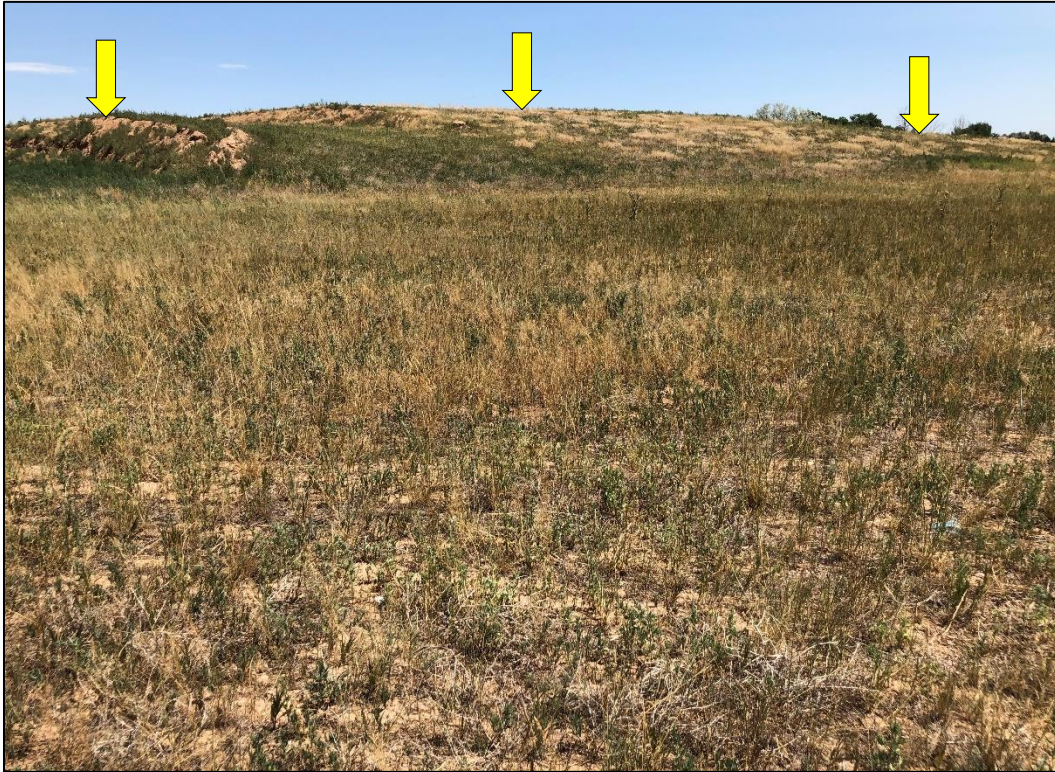
Photo 81. View looking northeast toward large overburden stockpile (indicated) left in area north of Veldman reservoir, graded to a stable configuration and well vegetated. This area has good grass establishment. However, additional weed management is required, particularly for Canada thistle, field bindweed, and downy brome.

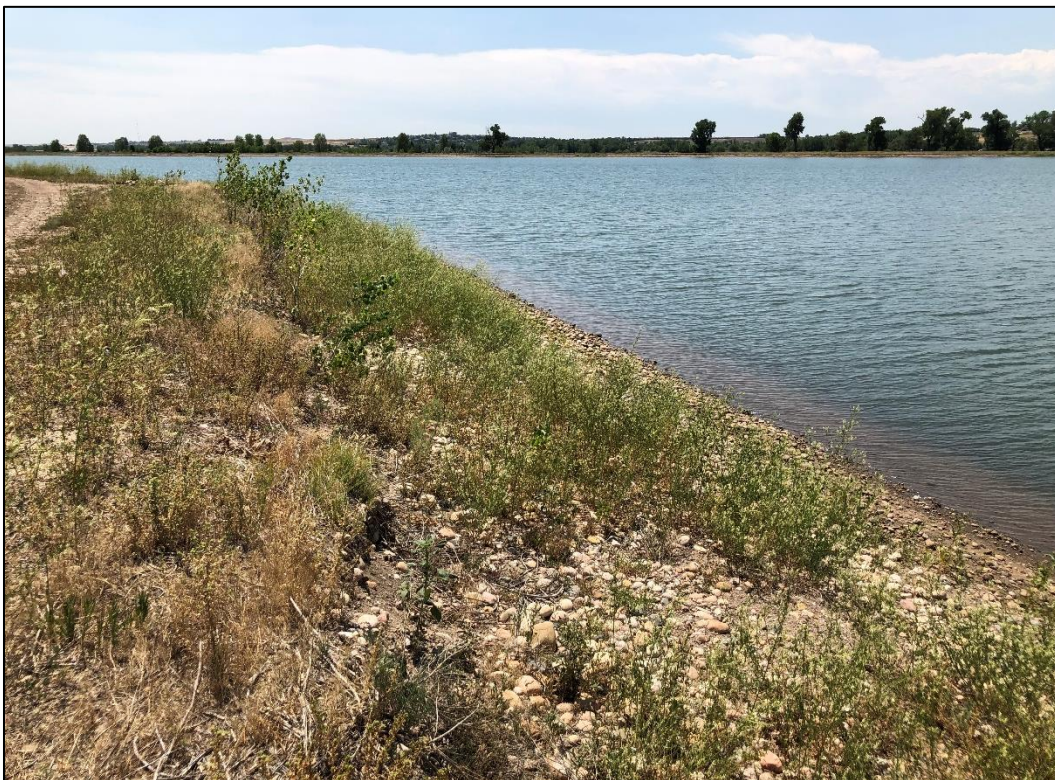
Photo 82. View looking southwest across northern shoreline of Veldman reservoir, showing slopes at a stable configuration with good grass cover. Volunteer trees must be removed from the shoreline. Additional weed management is required.

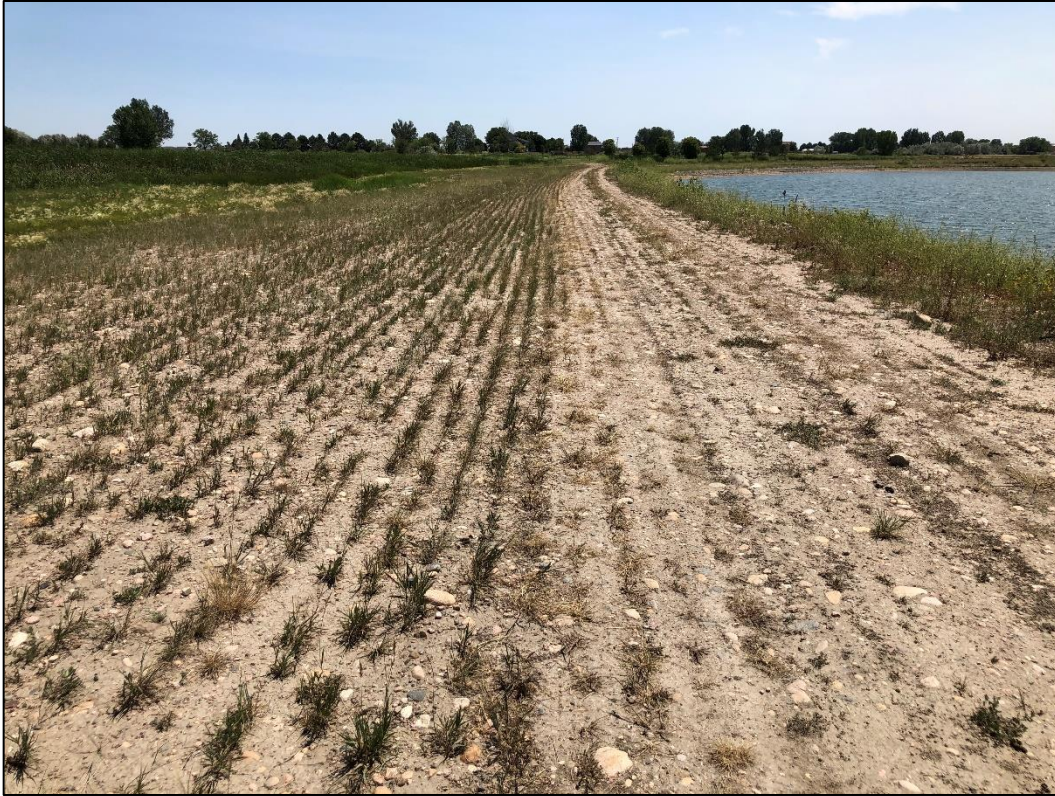
Photo 83. View looking east across area north of Veldman reservoir, showing haul road that remains (at right) and areas of fairly sparse vegetative growth adjacent to haul road (at left). Additional weed management is required in this area. Additional interseeding may also be necessary.

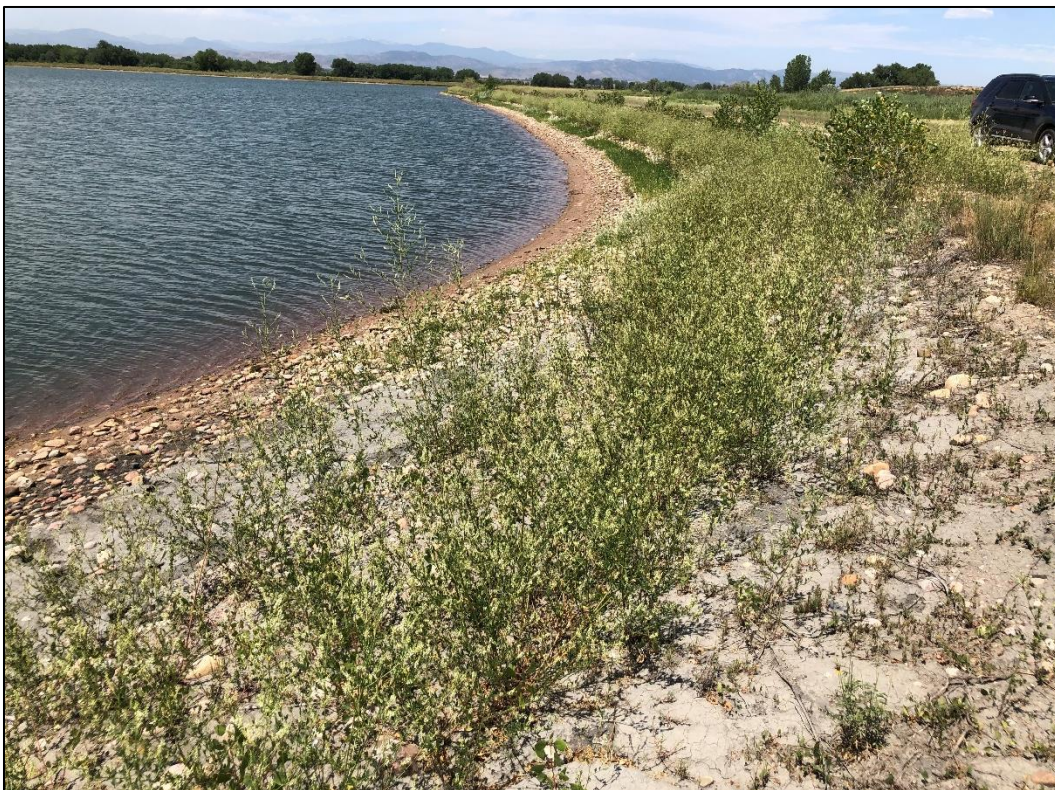
Photo 84. View looking northwest across northeastern shoreline of Veldman reservoir, showing slopes at a stable configuration with fairly good vegetative cover. Volunteer trees must be removed from the shoreline. Additional weed management is required.

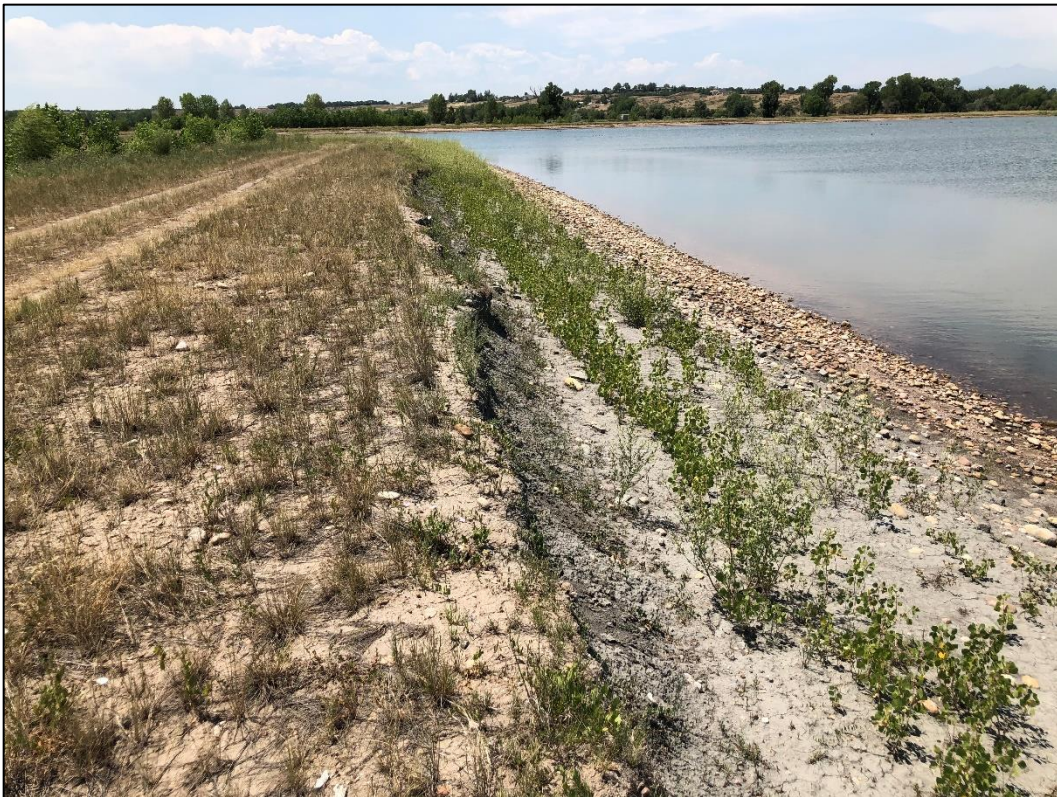
Photo 86. View looking south across eastern shoreline of Veldman reservoir, showing terraced slopes which appear to be at a stable configuration. Volunteer trees must be removed from the shoreline. Note grass growth in area adjacent to shoreline.

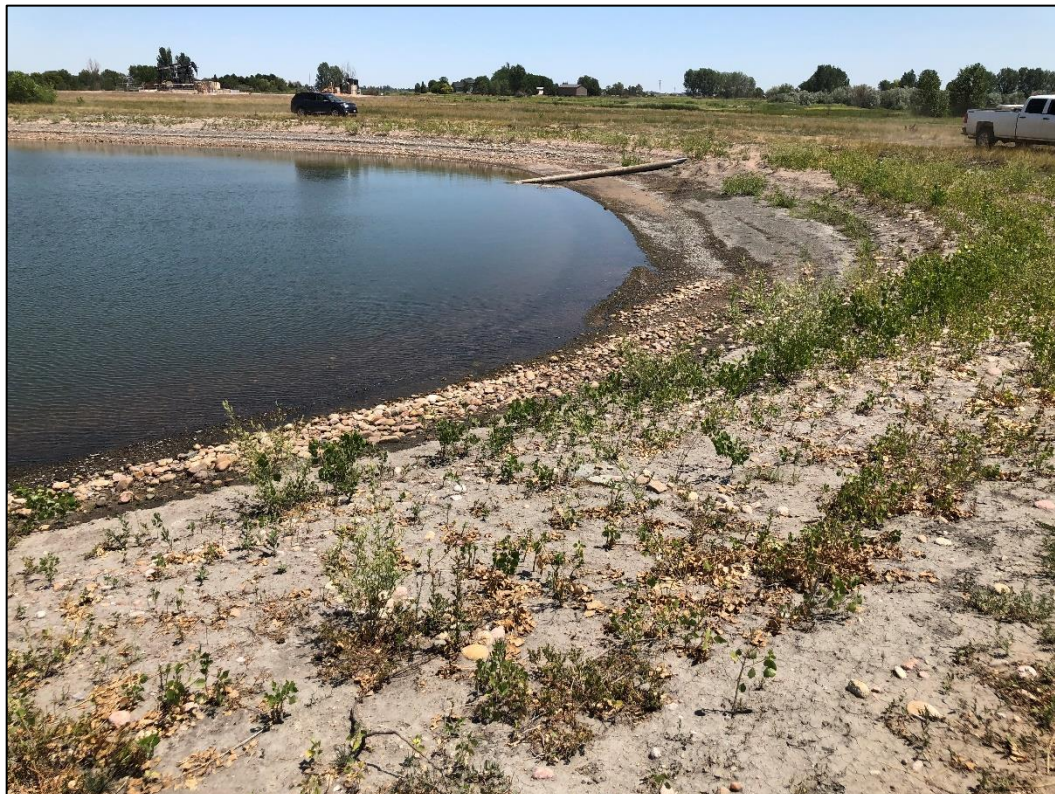
Photo 88. View looking northeast across southeastern shoreline of Veldman reservoir, showing terraced slopes which appear to be at a stable configuration. Volunteer trees must be removed from the shoreline.

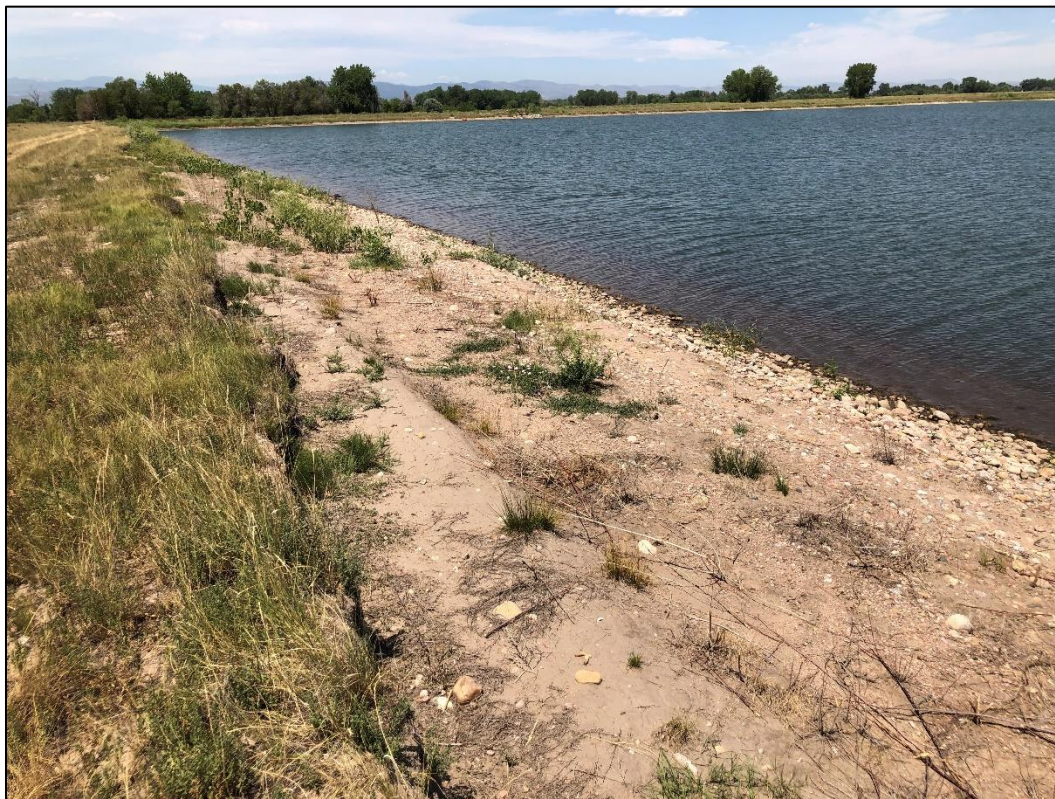
Photo 90. View looking west across southern shoreline of Veldman reservoir, showing terraced slopes which appear to be at a stable configuration. Volunteer trees must be removed from the shoreline. Note grass growth in area adjacent to shoreline.

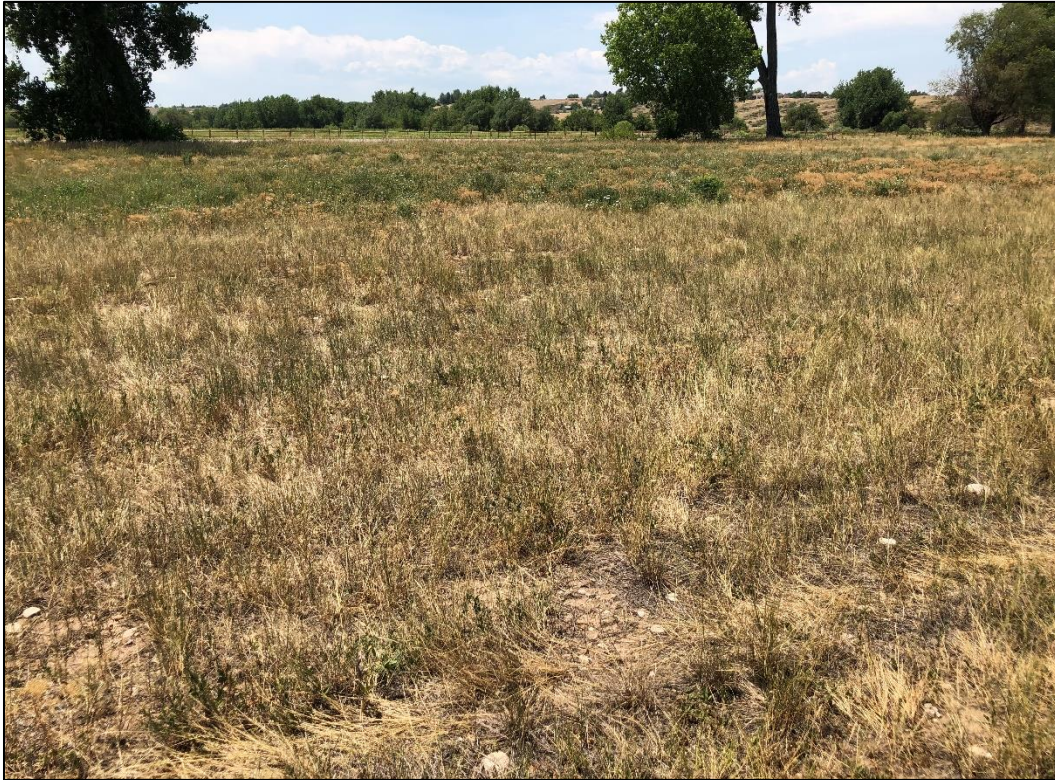
Photo 91. View looking south across area south of Veldman reservoir, showing good grass establishment in this area. However, additional weed management is required, particularly for field bindweed and downy brome.

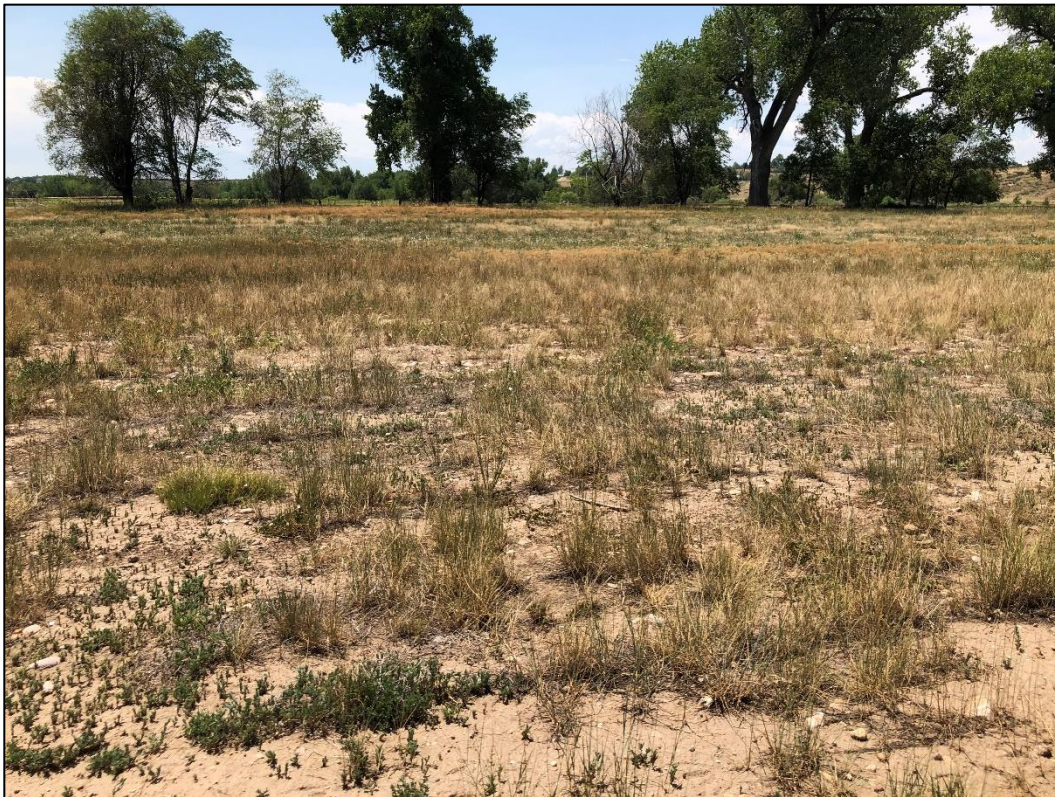
Photo 92. View looking south across area south of Veldman reservoir, showing fairly good grass establishment and abundant weeds. Additional weed management is required, particularly for field bindweed and downy brome. Additional interseeding may also be necessary.

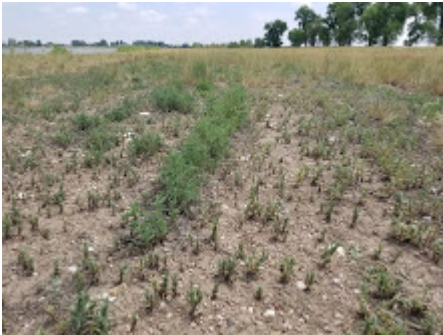
Image 3.jpg
934K

We received your letter regarding Martin Marietta Material's surety release request for the Three Bells Pit (M-1979-191). Unfortunately, we feel we must formally object to the site being released from the DRMS permit and surety bond. We (myself and Eric Reckentine from North Weld County Water District) visited the site and noted issues with reservoir shoreline erosion and unacceptable vegetation growth on both the reservoir shoreline and top of bank. More specifically: (1) There is significant erosion along most of the shoreline (Image 1). The presumed wave erosion has resulted in a fairly consistent 2 to 4 foot high steep or near vertical break between the water line and the top of bank. In addition to creating suspended sediment problems within the reservoir, uncontrolled, the erosion has the potential to impact the reservoir liner. (2) Undesirable vegetation, including trees and other woody vegetation, has taken hold along the reservoir shoreline (Image 2). Of most concern are the trees and woody vegetation that could potentially compromise the reservoir liner. (3) We believe the top of bank vegetation cover is sparse and contains a significant and unacceptable amount of weed growth (Image 3).
