Minerals Exploration/Sampling/Testing Inspection U.S. Department of the Interior Bureau of Land Management Royal Gorge Field Office

Operation Type:	□ 3802 Pre-10/21/1976	 ✓ 	3802 Post-10/21/1976 □ 3809 included
Date: Aug 6, 2020 Time: 09:10 Weather: Sunny			Operation Name: Dawson-Green Mtn., El Plomo section Operator: Zephyr Case Number: N/A CDRMS Number: P-2020-002
PIM : S Cartor I Sk	<u>Attendees</u>		<u>General</u>

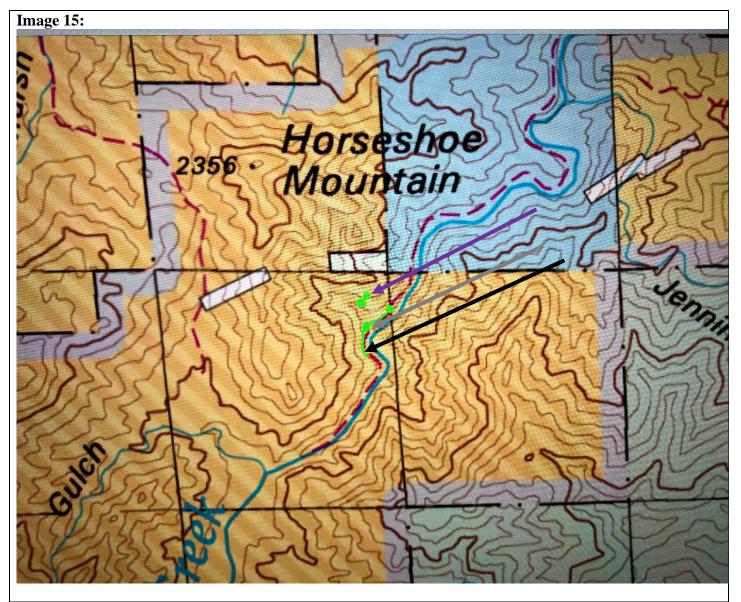
Comment: EP-20-01

Topo area snapshot with surface ownership. Black arrow is pointing to the green-highlighted part of the trail where the pump noise is audible. Purple arrow indicates location of rig platform. Gray arrow indicates helicopter landing area.

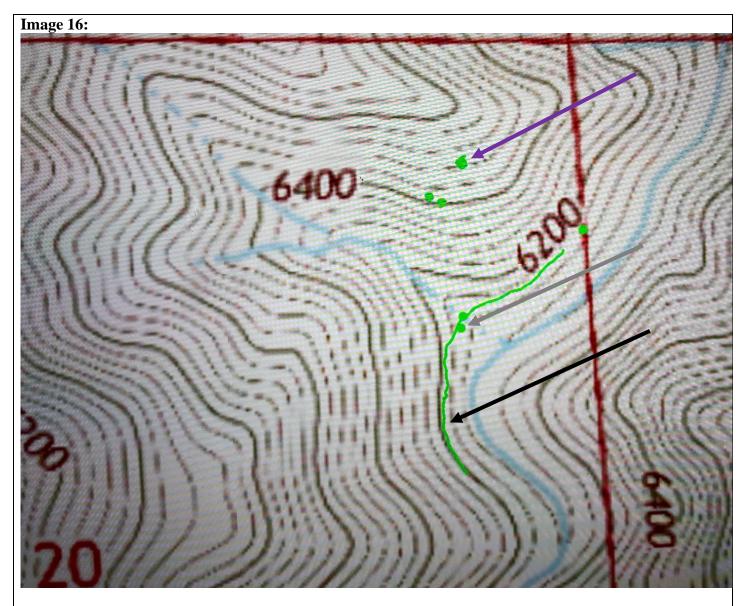
Comment: EP-20-01

Topo area snapshot. Black arrow is pointing to the green-highlighted part of the trail where the pump noise is audible. Purple arrow indicates location of rig platform. Gray arrow indicates helicopter landing area.
