**MINERALS PROGRAM INSPECTION REPORT**  
**PHONE: (303) 866-3567**

<b>MINE NAME:</b> Climax Mine	<b>MINE/PROSPECTING ID#:</b> M-1977-493	<b>MINERAL:</b> Molybdenum	<b>COUNTY:</b> Lake, Summit
<b>INSPECTION TYPE:</b> Monitoring	<b>INSPECTOR(S):</b> Stephanie Mitchell	<b>INSP. DATE:</b> August 26, 2020	<b>INSP. TIME:</b> 11:00
<b>OPERATOR:</b> Climax Molybdenum Company	<b>OPERATOR REPRESENTATIVE:</b> Alex Ungers	<b>TYPE OF OPERATION:</b> 112d-3 - Designated Mining Operation	
<b>REASON FOR INSPECTION:</b> Normal I&E Program	<b>BOND CALCULATION TYPE:</b>	<b>BOND AMOUNT:</b> \$91,011,850.00	
<b>DATE OF COMPLAINT:</b> NA	<b>POST INSP. CONTACTS:</b> None	<b>JOINT INSP. AGENCY:</b> None	
<b>WEATHER:</b> Clear	<b>INSPECTOR'S SIGNATURE:</b>

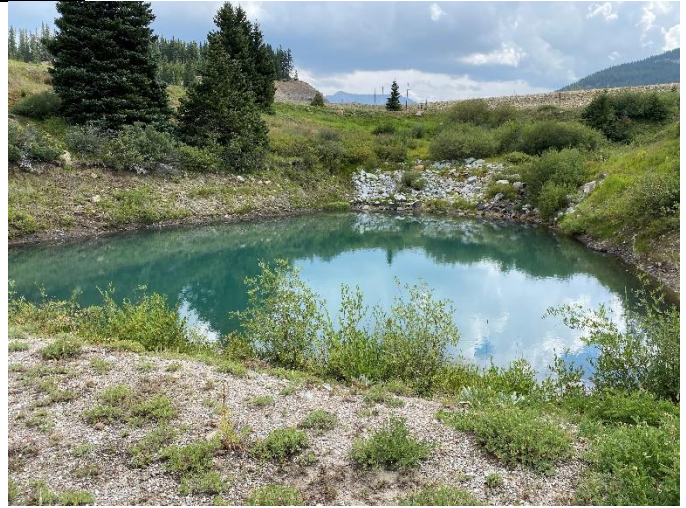
McNulty Underdrain Repair Area

Rip Rap was delivered, but no repairs were completed as of yet. Climax completed survey for underdrain pipe. Staff estimates that the repair will take 3 days to complete.
