MINERALS PROGRAM INSPECTION REPORT

MINE NAME: Nahcolite Project	MINE/PROSPECTING ID#: M-1983-194	MINERAL: Carbonates	COUNTY: Rio Blanco
INSPECTION TYPE: Monitoring	INSPECTOR(S): Amy Yeldell	INSP. DATE: October 22, 2020	INSP. TIME: 10:30
OPERATOR: Natural Soda LLC	OPERATOR REPRESENTATIVE: Kirk Daehling	TYPE OF OPERATION: 112d-3 - Designated Mining Operation	
REASON FOR INSPECTION: Normal I&E Program	BOND CALCULATION TYPE: None	BOND AMOUNT: \$3,671,965.00	
DATE OF COMPLAINT: NA	POST INSP. CONTACTS: DRMS	JOINT INSP. AGENCY: U.S.BLM	
WEATHER: Clear	INSPECTOR'S SIGNATURE:

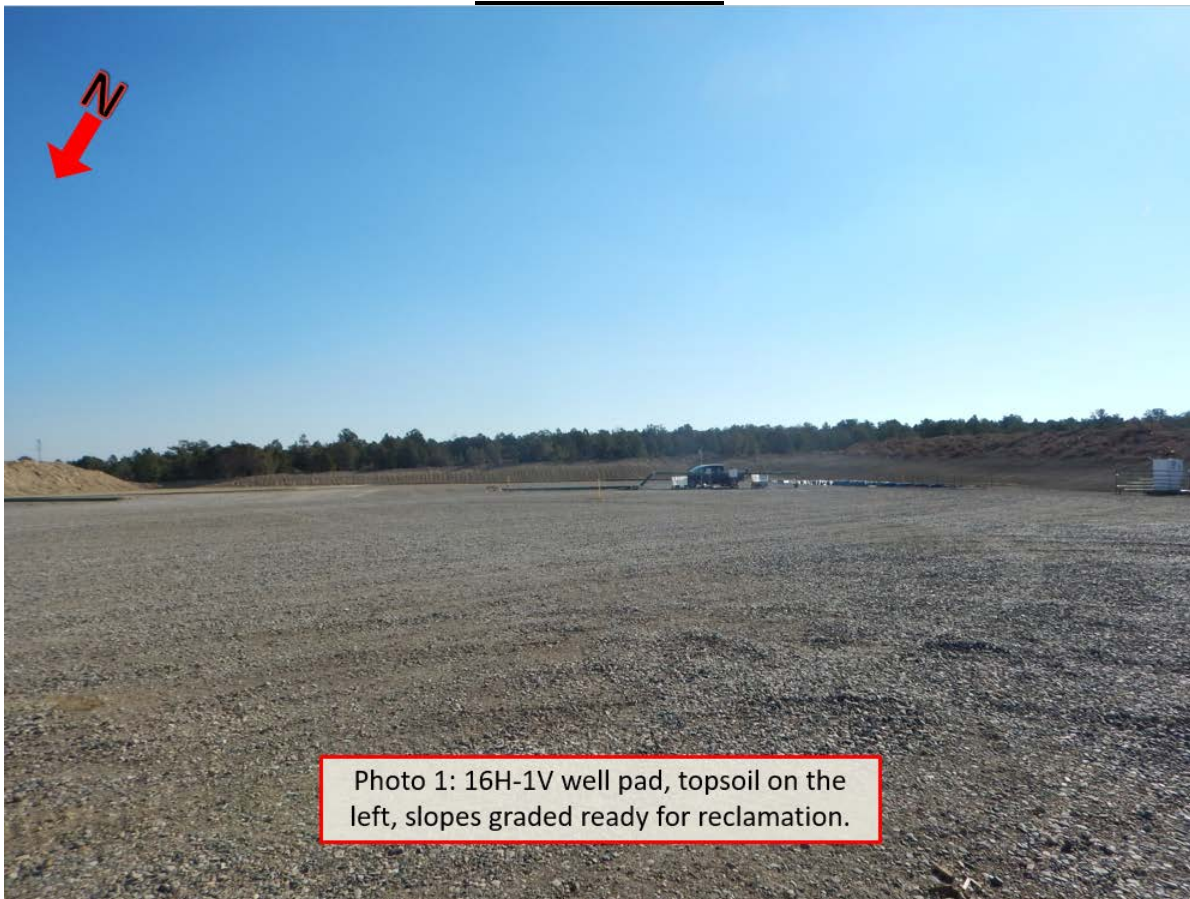
The 16H-1V well pad was inspected. This pad has been constructed since the last inspection and is nearly complete. All slopes are 3H: 1V or less and have been roughened. To date topsoil replacement and seeding has not yet occurred but is anticipated later this fall. The 16H-1V well is completed and online. The pit and liner still remain in place. The pad was built larger than currently necessary in anticipation of adding additional wells in the years to come.

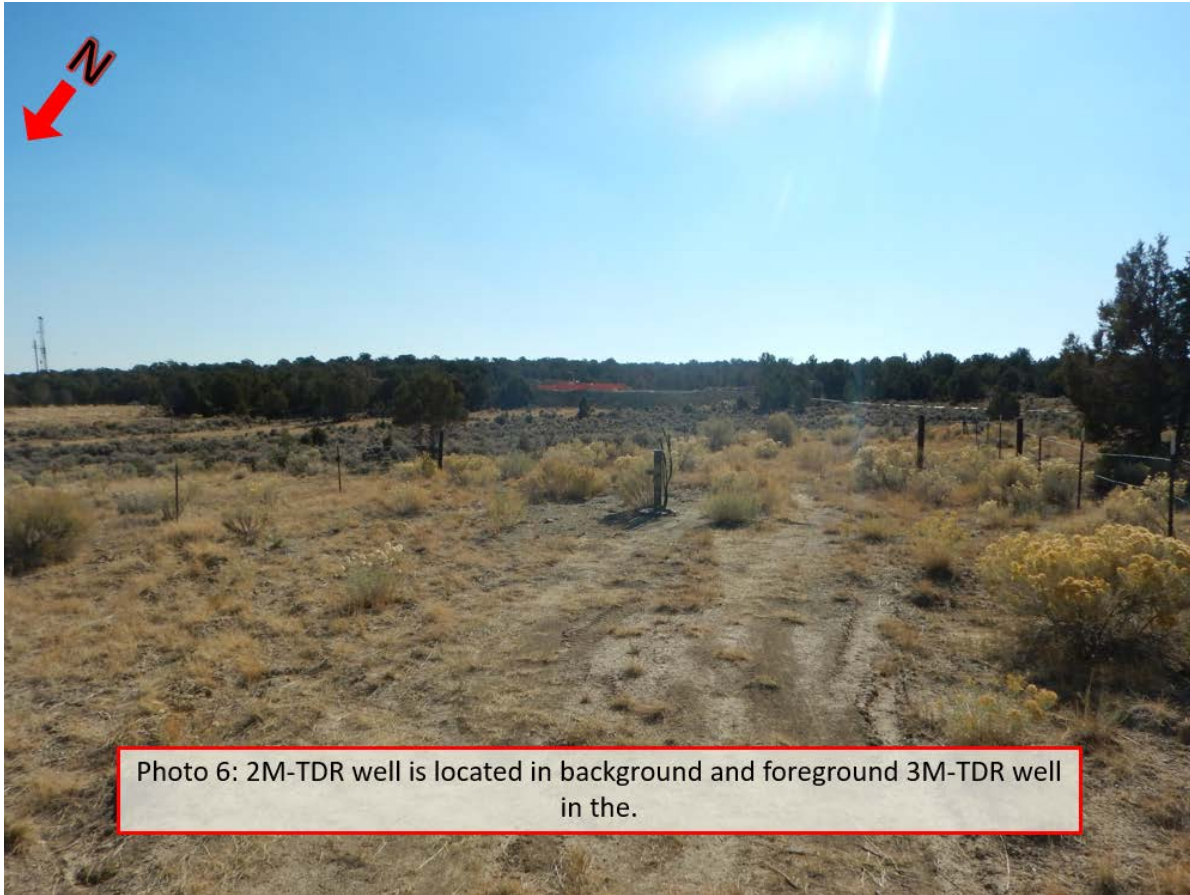
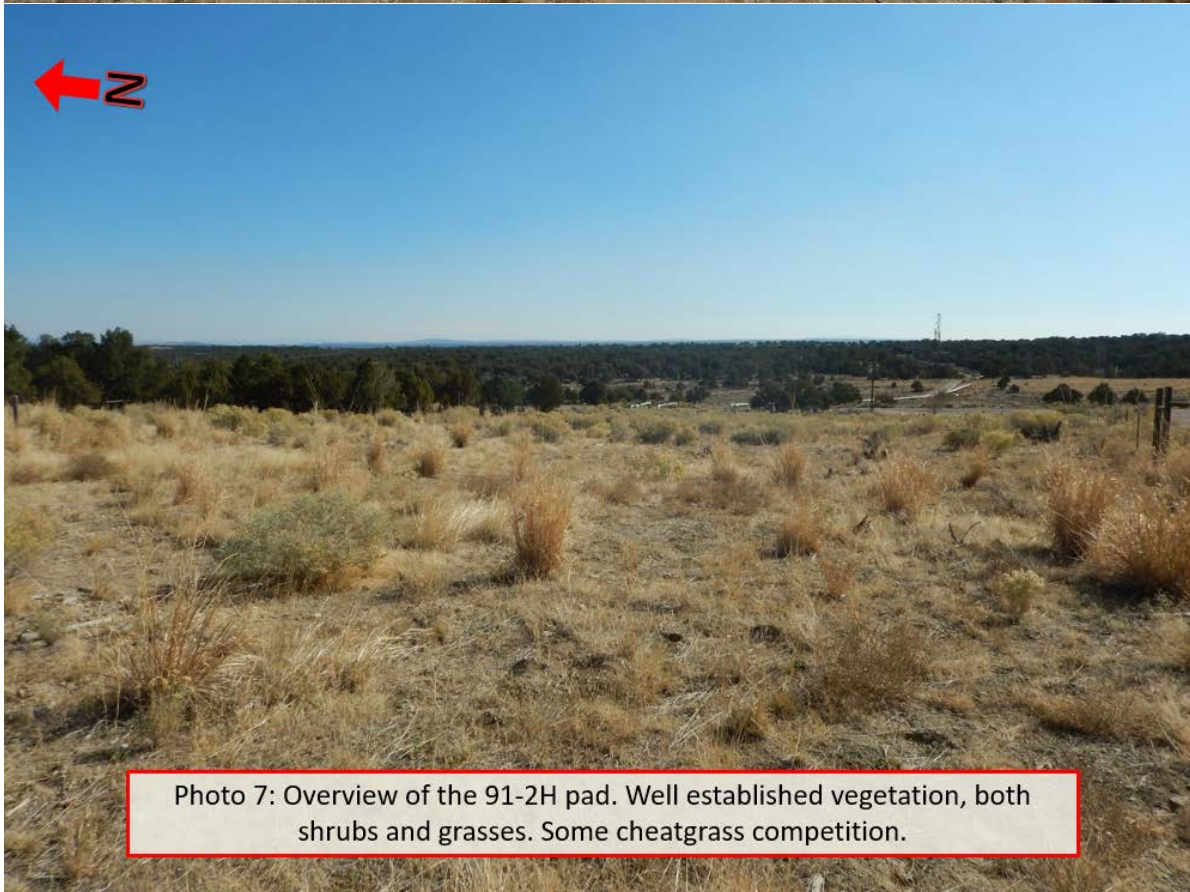
An increase in noxious weeds was observed during this inspection. The Operator disclosed to the Division that they had troubles securing a weed spraying contractor and had used three different vendors. Specific species of concern observed throughout the permit were Russian Thistle, Cheatgrass, and Halogeton. This was also an extremely hot and dry summer which only exacerbated the noxious weed problem. An increase in monitoring and spraying frequency may be needed in the coming year(s) to get the site back on track.
