## Pikeview monitoring report

To: Jerald Schnabel From: Paul Kos  
Continental Materials Corp. Denver, CO 80222  
File: October 2020 Monitoring Summary Date: November 30, 2020

**Reference: October 2020 Geotechnical Monitoring Summary Pikeview Quarry**

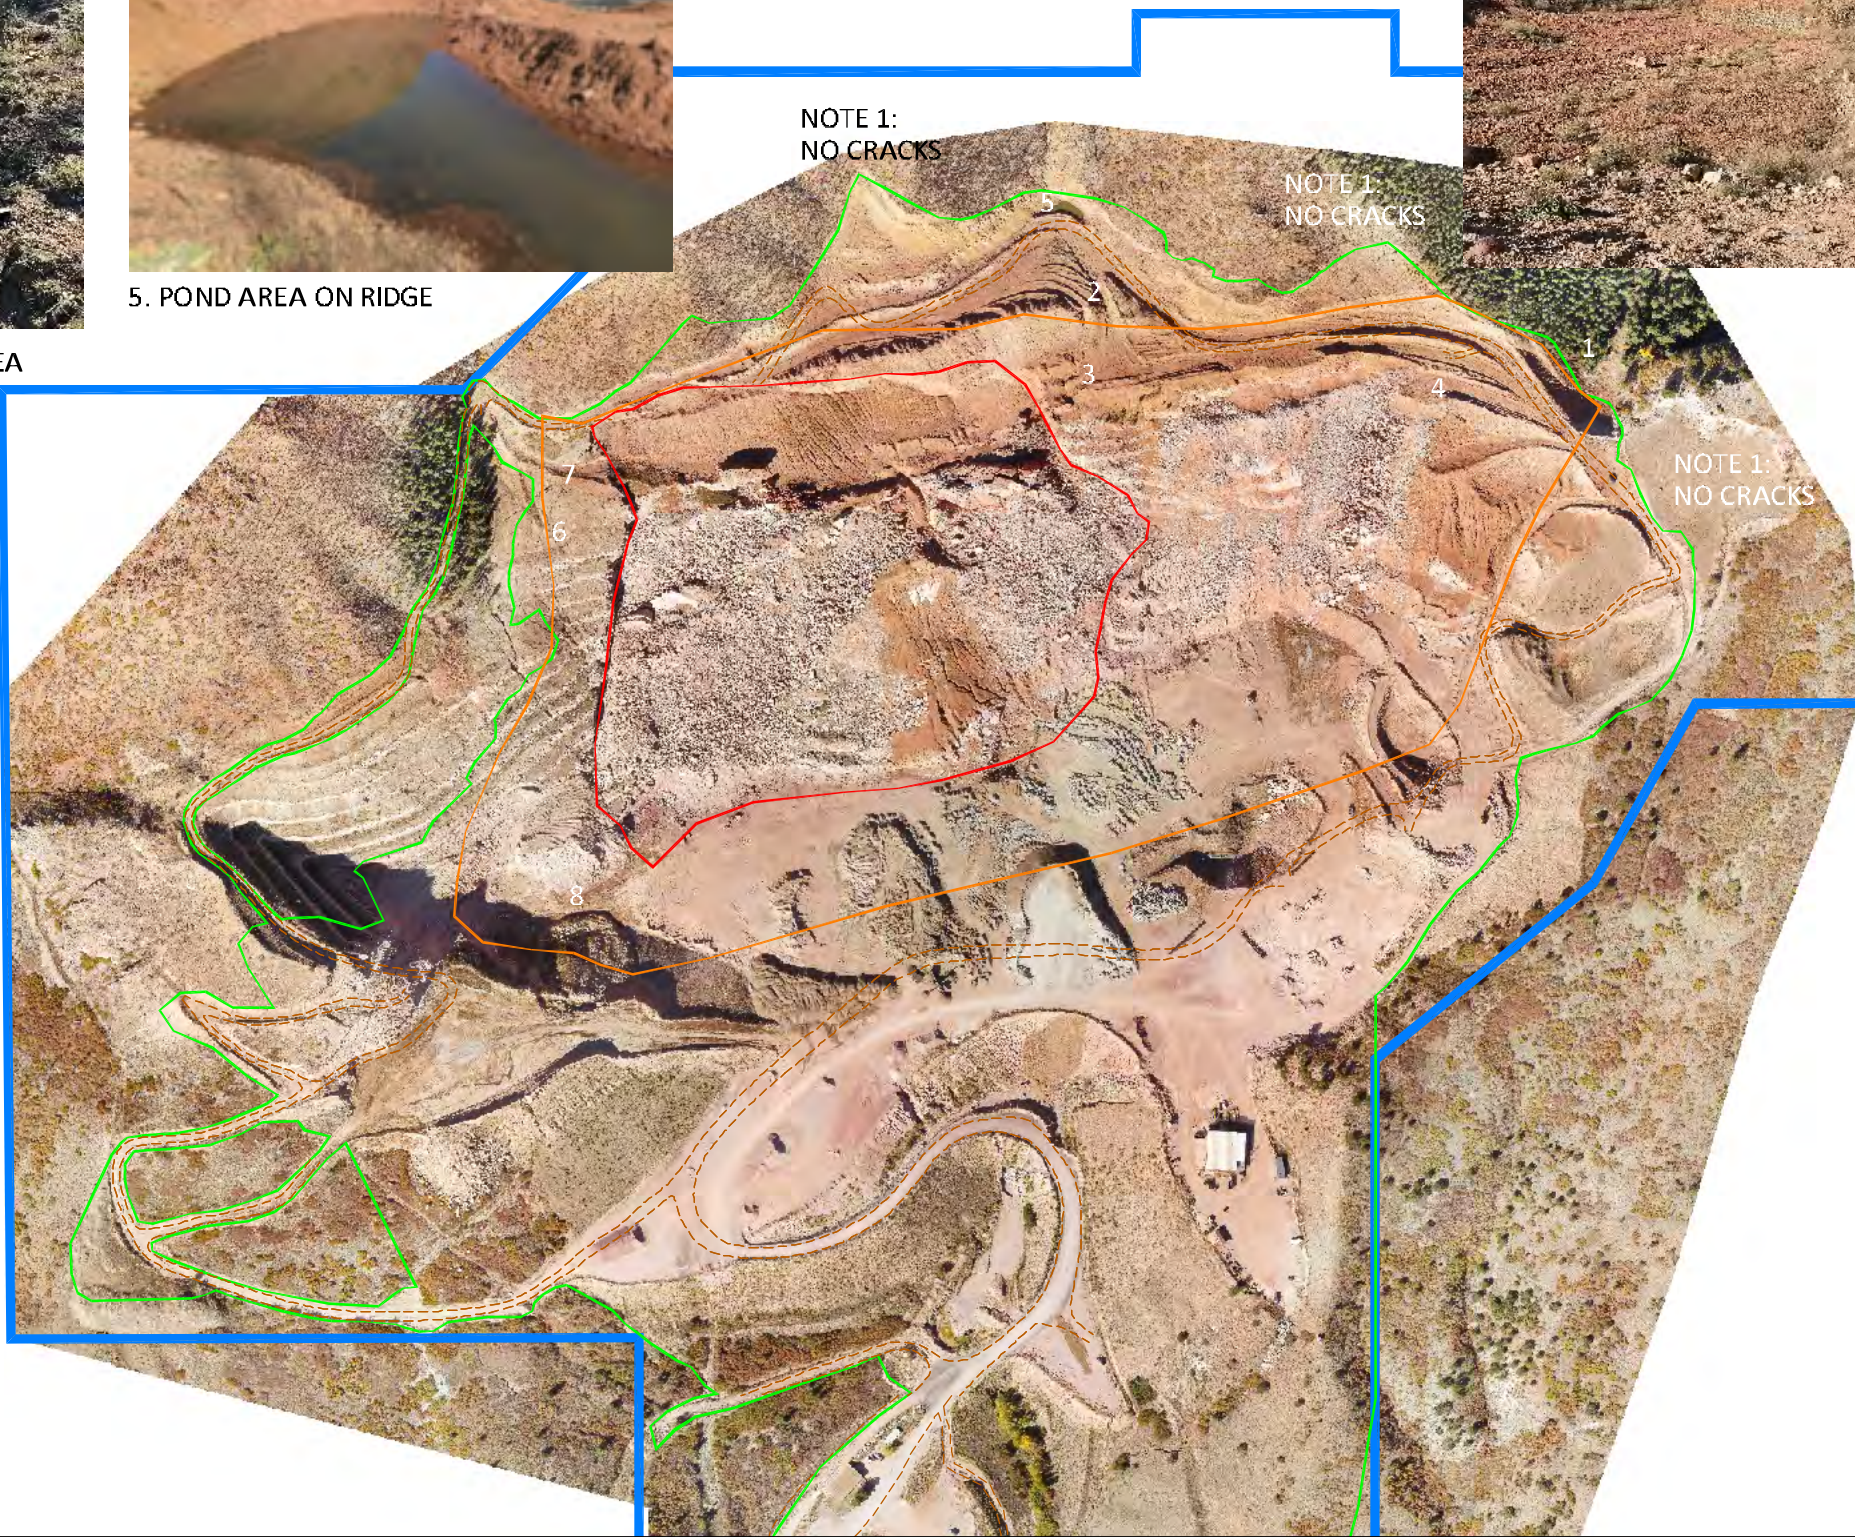
Figure No.  
2

NOTE 1:  
NO CRACKS

- NO CRACKS OBSERVED IN THIS AREA.
- ALL PHOTOS TAKEN NOVEMBER 2, 2020.

OBSERVATIONS FROM  
OCTOBER INSPECTION
