MINERALS PROGRAM INSPECTION REPORT

MINE NAME: Phil Sheridan Lode	MINE/PROSPECTING ID#: M-1988-081	MINERAL: Gold and silver	COUNTY: Boulder
INSPECTION TYPE: Surety-Related Inspection	INSPECTOR(S): Amy Eschberger	INSP. DATE: December 9, 2020	INSP. TIME: 10:00
OPERATOR: Harry Covey	OPERATOR REPRESENTATIVE: Janice Wheeler, Dennis Covey	TYPE OF OPERATION: 110(1) - Hard Rock Limited Impact	
REASON FOR INSPECTION: Surety Related	BOND CALCULATION TYPE: Complete Bond	BOND AMOUNT: \$6,100.00	
DATE OF COMPLAINT: NA	POST INSP. CONTACTS: None	JOINT INSP. AGENCY: None	
WEATHER: Clear	INSPECTOR'S SIGNATURE: 	SIGNATURE DATE: December 22, 2020

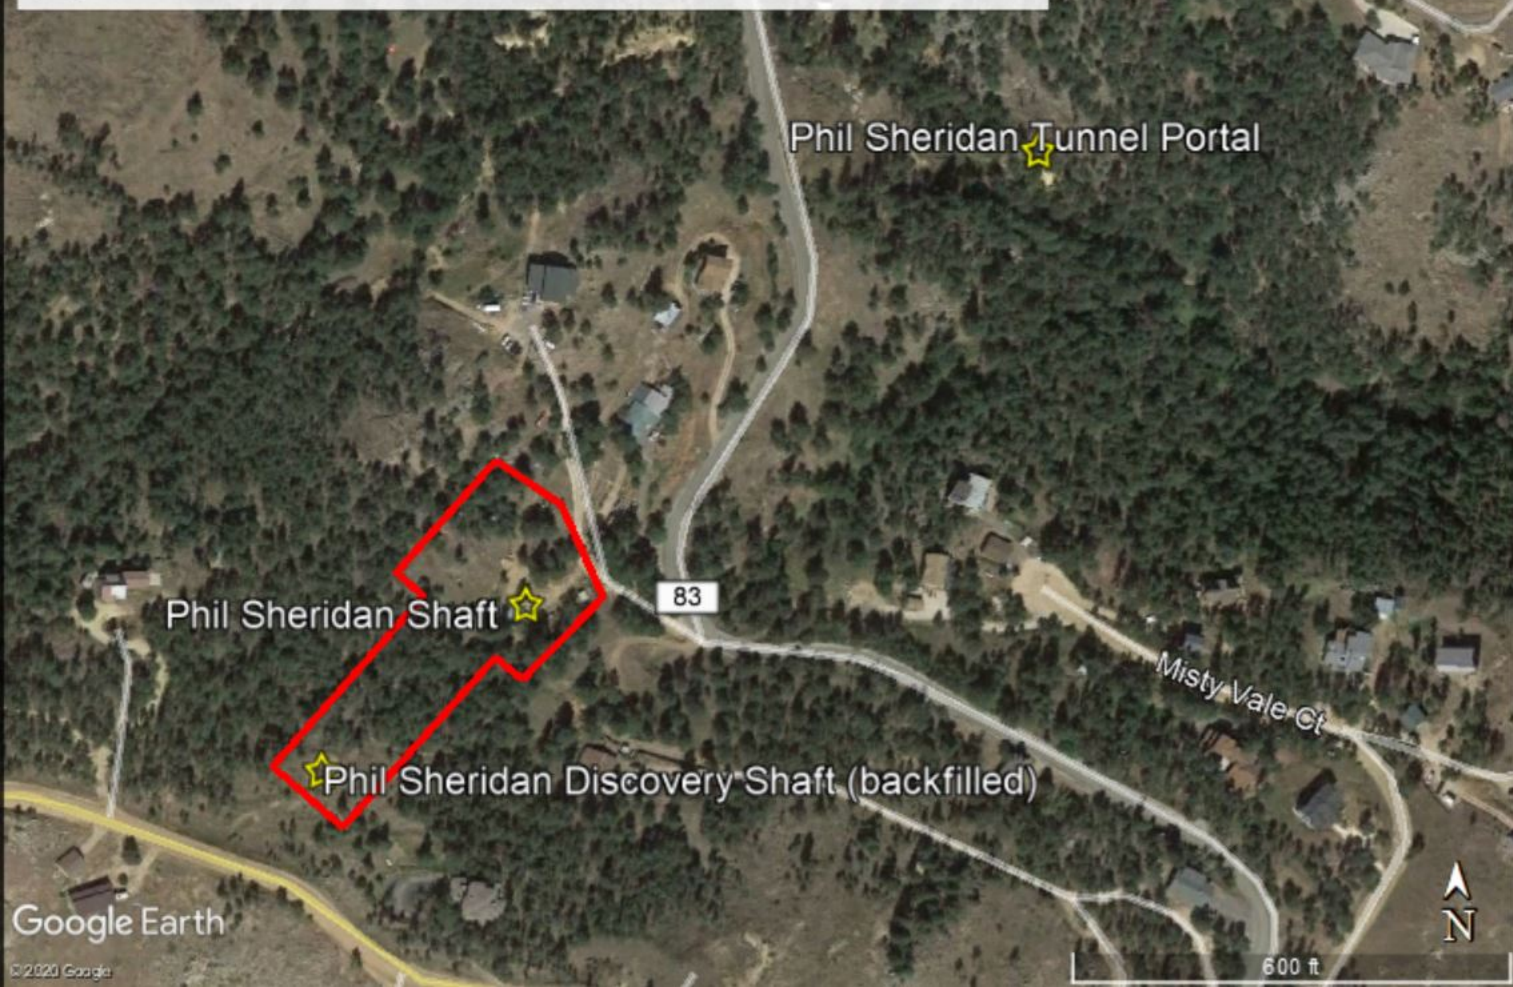
Site view showing location of Phil Sheridan Tunnel Portal (outside of Permit Area).

Red Outline = 1.94 acres = Approved Permit Area (location approximated based on approved maps)
(Image data from 9/12/2019)
