Pikeview monitoring report

To: Jerald Schnabel From: Paul Kos
Continental Materials Corp. Denver, CO 80222
File: November 2020 Monitoring Summary Date: December 31, 2020

Reference: November 2020 Geotechnical Monitoring Summary Pikeview Quarry

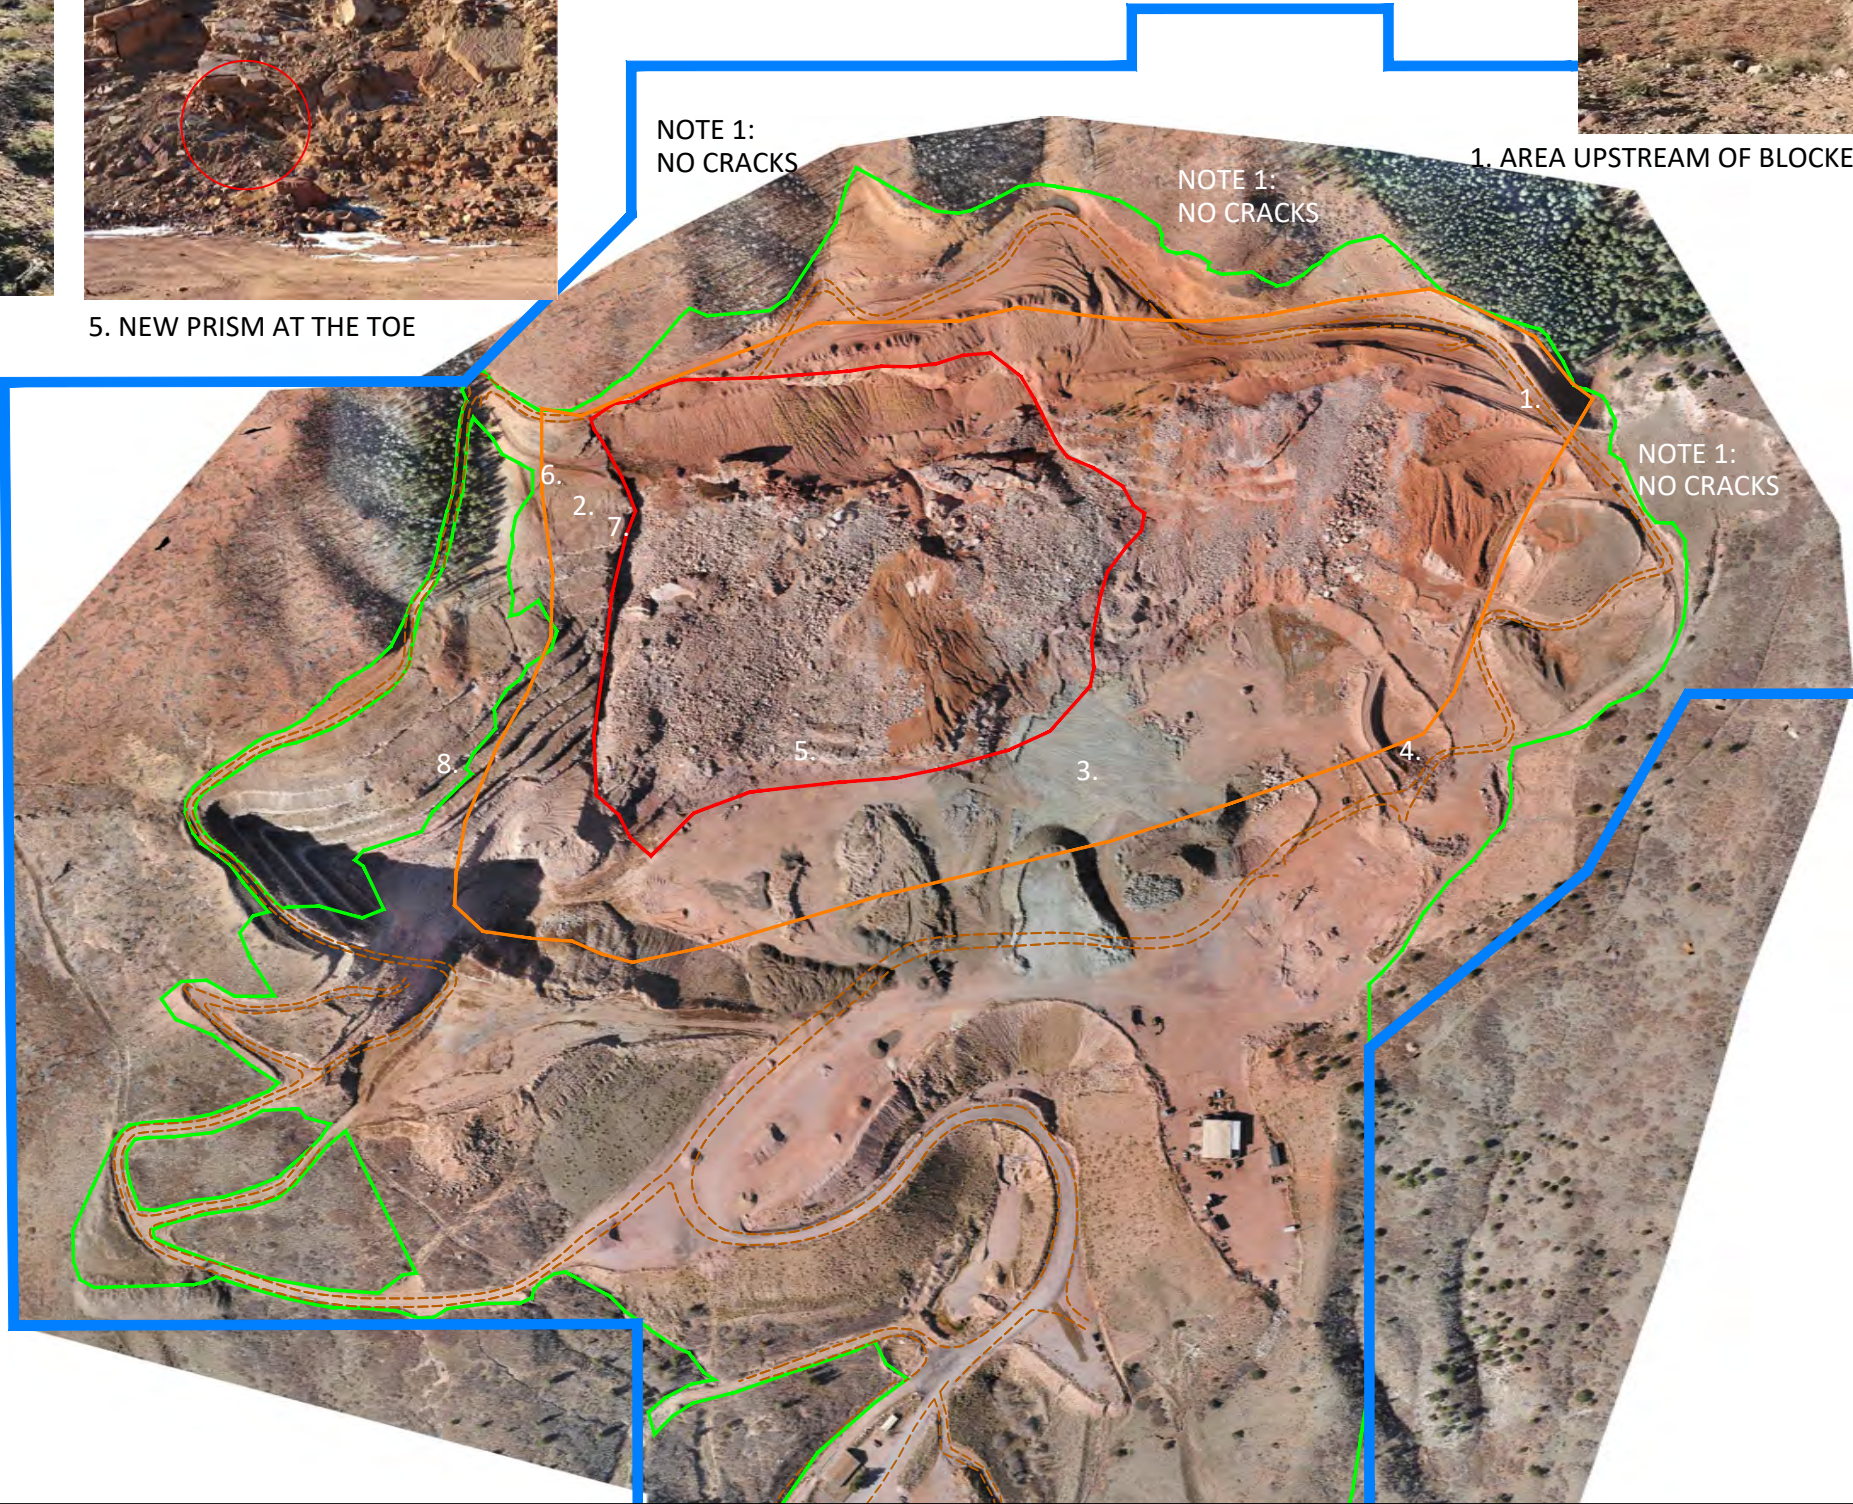
Title
OBSERVATIONS FROM
NOVEMBER INSPECTION

- Crack Free: No cracking was observed on the native granite slopes above the extents of the disturbed area. The hummocky field in the area immediately above the southern extent of the slide shows evidence of cracking but they are not fresh or active. No new or open cracks were found immediately inside or next to the slide area.

NOTE 1:
NO CRACKS

- NOTES
1. NO CRACKS OBSERVED IN THIS AREA.
 2. ALL PHOTOS TAKEN DECEMBER 4, 2020.
