MINERALS PROGRAM INSPECTION REPORT
PHONE: (303) 866-3567

MINE NAME: San Luis Project	MINE/PROSPECTING ID#: M-1988-112	MINERAL: Gold and silver	COUNTY: Costilla
INSPECTION TYPE: Monitoring	INSPECTOR(S): Lucas West	INSP. DATE: December 28, 2020	INSP. TIME: 10:00
OPERATOR: Battle Mountain Resources, Inc.	OPERATOR REPRESENTATIVE: Julio Madrid	TYPE OF OPERATION: 112d-3 - Designated Mining Operation	
REASON FOR INSPECTION: Normal I&E Program	BOND CALCULATION TYPE: None	BOND AMOUNT: \$7,400,000.00	
DATE OF COMPLAINT: NA	POST INSP. CONTACTS: None	JOINT INSP. AGENCY: None	
WEATHER: Snowing	INSPECTOR'S SIGNATURE:

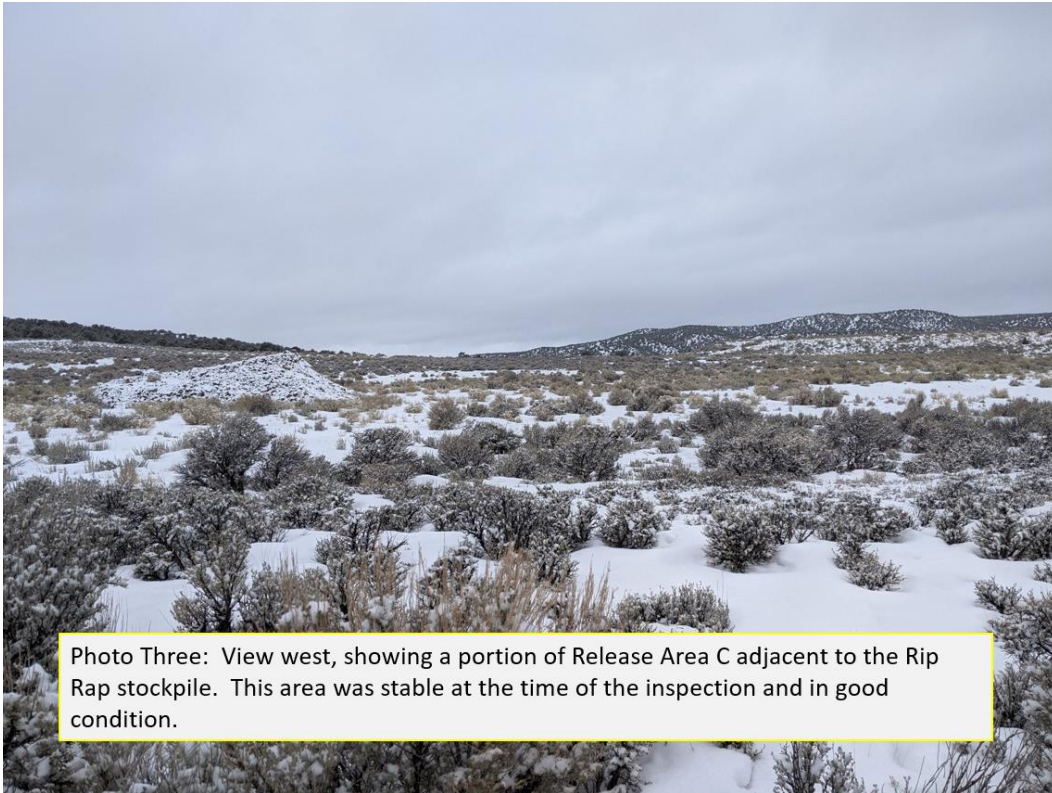
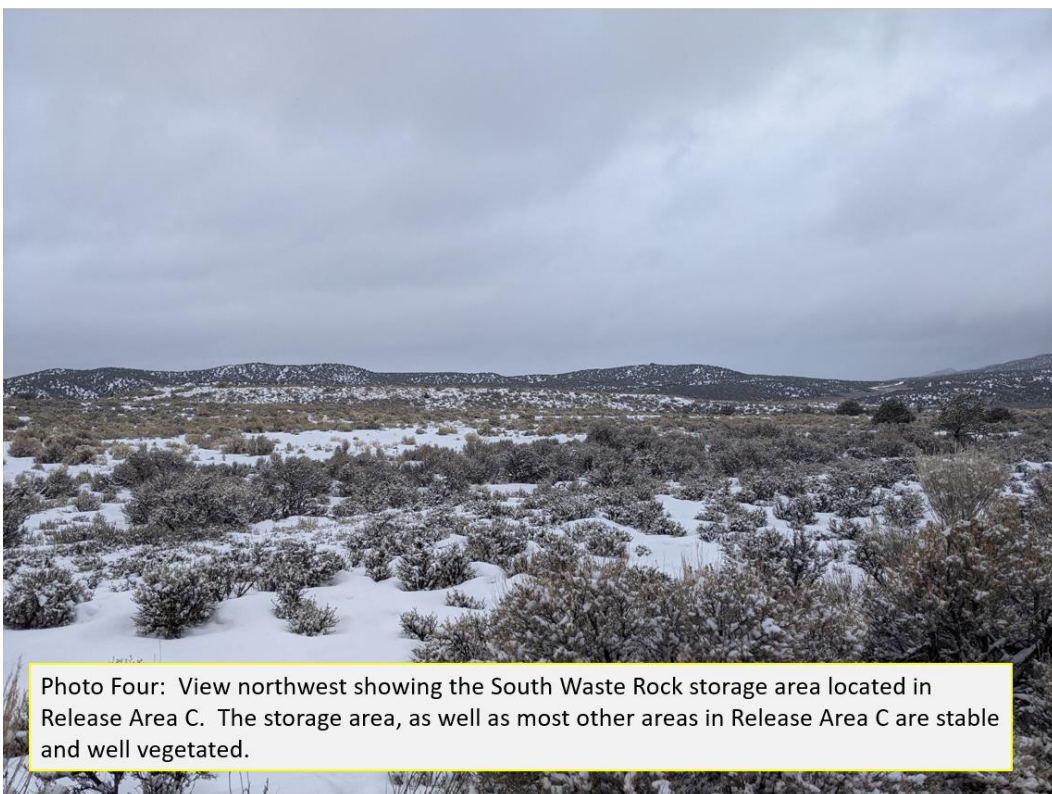
Release Area C: Release Area C totals 39 Acres that contains the old Mill Area, South Waste Rock Storage Area and 24.5 Acres of Undisturbed lands. Both the South Waste Rock Storage Area and old Mill Area have been graded, capped and revegetated. The grading and earthwork was stable at the time of the inspection and no signs of settling or slumping were observed. All areas located within Release Area C, which can be seen in Photos Three and Four, are well vegetated. The vegetative cover is as good as or better than the adjacent undisturbed areas. An error was noticed in the release request during this inspection. Within Release Area C, a large stockpile of borrow material exists adjacent to the access road that is still utilized by the Operator, shown in Photo Five. This stockpile can be seen in Photo Five. On site discussions with the Operator's
