Pikeview Monitoring Report

To: Jerald Schnabel From: Paul Kos
Continental Materials Corp. Denver, CO 80222
File: December 2020 Monitoring Summary Date: January 31, 2021

Reference: December 2020 Geotechnical Monitoring Summary Pikeview Quarry

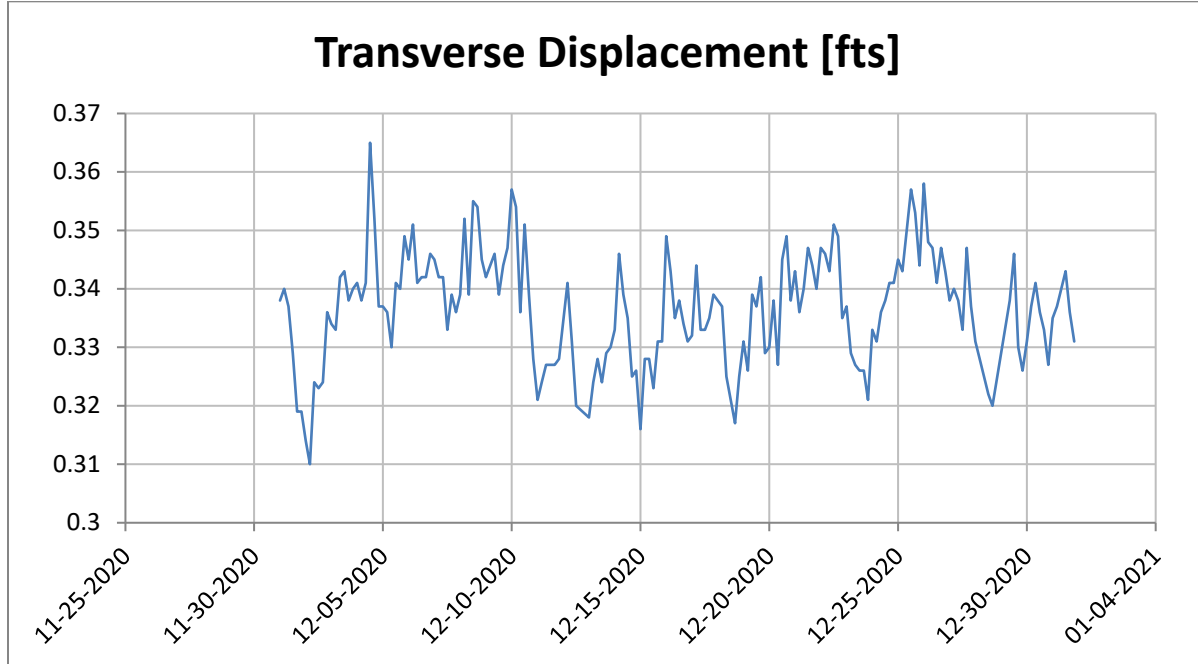
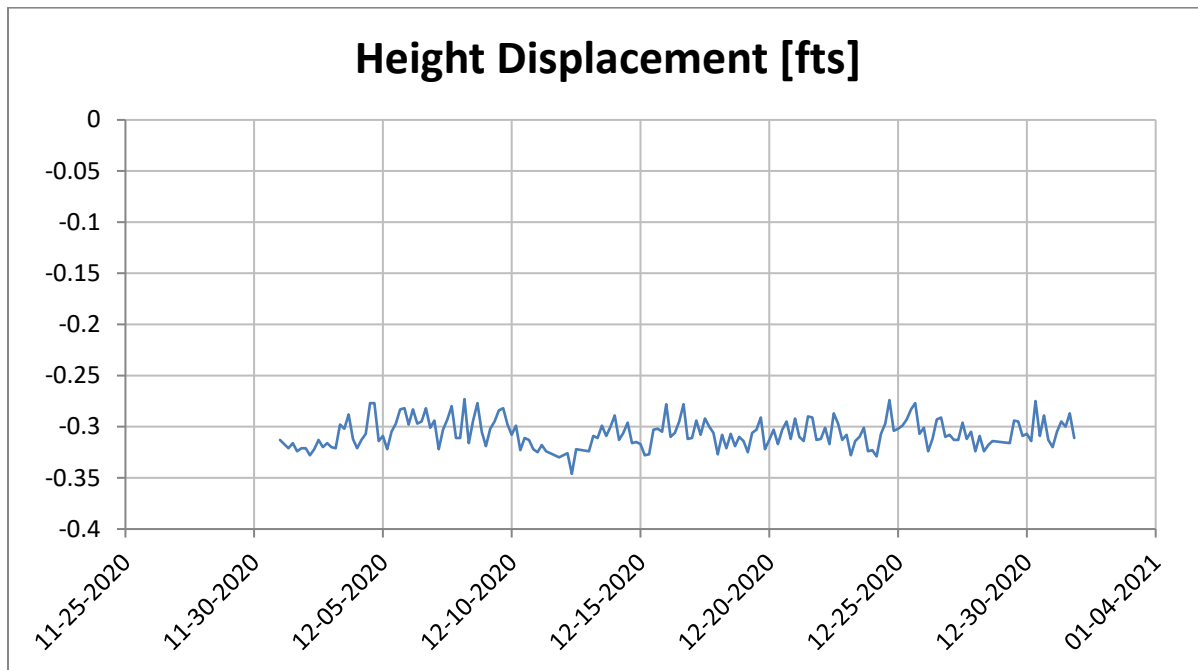
Prism P70

Prism ID	Cumulative Transverse Displacement (ft)	Cumulative Height Displacement (ft)	Monthly Delta (ft)	Cumulative Delta (ft)	Needs / Recommendations
CP1	-0.001	-0.015	-0.0088	0.0153	
CP2	-0.068	-0.019	-0.0163	0.3924	
CP3	0.278	-0.222	-0.0115	0.3585	
NP1	0.050	-0.006	0.0227	0.0689	
NP2	-0.016	-0.081	-0.0044	0.0922	
NP66	0.135	-0.212	-0.2120	0.2996	
P1	0.328	-0.072	0.0080	0.3363	
P2	0.139	-0.052	-0.0059	0.2054	
P25	-0.029	0.025	-0.0014	0.1471	
P32	-0.094	-0.101	-0.0089	0.2794	
P33	-0.119	-0.052	0.0038	0.2228	
P35	0.019	-0.189	-0.1890	0.4311	
P4	0.349	-0.137	-0.0060	0.4650	
P5	0.376	-0.164	-0.0071	0.6023	
P63	15.246	-6.248	0.0128	16.4767	Prism at toe of slide. Movements are within expected range.
P69	-0.063	-0.037	-0.0077	1.9923	
P70	0.331	-0.311	-0.0070	0.5716
