**MINERALS PROGRAM INSPECTION REPORT**  
**PHONE: (303) 866-3567**

<b>MINE NAME:</b> Miller Gravel Pit	<b>MINE/PROSPECTING ID#:</b> M-1982-112	<b>MINERAL:</b> Sand and gravel	<b>COUNTY:</b> Elbert
<b>INSPECTION TYPE:</b> Monitoring	<b>INSPECTOR(S):</b> Amy Eschberger	<b>INSP. DATE:</b> February 3, 2021	<b>INSP. TIME:</b> 10:30
<b>OPERATOR:</b> Schmidt Construction Company	<b>OPERATOR REPRESENTATIVE:</b> Dan Chavez, Greg Olson, Mark Heifner	<b>TYPE OF OPERATION:</b> 112c - Construction Regular Operation	
<b>REASON FOR INSPECTION:</b> Normal I&E Program	<b>BOND CALCULATION TYPE:</b> Partial	<b>BOND AMOUNT:</b> \$146,646.00	
<b>DATE OF COMPLAINT:</b> NA	<b>POST INSP. CONTACTS:</b> None	<b>JOINT INSP. AGENCY:</b> None	
<b>WEATHER:</b> Clear	<b>INSPECTOR'S SIGNATURE:</b>

## M-1982-112 / Miller Gravel Pit / Schmidt Construction Company (112c)

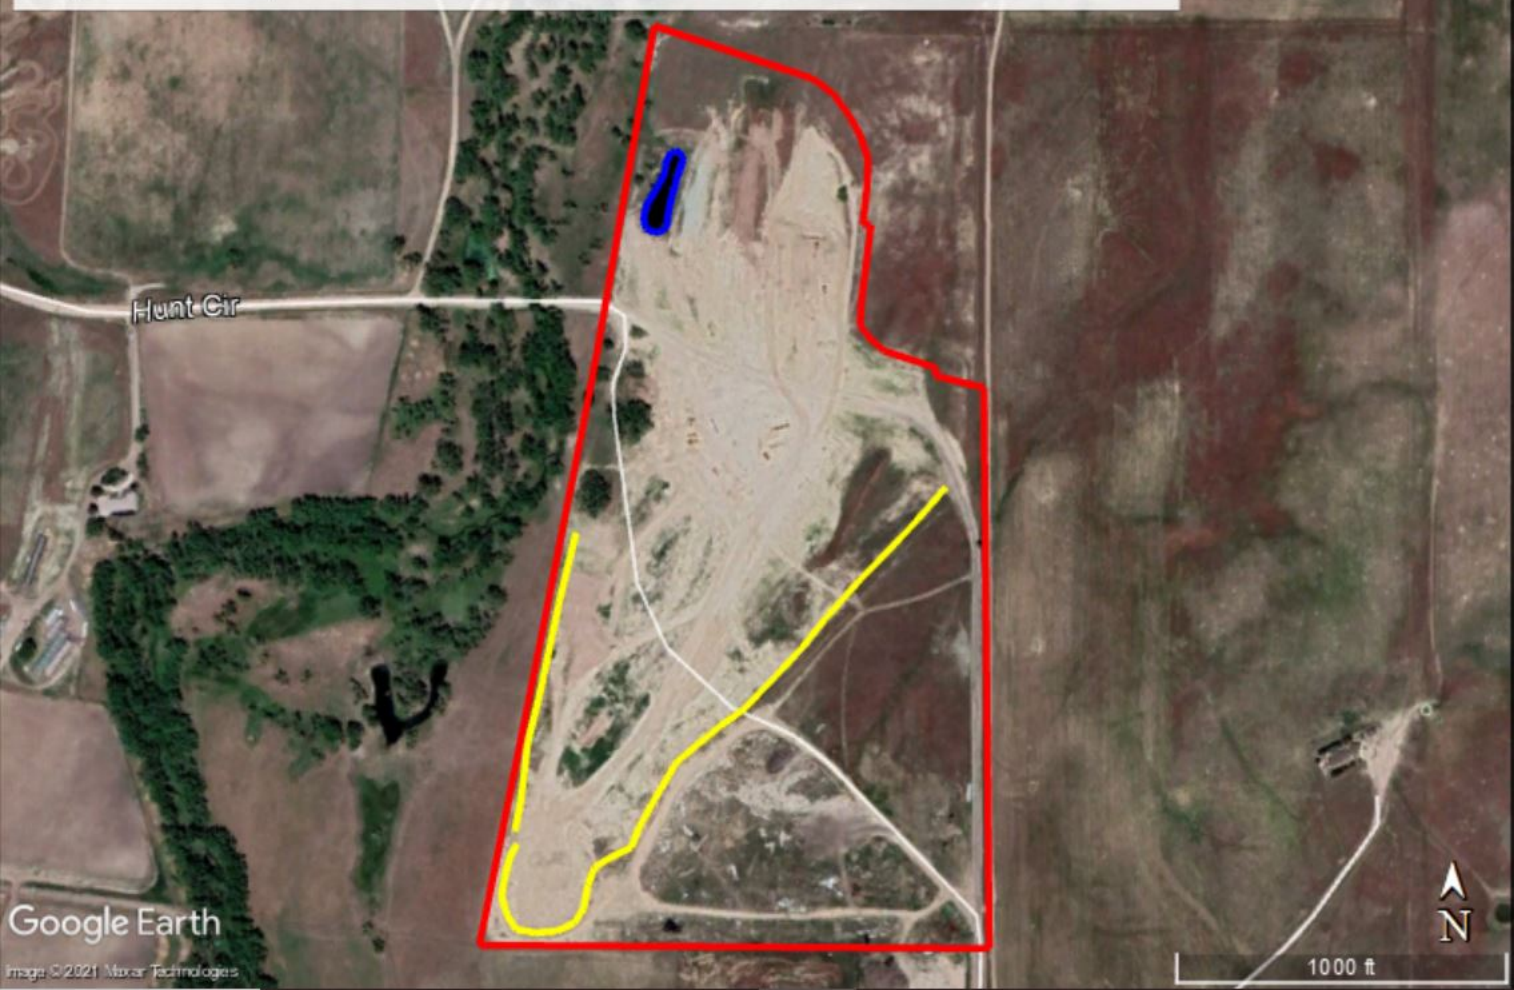
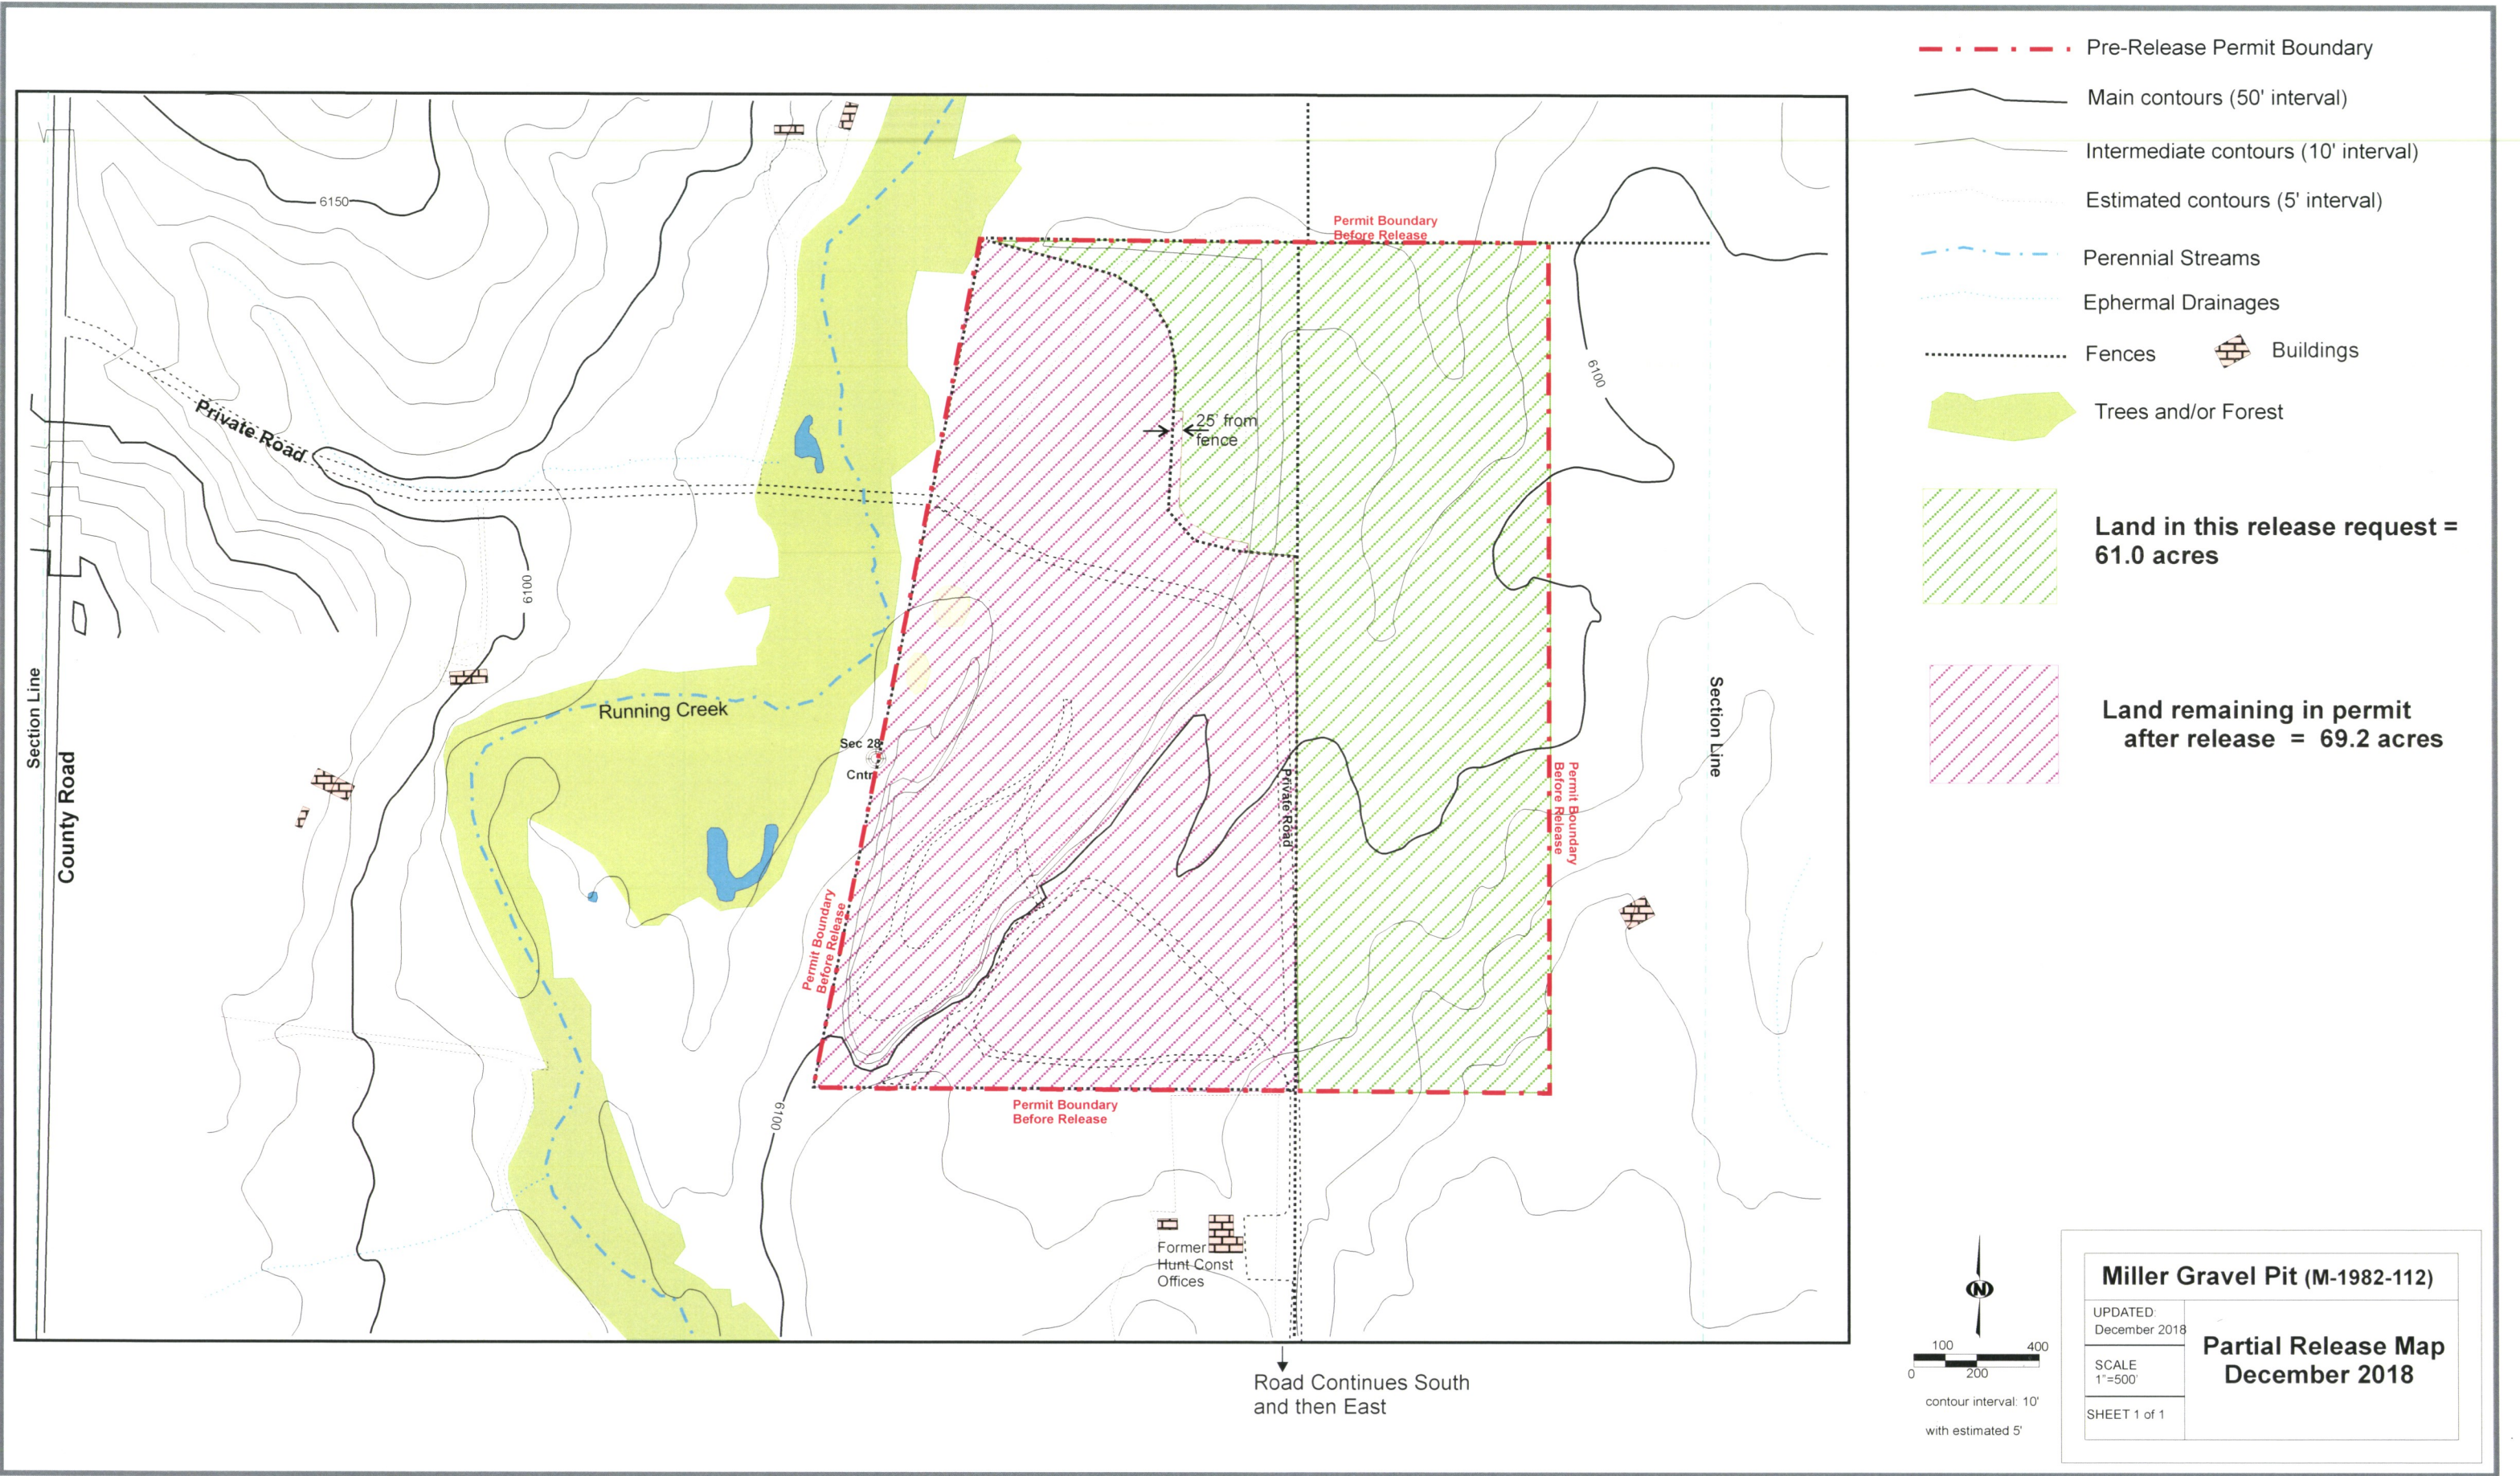
Red outline = 69.2 acres = Approved Permit Area (location approximated based on AR-1 map)  
Blue outline = 0.30 acres = Wash pond surface area (actual size may be reduced from partial backfilling)  
Yellow line = Approximate trace of pit highwalls  
(Image data from 6/4/2020)
