RE: 2020 Annual Report, Henderson Mine and Mill, Permit No M-1977-342

HENDERSON MILL
MLRB Permit No. M-77-342
Annual Reclamation Report
March 3, 2021

HENDERSON MINE
MLRB Permit No. M-77-342
Annual Reclamation Report
March 3, 2021

Subject: Annual (Year 2020) Tailings Storage Facility Evaluation, Henderson Tailings Storage Facility, Henderson Mill, Colorado

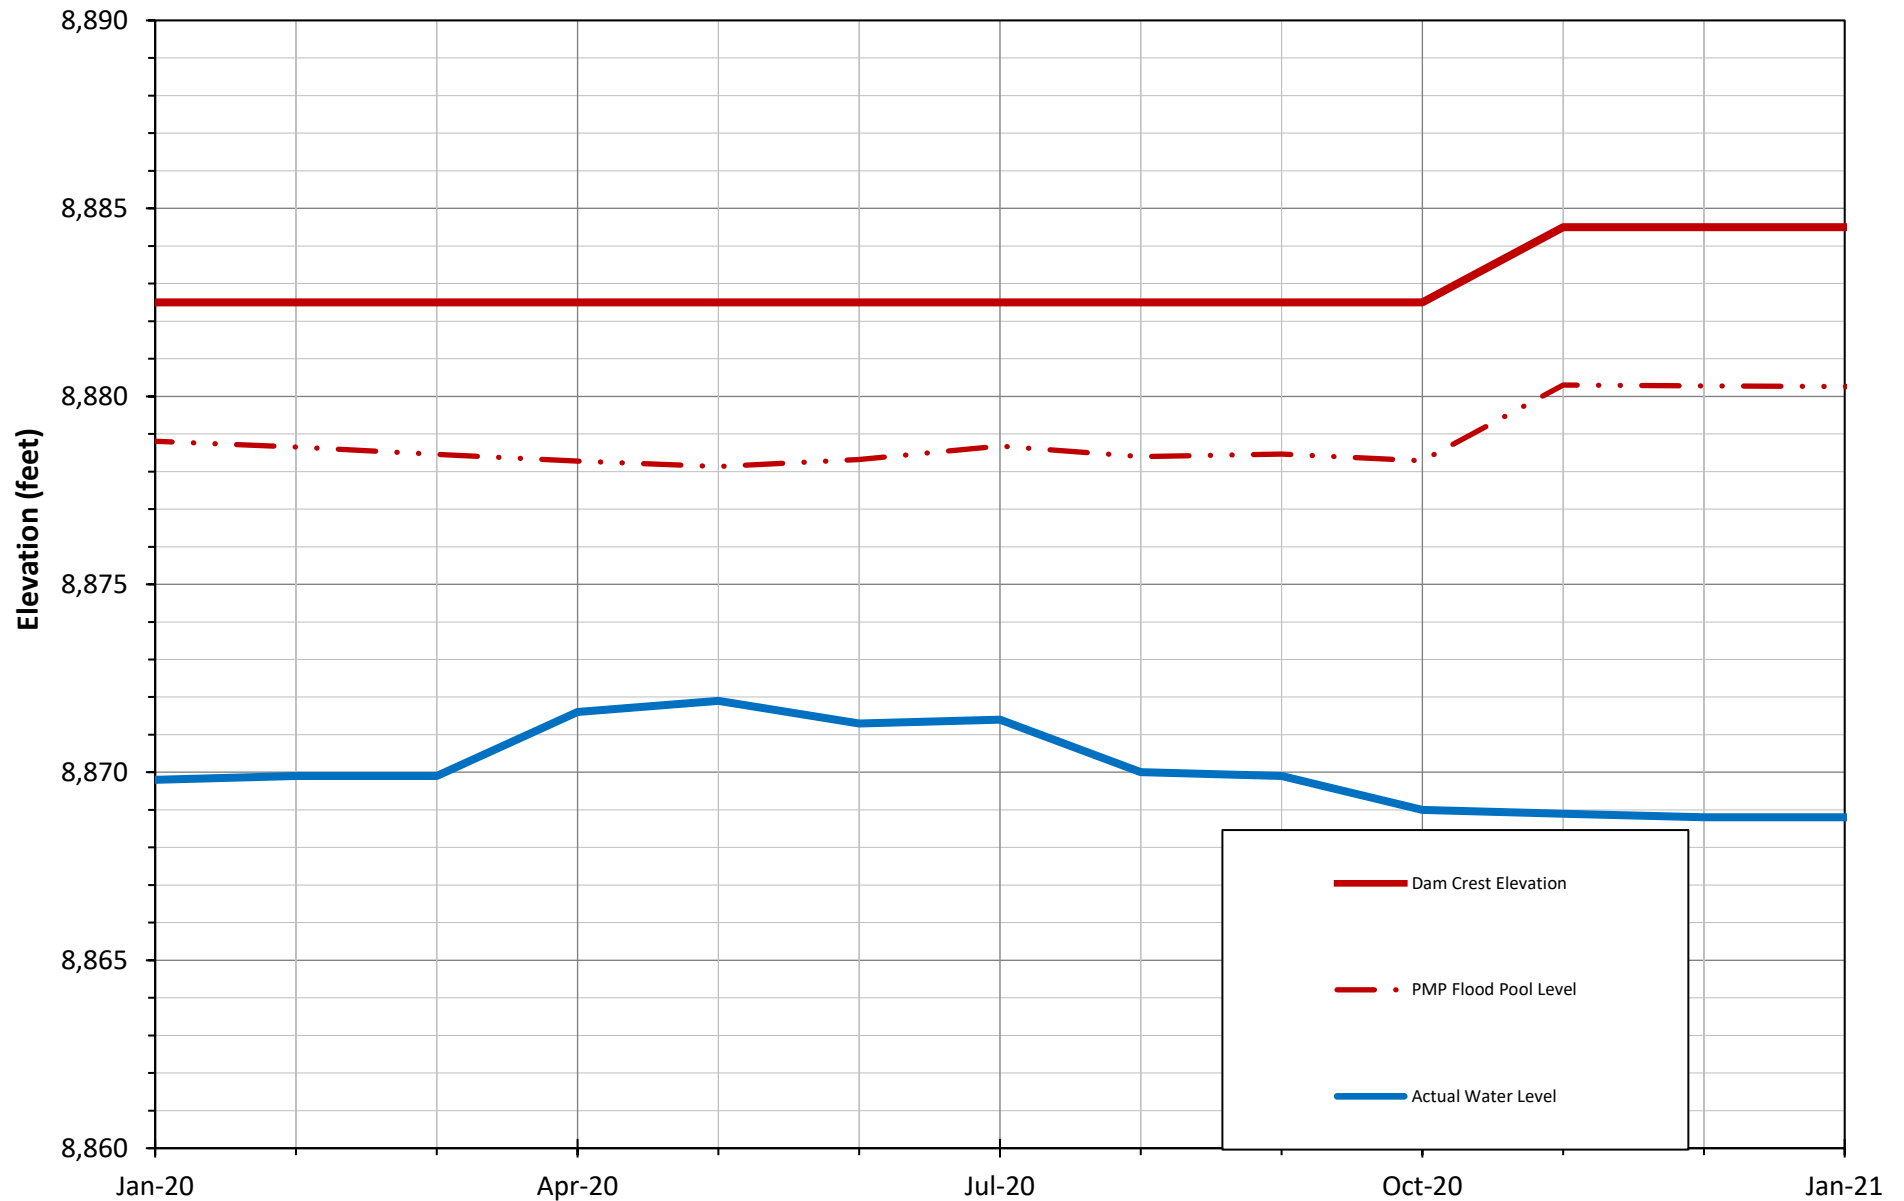
**Figure 3 Henderson TSF
Water Pool Level Tracking**

A relatively accurate determination of the flood storage capacity in the impoundment can be made at the time of the spring and fall pond surveys. An operations model has been developed to track water levels and estimate the flood storage availability in the system between surveys. This model is updated by Wheeler on a monthly basis. One of the reports generated by this model is the attached TSF Water Level Report (Figure 3). This graph shows the actual water level in the TSF as compared to the flood pool level in the pond, which is defined as the level corresponding to 3,582 acre-feet of available capacity. Note that the actual water level did not exceed the flood pool level at any time in 2020. This shows that the required flood storage space was maintained in the system throughout the 2020 calendar year.
