## MINERALS PROGRAM INSPECTION REPORT

<b>MINE NAME:</b> Weaver Quarry	<b>MINE/PROSPECTING ID#:</b> M-1986-085	<b>MINERAL:</b> Sandstone (silica, stone, quartzite)	<b>COUNTY:</b> Larimer
<b>INSPECTION TYPE:</b> Monitoring	<b>INSPECTOR(S):</b> Amy Eschberger	<b>INSP. DATE:</b> March 11, 2021	<b>INSP. TIME:</b> 10:15
<b>OPERATOR:</b> Loukonen Bros. Stone Company	<b>OPERATOR REPRESENTATIVE:</b> Michael Loukonen	<b>TYPE OF OPERATION:</b> 110c - Construction Limited Impact

## M-1986-085 / Weaver Quarry / Loukonen Bros. Stone Company (110c)

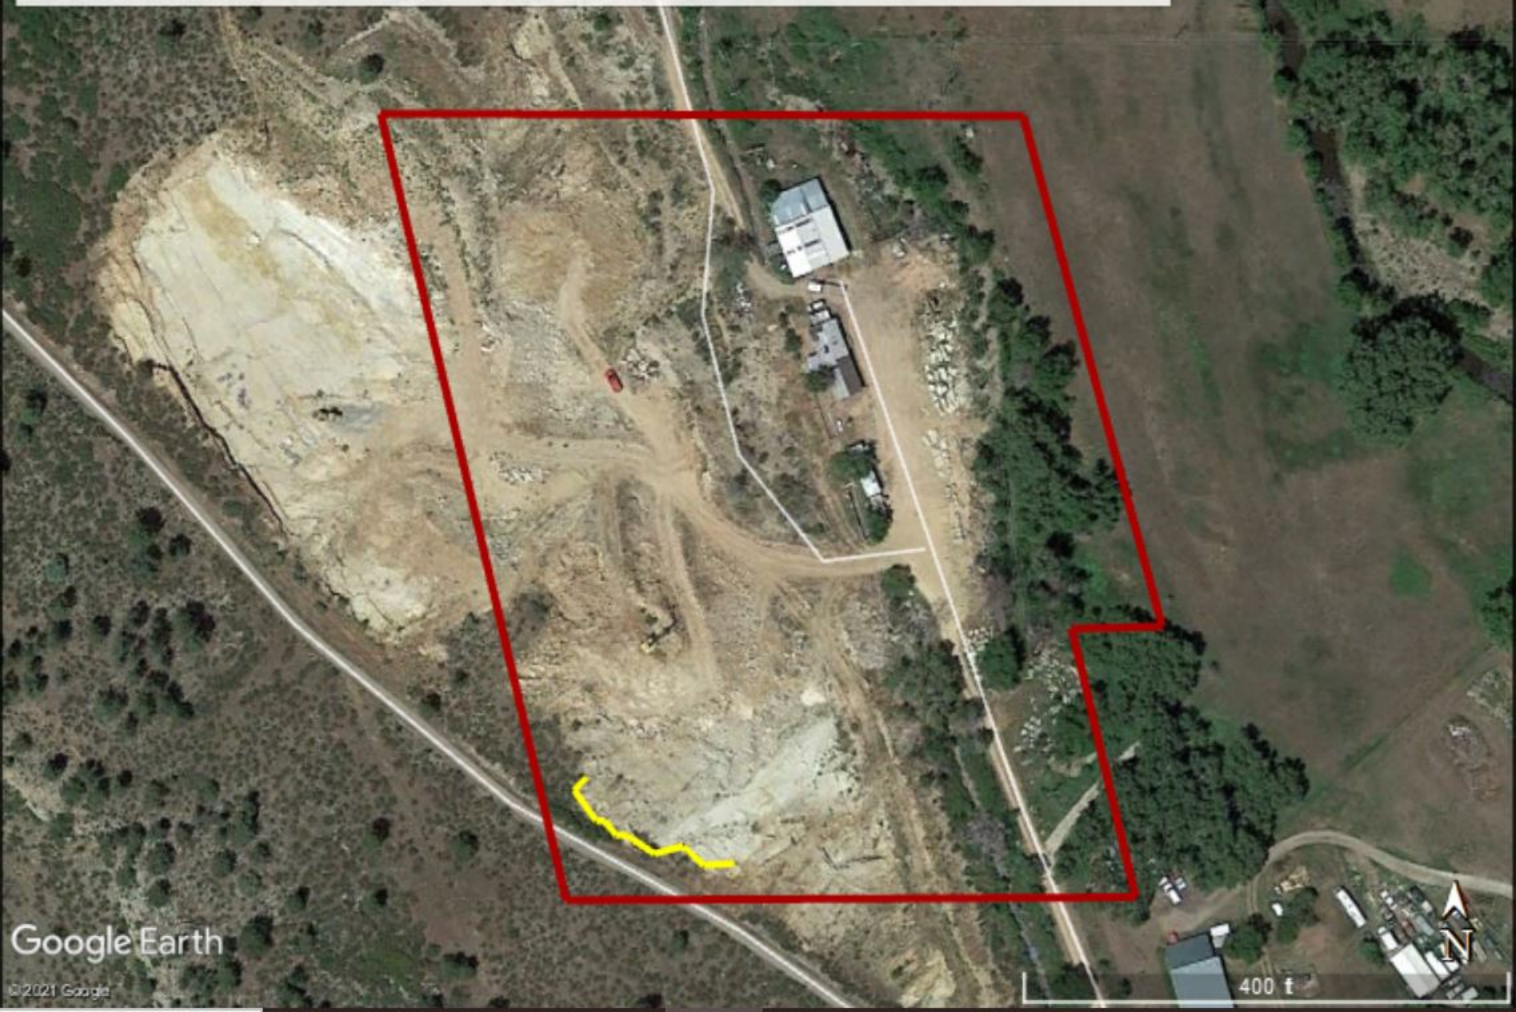
Yellow Line = 176 feet = Approximate Length of Active Highwall

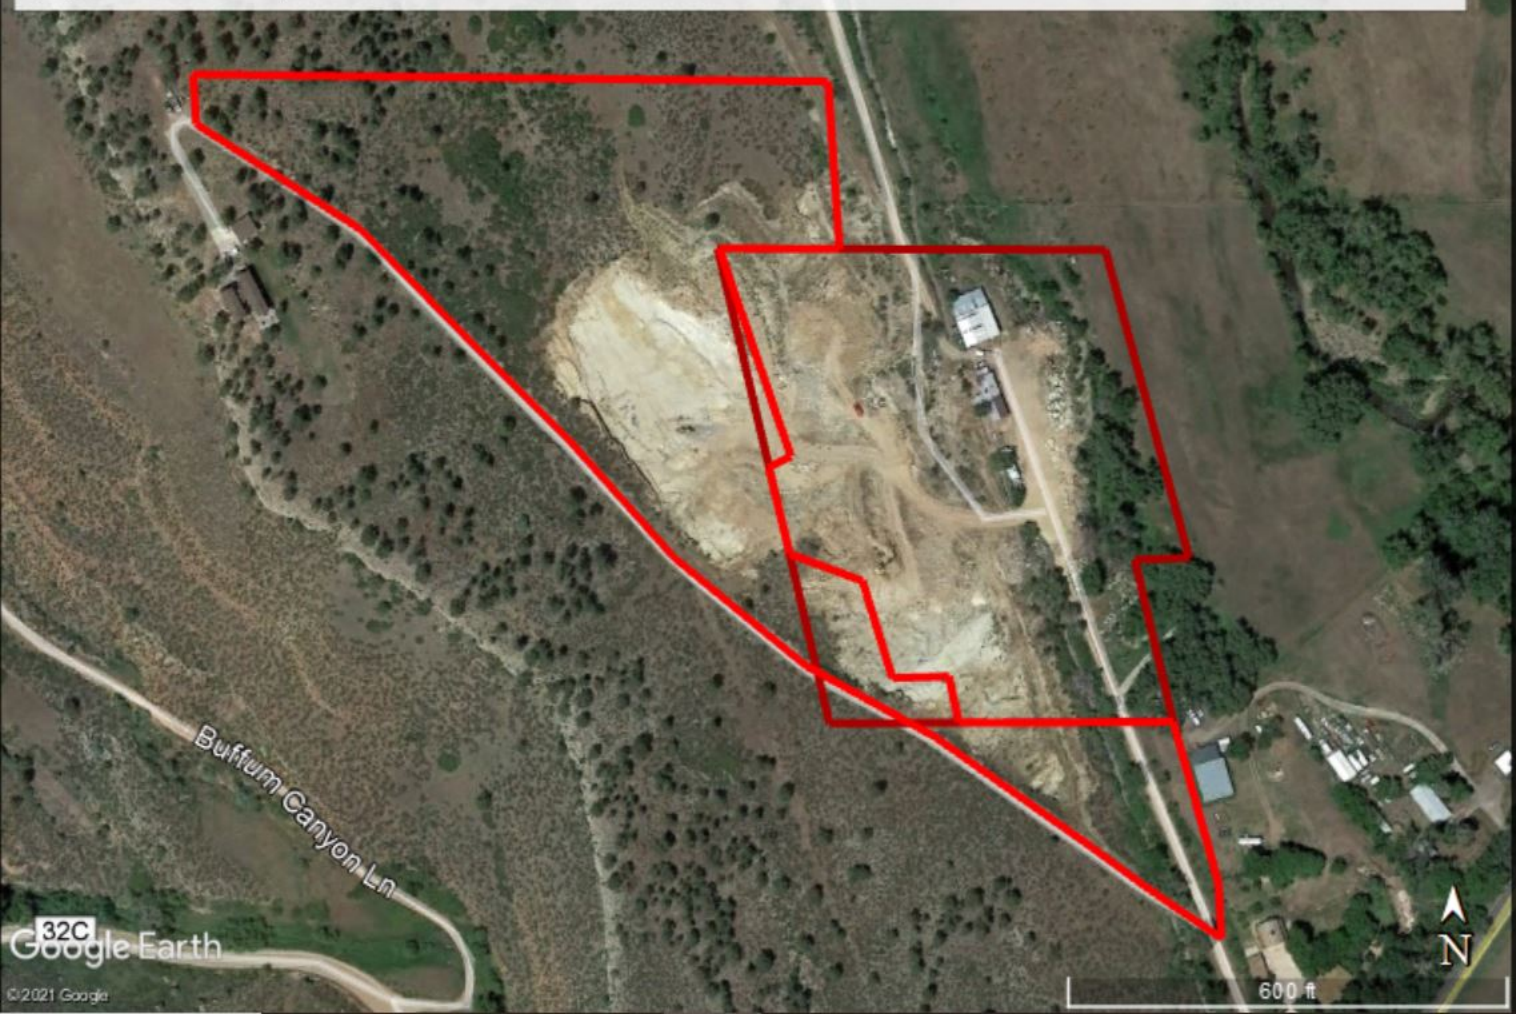
# M2001-114/M1986-085 - Starks Quarry/Weaver Quarry - Loukonen Bros. Stone Company

Dark Red Outline = 7.5 acres = Permit Area for Weaver Quarry (location approximated based on permit maps)
