2021 ANNUAL REPORT STRUCTURAL GEOLOGY EVALUATION SPECIFICATIONS AGGREGATE QUARRY

**Martin Marietta Materials
Golden, Colorado**

20C64005.00
February 17, 2021

**Subject: Project 20C64005.00, 2021 Annual Report, Structural Geology Evaluation,
Specification Aggregates Quarry, Golden, Colorado**

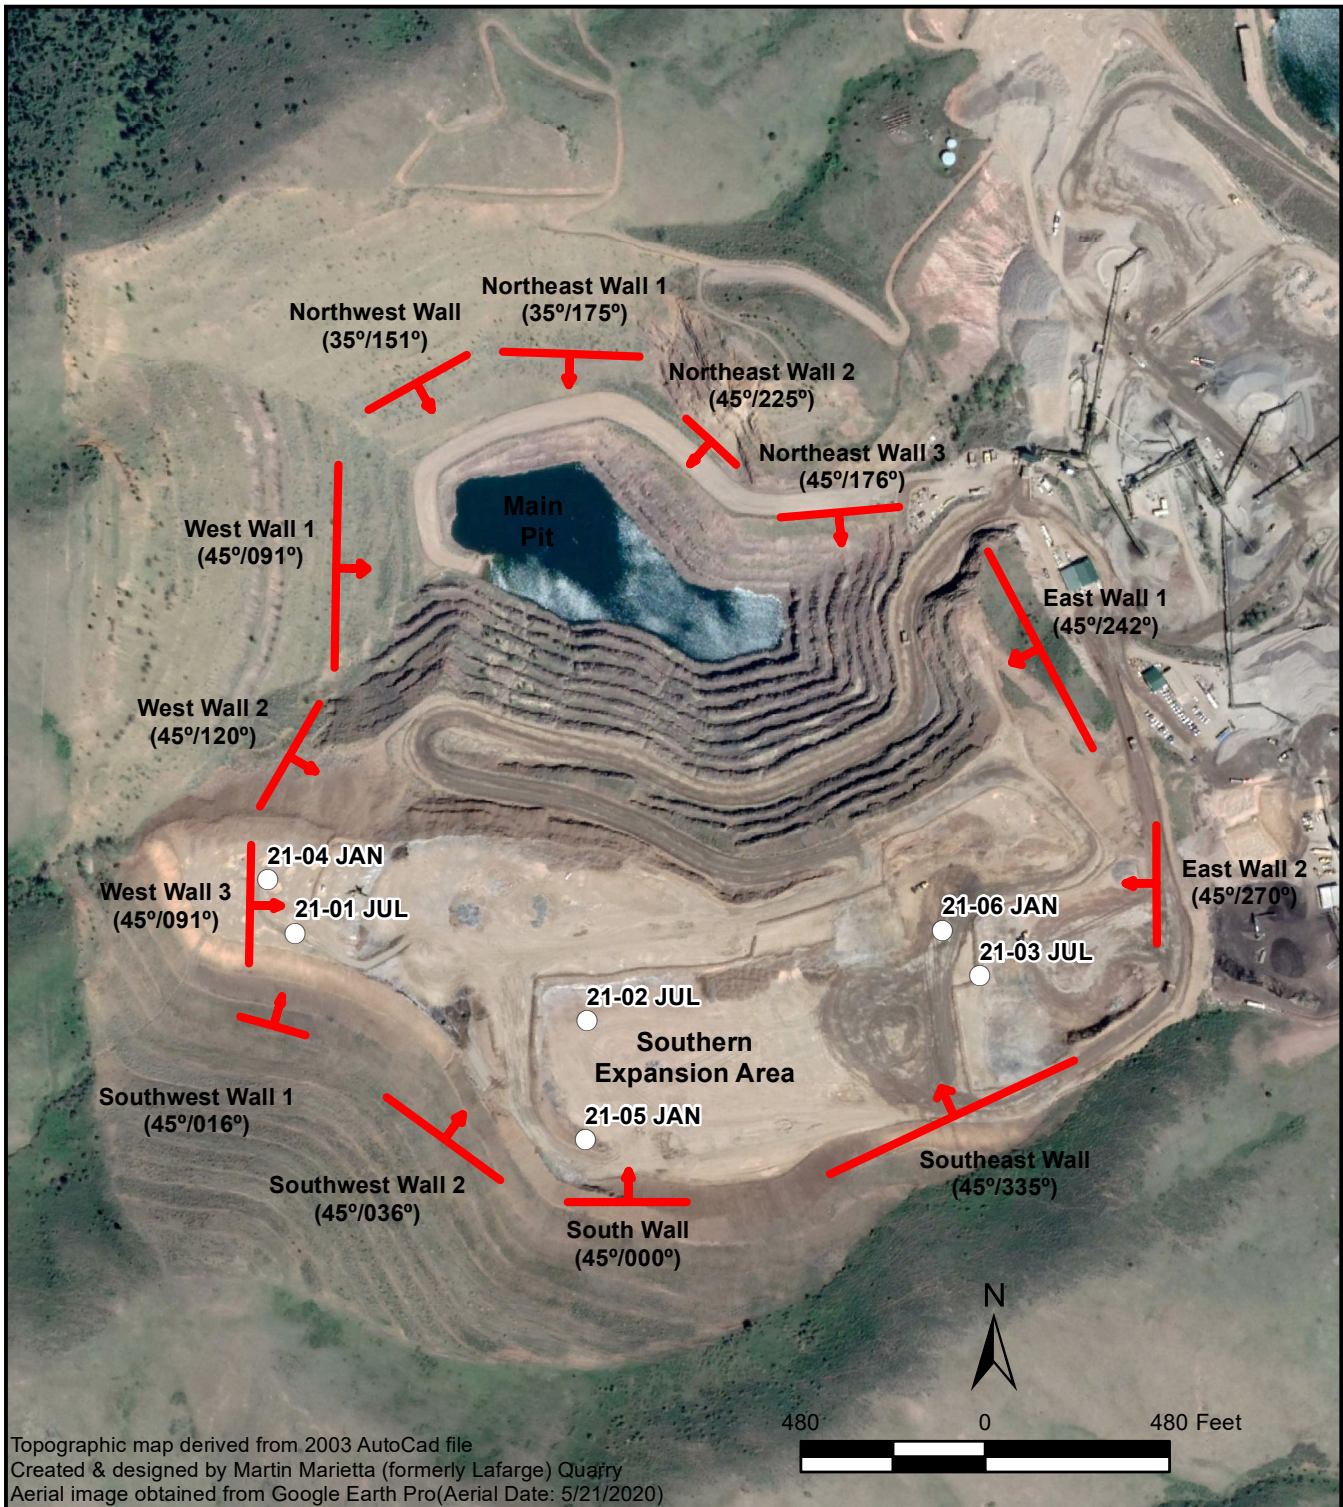
Figure 2

During our visits, we performed rock structure mapping to collect representative discontinuity measurements from recently mined rock exposures in the Southern Expansion Areas (Figure 2; Photos 1 through 3). Orientation measurements (i.e., dip/dip direction) of joints, foliation, and faults were taken from the faces of advancing benches. A geological compass was used to obtain discontinuity measurements by sighting along the discontinuity surfaces. A handheld GPS was used to record the location of data collection points (Figure 2).

A total of 57 discontinuity measurements were collected in 2020/2021 at six (6) data collection points (Figure 2), and were added to the measurements from previous years. When combined with data collected from previous annual reports (1997-2002, 2004-2020) and with borehole geophysical data collected during the 2003 geotechnical investigation, a total of 3,789 discontinuity orientation measurements have been obtained over the past 23 years. Figure 5 shows the 57 discontinuity orientation measurements collected for this annual report overlain on a contour stereonet plot of the entire Spec-Agg structural dataset.

During our 2020/2021 site visits, no major shear zone (fault) exposure along the temporary excavation wall in the Southern Expansion Area was observed, only localized small scale shear zone was observed at station 21-02 (Figure 2, and Photo 3). The localized shear zone is oriented approximately north-south with high angle dipping to the east and was exposed in the north to northwest facing temporary wall of the expansion area. The localized shear zone consists of yellowish-brownish weathered, broken granitic rock, with parallel closed-spacing fractures. This shear zone is most likely localized and is not associated with previously reported faults. Previous fault measurements are shown in Figure 4.
